Crane rope sheave failures

Issued: 21/06/2019

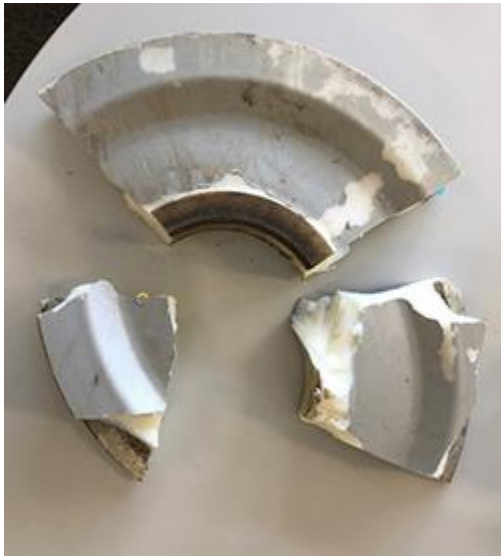
In the first incident, a plastic sheave on a 130-tonne hydraulic mobile crane failed and broke into pieces during an attempt to lift an 8-tonne load on the main winch rope (refer Photograph 1). As the sheave failed, the load dropped a short distance and applied shock loading to the hoist rope, damaging it. The main winch was rigged with three parts (falls) of rope. The sheave that failed was a top sheave on the end of the hydraulic boom. On this crane, the hoist rope passes through the top sheave and then down to a sheave on the bottom of the boom tip before passing down to the hook block.

In the first incident, it appears the main reason was the hoist rope applied a side loading to the sheave, caused by misalignment from incorrect rigging of the hoist rope. Instead of the hoist rope passing from a top sheave to the sheave directly below (so that it is close to vertical), it passed from the top sheave to the third sheave along (refer Photograph 3). Sheaves are designed to freely rotate with negligible side load.

Photograph 1: Failed sheave segments (130-tonne crane)

Mobile cranes are to be rigged in accordance with the manufacturer's instructions. The rigging set up should ensure when a rope passes from one rope sheave to another, the consecutive sheaves are aligned as closely as possible.

Regular inspection and service of all rope sheaves should be carried out in accordance with the crane manufacturer's instructions during the crane's periodic safety inspections. All sheaves should freely rotate without excessive end play. Damaged and worn sheaves are to be replaced. At the major inspection, all rope sheaves should be removed from the crane and closely inspected for both their condition and operation. Sheaves should not be painted. Information on ways to identify worn, damaged or otherwise degraded plastic rope sheaves should be requested from the crane manufacturer.

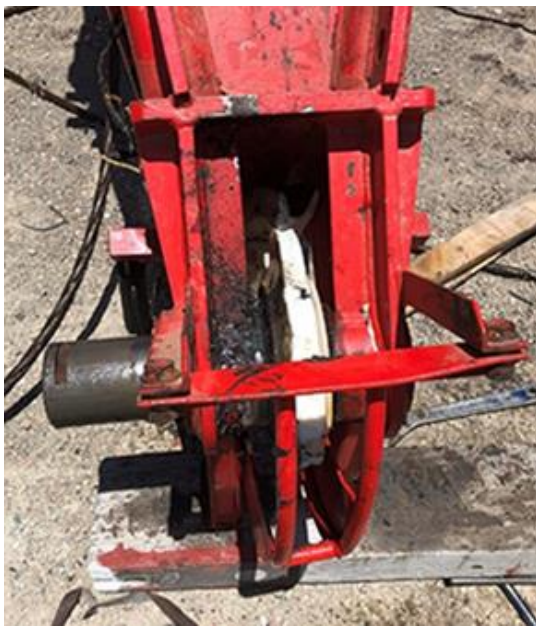
In the second incident, a plastic rooster sheave on a 180-tonne lattice boom mobile crane failed (refer Photograph 2). The crane was being used to lift a 12.5-tonne dumb barge off the back of a truck when the sheave failed. Before the crane could completely lower the barge to the ground, the hoist rope broke and the barge dropped.

Photograph 2: Failed rooster sheave (180-tonne crane)

In the second incident, it appears the sheave may have had inadequate strength for the additional *potential* side loading experienced by rooster sheaves. Since the incident, the sheave has been replaced with a reinforced sheave that can withstand greater potential side loading.

Potential side loading increases if, while the crane is operated, the hoist rope does not remain vertical. For example, if the crane is slewed rapidly and/or is slewed before the load is completely lifted off the ground, side loading can dramatically increase. On rooster sheaves, where there's only one fall of rope, there can be a greater tendency for side loading due to the rapid hoisting speed, and the propensity for the crane to be operated quickly. To reduce the likelihood of side loading on sheaves, it is important all cranes are operated smoothly and in compliance with both the crane operator's manual and safe lifting practices. If inspection shows the reeving is incorrect and excessive side load is being applied to the sheaves, the sheaves should be thoroughly inspected and, if necessary, replaced with new sheaves that comply with the crane manufacturer's specifications.

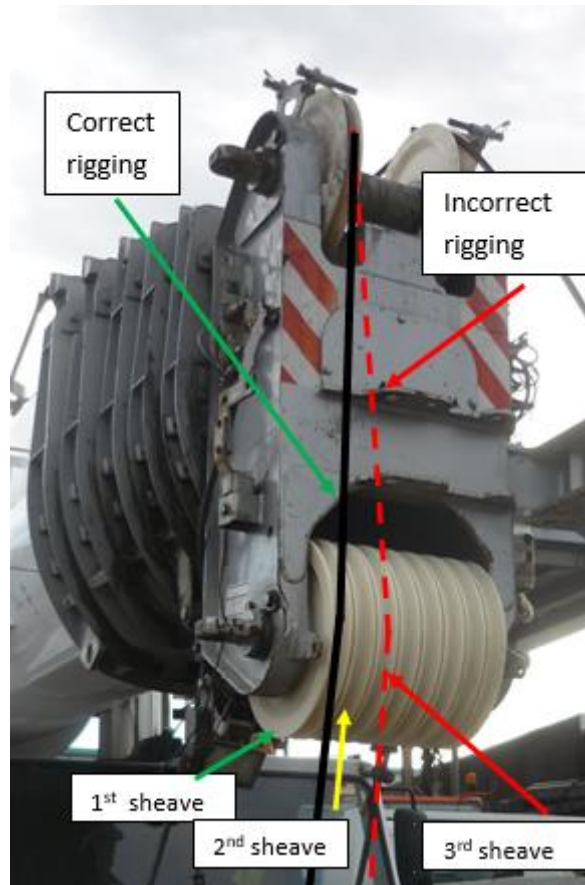
It is acknowledged that when rigging a mobile crane in multiple falls (parts) of rope, there will be a slight rope angle between sheaves due to the position of consecutive sheaves. In this configuration, when the hook block is hoisted down, this angle will reduce as the sheaves move further apart. Consequently, for a given load, the side loading applied to the sheaves will also reduce. However, for a misaligned rope on the end of a crane boom, the distance between the top and bottom sheaves stays the same and the associated side loading remains constant when the hook block is hoisted up or down.

Photograph 3: Example of correct and incorrect rigging on boom head (note: rope keeper bar removed for clarity)
