LEARN

INCIDENT	A1P4
SUBJECT	Underground Power Strike
INCIDENT DATE	14/08/2020
BUSINESS UNIT	Higgins – Levin

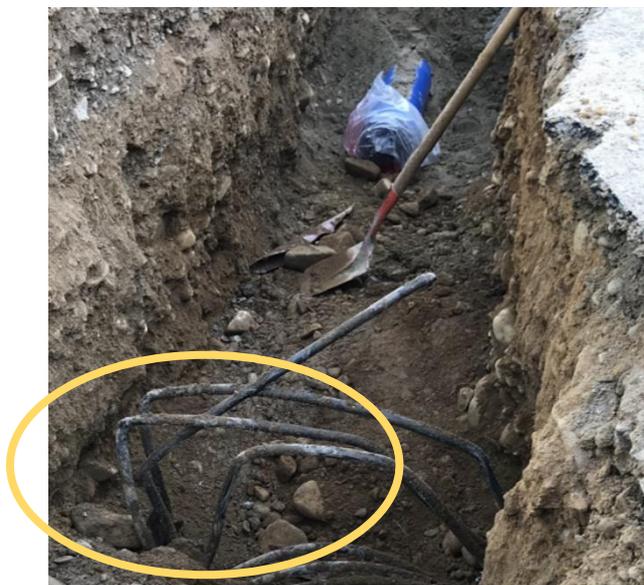
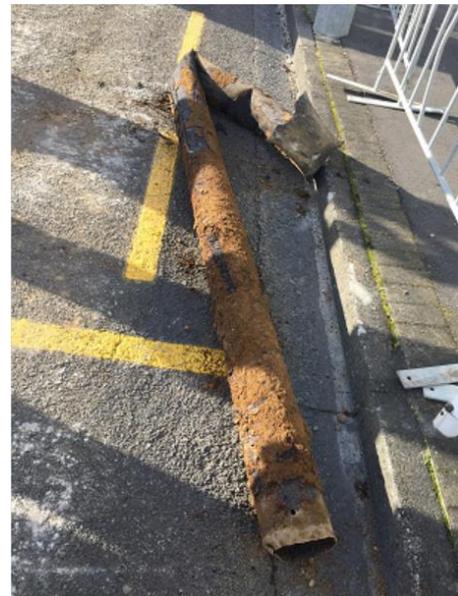
The Network service owners (Electra) conducted locate and mark-out in early June during the design stage of the job. The operator had excavated approximately 7m of trench and was in the process of lifting out a section of an old water pipe. Unknown to the operator this section of pipe passed between a 400V power main (on top) and an 11kV power cable (beneath the pipe).

The spotter had noticed the wire and called the operator to cease operation. The pipe (being free of the cable) and bucket were lifted from the trench. It was noticed the pipe had snagged the power cable and as a result had severed the 400V negative cable.

Photo: Section of old pipe passed between a 400V power main (on top) and an 11kV power cable (beneath the pipe)

Element	Corrective Action
Monitoring	We are increasing our focus on critical risk verification audits for working around utility services.
Hazard Identification Process	We have updated our JSEA to include an additional control to run locators across the intended path of excavation to check the ground between marked services.
Service Location Devices	We have requested the purchase of a ground penetrating radar unit.
Communication	We are working closely with the Network Owner including the sharing of GPS location data for the Electra GIS team to use when updating their service plans.
Training	We have conducted an introduction training on the new Critical Risk Standard (CRS) and safe work system for working around utilities. Two Branch staff have completed the CRS Train the Trainer sessions and will be able to continue educating the local staff.
