## SIGNIFICANT INCIDENT #82

### Worker Entangled in Conveyor Tail Drum

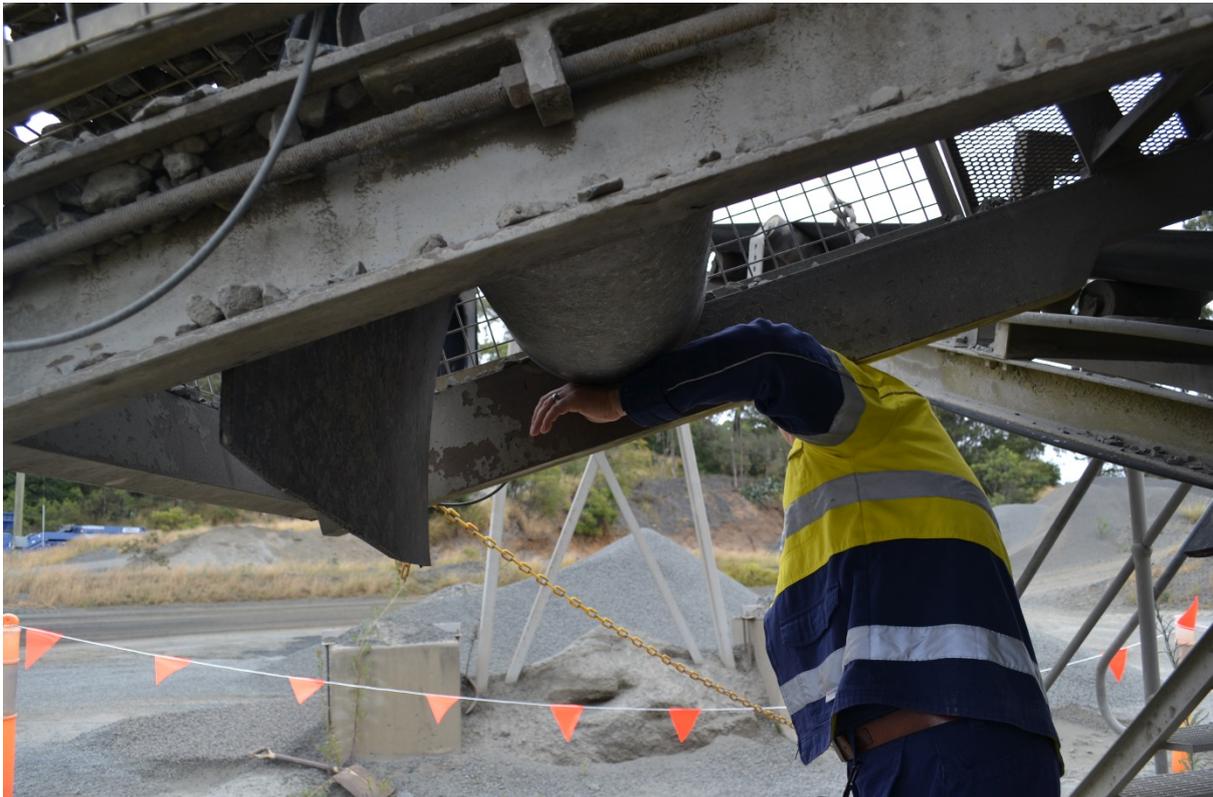
On Tuesday 19 May 2020, a worker was seriously injured at a quarry when his left arm became entangled in the rotating tail drum of a conveyor belt. Prior to the accident, the conveyor had been stopped to enable clearing of rock spillage from the tail drum area. The injured worker was attempting to clear rock from the nip point where the return side of the belt meets the tail drum, when the conveyor was briefly energised (jogged) by another worker from the plant switchboard located some distance away. The conveyor belt was cut in order to free the injured worker.

The incident is under investigation. Preliminary findings indicate that the plant was not isolated and that the conveyor was inadequately guarded.

- Plant should be maintained and operated in a way that reduces or eliminates spillage. Guards must be securely fitted and require the plant to be isolated and locked out prior to being removed to clear unintended spillage.
- If personnel are to carry out work on plant it must be isolated and locked out.
- Implement a monitoring program to ensure that guarding on conveyors remains effective.
