INCIDENT	High Potential (A1P3)
SUBJECT	Excavator Topples into Trench
INCIDENT DATE	20 th March 2020
BUSINESS UNIT	Higgins – Auckland

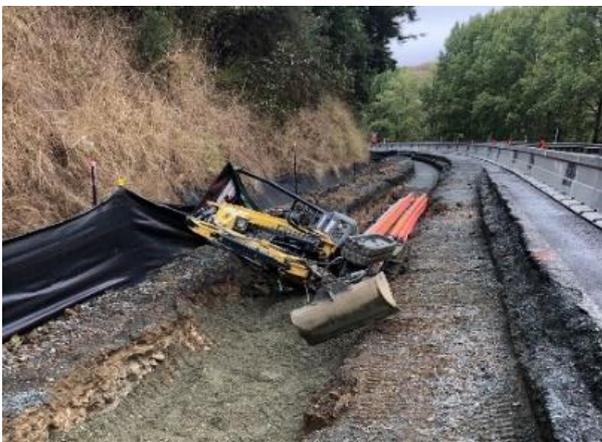
As the excavator was climbing off the undercut pavement into the trench to shift the aggregate, the side wall of the bench subsided, and the excavator slowly tipped coming to rest on its side. Fortunately, the excavator operator was wearing his seatbelt and he did not sustain any injuries. There was no obvious damage to the excavator.

Photos from the incident scene: Left – Excavator toppled over; Right – Trench dimensions;

Element	Corrective Action
Procedures	We are ensuring that approved site plans (work methodologies) are: detailed, specify type of plant and equipment required, specify operator competency required for the task, that are appropriately communicated and adhered to.
Supervision	We are also ensuring adequate supervision is provided to monitor the above requirements are implemented and no shortcuts are taken.

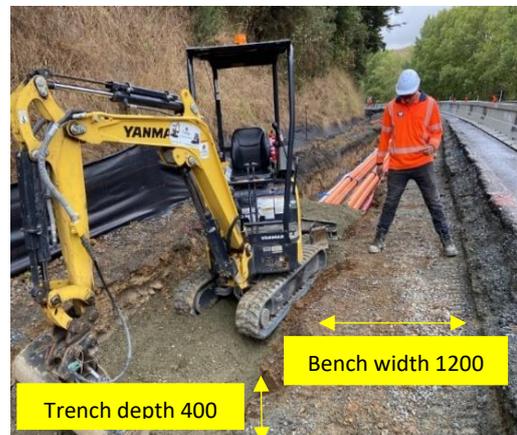
A Higgins subcontractor was backfilling a service trench. Due to the narrow workspace, 1.7T Yanmar excavator was selected to backfill the trench. A 1.5T front-end dumper was dumping aggregate in to the 0.4m deep service trench. Once the aggregate was placed into the trench the excavator positioned on the undercut pavement bench would transition into the trench and spread the aggregate. The trench access ramp was located approximately 50m south of the backfilling activities. The front-end dumper made multiple trips back and forth from the stockpile to the excavator. Due to the narrow width of the undercut pavement bench (1.2m), the excavator operator set the tracks to 0.9m. This meant that the tracks were tight under the machine, which reduced the stability of the machine. The tracks on this particular type of excavator are capable of extending to 1.2m.
