WEEKLY INCIDENT SUMMARY

Week ending Friday 22 May 2020

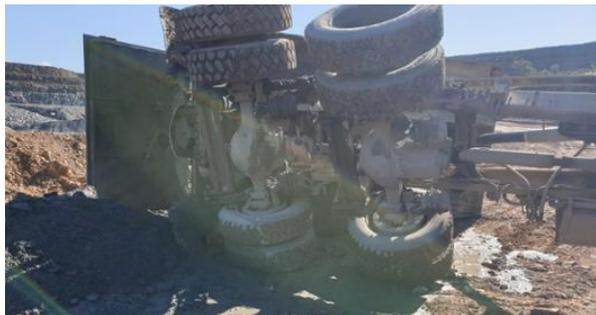
INCIDENT TYPE	SUMMARY	COMMENTS TO INDUSTRY
Dangerous incident IncNot0037381 Open cut construction materials	While unloading a trailer at a site dump, the trailer rolled onto its side when the third stage of the hoist ram was reached. The trailer tipped because of wet material hang-up. The trailer rolled towards the passenger side of the truck. The driver's cabin remained upright.	The stability of articulated vehicles is a known risk. Following a succession of similar incidents, the NSW Resources Regulator published two safety bulletins with recommendations to help prevent truck rollovers.

Refer to safety bulletins: <ul style="list-style-type: none"> ■ SB17-01 Industry reports more truck rollovers ■ SB18-07 Safe systems of work for mobile plant

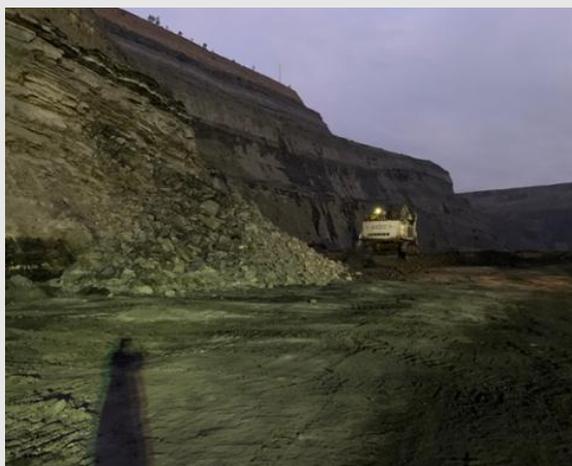
IncNot0037386

A section of a 20-metre highwall failed at an open cut mine.

An excavator crew was about 200 metres from the fall at the time.

Following several incidents in which people and equipment have been exposed to significant health and safety risks as a result of highwalls, low walls and dumps failing, we have published a safety bulletin:

- [SB20-01 Failure of highwalls, low walls and dumps](#)

Operators should take note of the recommendations in this bulletin.

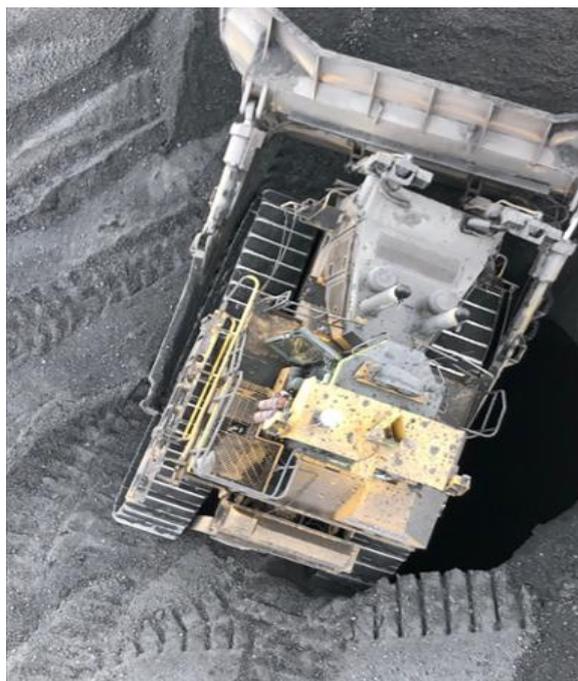
IncNot0037393

A dozer operator was pushing coal on a stockpile and was trying to dig out a bridge that had formed over a valve. The bridge unexpectedly collapsed, causing the coal to slump under the right-hand track of the dozer. The operator was unable to drive the dozer out, but decided to exit the dozer and walk from the stockpile.

Operators are reminded of the potential hazards associated with a dozer on a stockpile.

Importantly, the decision to exit the dozer placed the operator at heightened risk, because further movement of the stockpiled material could have resulted in him being engulfed.

Before starting work, supervisors and equipment operators should inspect and assess the work area to determine hazards, such as the potential for material bridging and subsequent collapse. Planning for the work must include identification of hazards, risk assessment and control.

- [MDG28 Safety for stockpiles and reclaim tunnels](#)

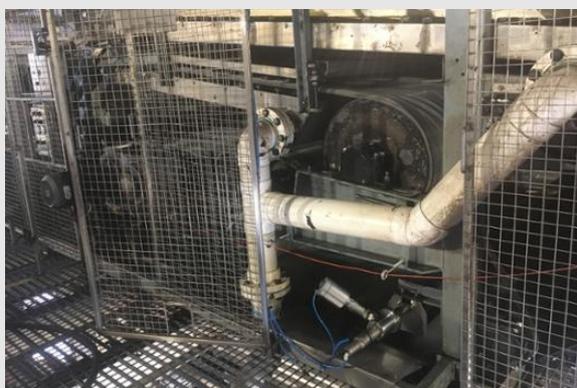
Serious injury
IncNot0037398
Coal preparation
plant

An operator was cleaning a belt press filter when he became entangled between a roller and the filter cloth. He could not free himself, and remained with his arm trapped by the rotating apparatus until released by a supervisor. The operator suffered arm fractures, a serious laceration to the top of his left forearm and an abrasive-type burn to his left lower forearm.

Under no circumstances should guards be removed, or work carried out on rotating equipment without the equipment being shut down and correctly isolated before work commences.

Where limit switches are identified as a control, mines should ensure that they are installed and operational.

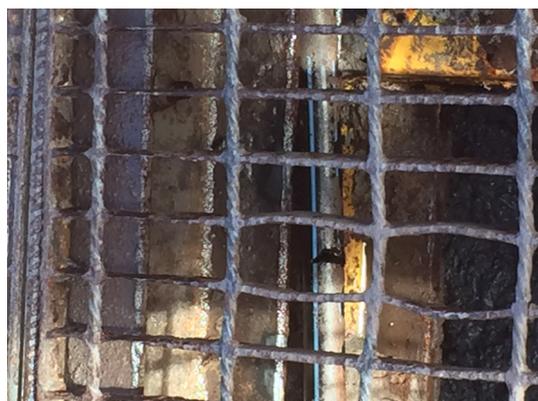
Serious injury
IncNot0037412
Underground
metals

A contractor was cleaning the floor grate on top of a leach tank area using a high-pressure cleaner. During the cleaning process, a 1.5 centimetre cut was created by the high pressure water jet on a poly line that was sitting underneath the mesh floor.

The line was a cyanide feed line and cyanide fluid sprayed from the cut pipe. The leaking cyanide sprayed for three to five minutes before the line was isolated. The operator had placed the head of the high-pressure washer below the grid mesh to remove some build-up on a beam. No-one was injured.

A job safety analysis (JSA) was completed for this task but did not identify the risk of the lines underneath the mesh floor being compromised. The pressure cleaner operating pressure was reduced for the job from a maximum pressure of 2500bar to 690bar.

The incident highlights the importance of contractors being provided with all relevant information before work begins. Appropriate labelling of the poly pipeline may have alerted the cleaning contractor to the existing hazard.
