INCIDENT ALERT

LOCATION:	AGGREGATE DREDGER	ALERT STATUS:	Normal
ACTIVITY:	LIFTING	DATE ISSUED:	03/12/2020 16:24:47
SUB ACTIVITY:	NO SUB ACTIVITY AVAILABLE	INCIDENT No:	03580

Fatal 6 - Lifting operation LTI injury - BMAPA Alert

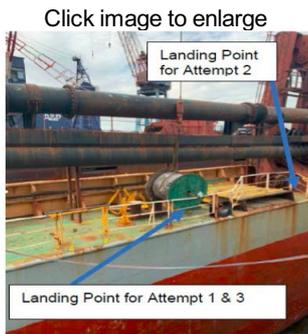
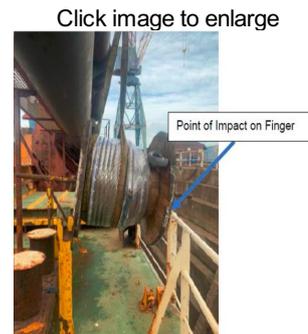
A decision was then made to move back to the original location and the trestles were set up in this location. The wire reel was lifted on-board, a cross bar was then inserted through the centre of the reel to facilitate rotating the reel into the fore and aft direction. During the rotation, the reel moved more quickly than in the previous attempts, it was at this point the IP sustained a crush injury to his left forefinger. The reel crushed his finger against the upright stanchion of the hand railings.

- The dimensions of the reels used to dispatch replacement wires are not a standard size.
- If a particular size is required to fit an existing support trestle or to enable access through a hatchway to the hold for storage then it should be specified at the point of order.

- All vessels to discuss this incident in detail at the next available opportunity and ask "...could this happen on my watch?"
- All vessels to reflect on risk assessments for changing wires to ensure effective hazard identification has been completed.
