Coal Inspectorate | Alert | No.395 V 1 | 16 August 2021

CHPP pump suction pipe dislodges resulting in a serious injury

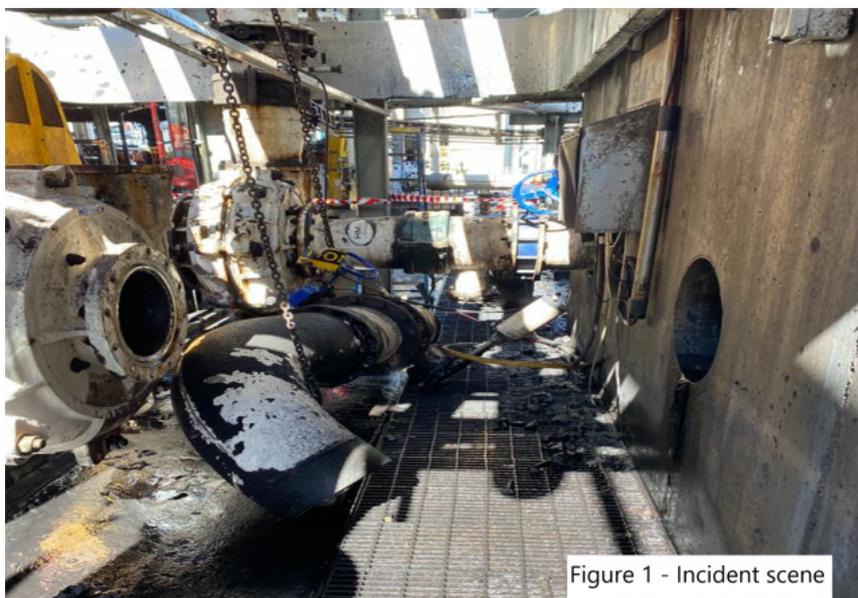
On the 21 July 2021 coal mine workers were undertaking maintenance work on a pump in a coal handling and preparation plant. During the process the suction line, including the sump isolation valve released from the sump wall under pressure. A worker was impacted by the expelled components suffering a serious injury. The expelled pipework, pump and sump are shown in Figure 1.

Figure 1 - Incident scene

- Complete an audit of site plant and identify where Link-Seal type seals or similar are installed.
- Make sure that Link-Seals are installed as per the Original Equipment Suppliers requirements.
- Make sure that pipes and valves are adequately supported and restrained. That Link-Seals are not relied on for structural support. Engineered supports and restraints should be used.
- Review and update risk assessments and associated procedures ensuring risks associated with all stage of the life-cycle of the seal and associated components in the system (eg pipes, valves, seals) are considered. This should include foreseeable installation, operation and maintenance scenarios.
- Ensure the failure of pipework and seals has been adequately considered. The potential for serious harm to workers in the “line of fire” must be considered and controls implemented to minimise risk to worker.

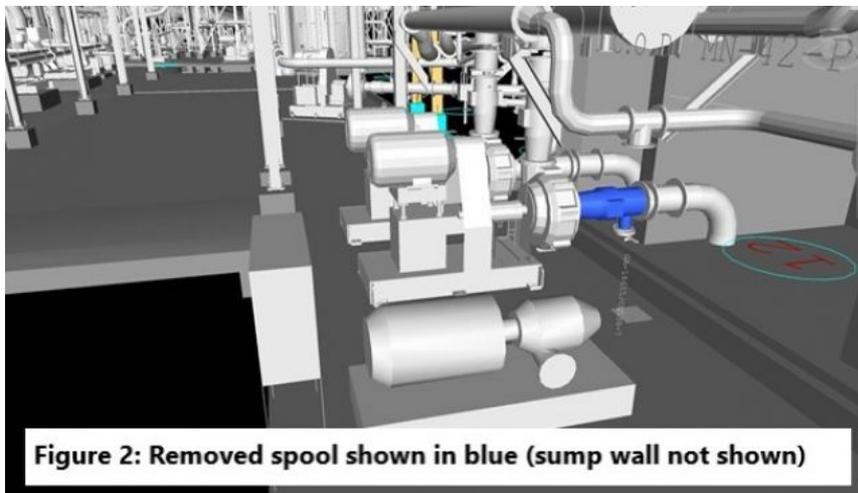
- Coal mine workers were in the process of changing a pump in a coal handling and preparation plant.
- The suction valve and pipe from the sump was isolated. The sump contained fluid.
- At the time of the incident a pipe spool had been removed as planned. The pipe spool which had been removed is shown schematically in Figure 2.
- The injured worker was standing between the pump and the suction pipe protruding from the sump wall.
- The isolation valve, piping and Link-Seal released from the sump wall, impacting the worker and pushing him against pump. The pipework ejected from the sump is schematically shown in Figure 3.
- Emergency response procedures were initiated by the work crew and the worker was removed to a safe location.

Figure 2: Removed spool shown in blue (sump wall not shown)

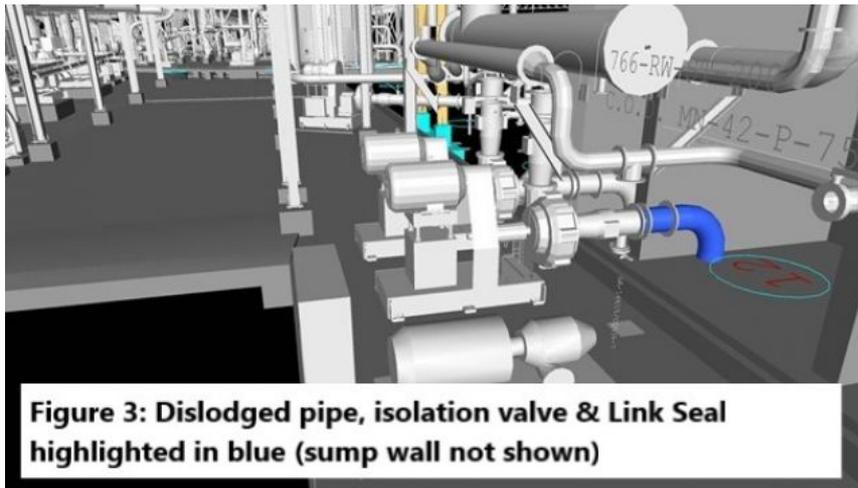
- The suction pipe had been retained in the sump wall by a Link-Seal.
- Link-Seal modular seals are penetration type seals. They are not intended to be a structural support.
- Suction pipework was not supported or restrained by other means.

Figure 3: Dislodged pipe, isolation valve & Link Seal highlighted in blue (sump wall not shown)
