Electrical Shock Incident

Alert No. HSEQ-SA-088
Date of issue 09/12/2019

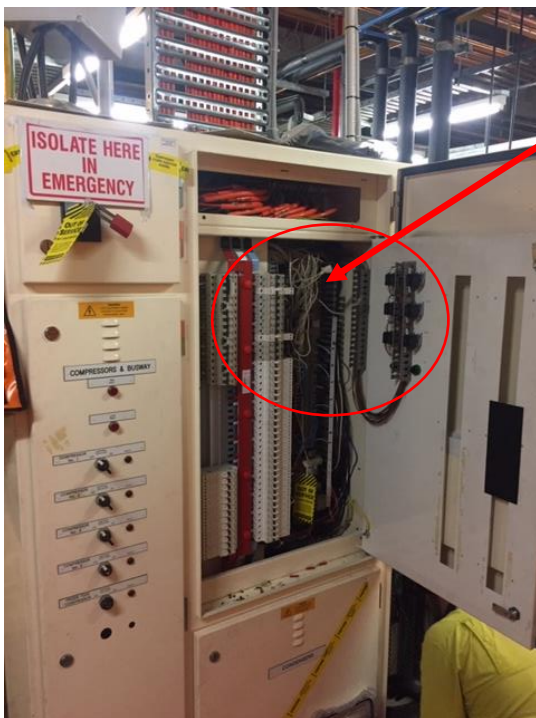
While waiting for technicians to finalise the installation of the split condenser valve in the adjacent area the contractor identified existing untidy cabling behind the panel and made the decision to tidy the cables by pushing them to the rear of the board. The contractor pushed the cables with his hand and contacted an exposed energised wire resulting in an electric shock to the finger.

Untidy wiring within switchboard.

- The non-compliant cabling to be inspected and removed from switchboards in the plant room.
- The contractor has been issued with a corrective action to update their SWMS to address the non-conformances relating to identification of electrical hazards for installing cables in energised cable ducts and working near energised cables in switchboards.
- Isolation of switchboards is required when any physical inspection, including touching of insulated cables is undertaken.
- Technicians are to be reminded that appropriate PPE is to be worn/used during live access work, including testing – LV gloves, face shield or safety glasses, insulated mat/barriers.

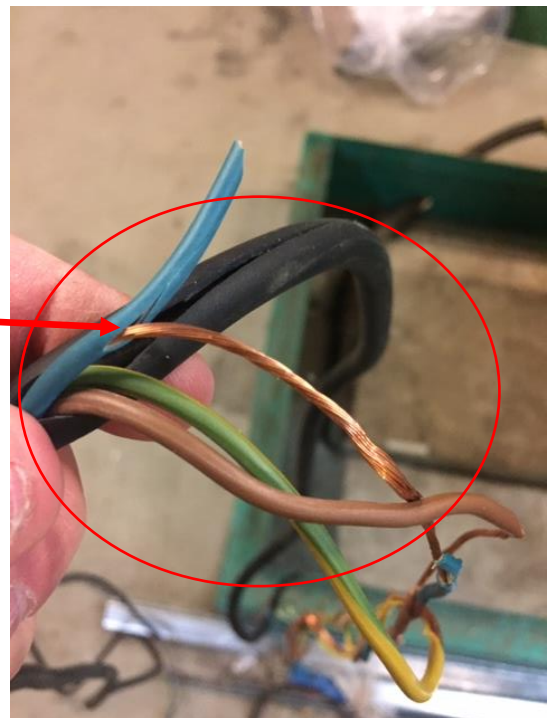
Substandard insulation on the wires inside the switchboard.

- Worker was reliant on the insulation on the cabling for protection from potential electrical shock.
- Worker did not wear low voltage insulated gloves.
- Existing cable was of a substandard manufacturing process.
