# NZ Safety Alert

2 October 2020

## Crushed finger injury

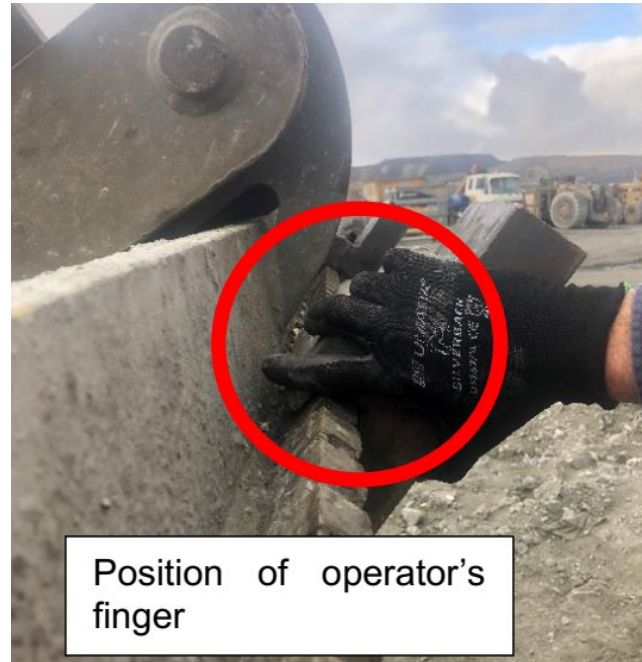
An Integrated Tool Carrier (IT) operator was in the process of loading a pallet at the batch plant using a forklift attachment. The tines on the attachment required adjusting as both were positioned to one side of the frame.

In the process of repositioning, the operator pushed the tine across to the centre of the frame where it has released through a slot and swung forward, crushing the operator's finger between the top of the tine and frame, resulting in a deep laceration to the right-hand ring finger.

1. Where equipment crush or entrapment hazards exist, all plant is isolated prior to commencing work on it.
2. Maintenance is always conducted in accordance with Original Equipment Manufacturers specifications.
3. Regular workplace inspections are conducted to check equipment and to ensure procedures are being followed.
4. PPE is checked to ensure it is appropriate for the task being conducted.
