NZ Safety Alert

September 2019

Fire risk on excavator

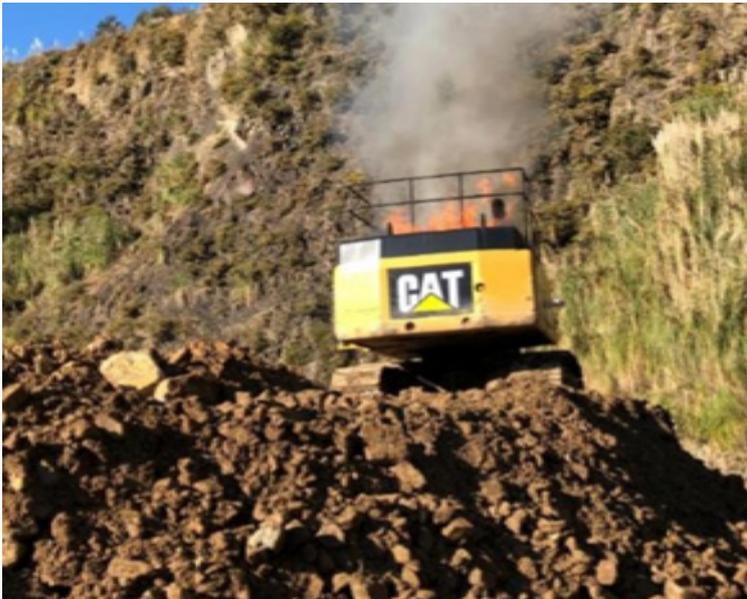
A hired CAT 345D Excavator operating on a quarry stockpile caught fire in the engine compartment. The speed of the fire and smoke meant that the operator had to turn off the excavator and jump clear. No injuries were sustained however the excavator received fire damage, which was confined to the engine compartment.

The main wiring loom and main power cable to the starter motor of the excavator are secured by a "P" clamp where they pass through the main cross member of the chassis.

The rubber insulation on the "P" clamp had failed and fallen out due to contamination from oil and heat over the lifespan of the excavator.

This has allowed the wiring loom and power cable to vibrate in the "P" clamp and cause wear on the insulation of the wiring loom.

The wear on the insulation and wiring loom has caused a wire in the loom to short, overheat and set fire to the insulation. The fire has then spread through the engine bay of the excavator.

1. Regular inspections are conducted on mobile equipment of wiring looms. Checks should look for any chaffing/rubbing of wires and faulty securing clamps, especially "P" clamps.
2. Immediately replace any worn insulation or "P" clamps.
3. This alert, and others, are shared with all workers, particularly mobile equipment operators, mechanics and contractors.
4. Speed is reduced to match the conditions, particularly when travelling loaded, down steep slopes.
5. Procedures are clear on action to be taken by mobile plant operators when they experience an engine fire on mobile plant.
