NZ Safety Alert

December 2019

Excavator uncovers misfire

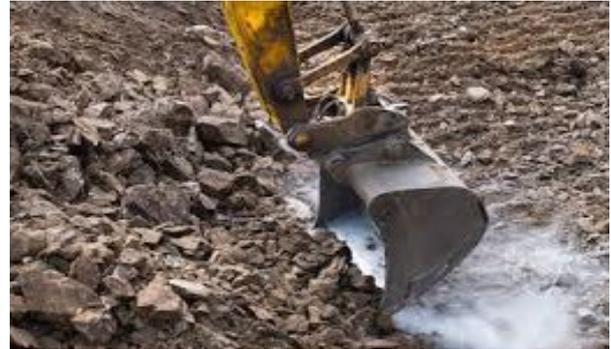
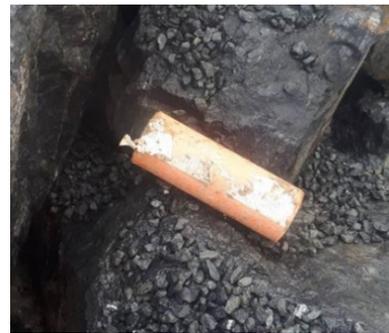
A digger was moving rock from the quarry pit when the operator saw a detonator and booster in the digger bucket. The operator stopped and advised the quarry manager who advised the current blasting contractor and requested them to check the explosive.

The detonator and booster were from a previous shot over two years ago and were placed in a safe area and this area was isolated off. The blasting contractor gave advice and removed the explosive from the site to be stored in a safe location prior to disposal.

Recently at a different quarry, while excavating rock from a production blast area an operator noticed a booster protruding from the blasted rock. Upon inspection the operator noticed that there was no detonator in the booster.

1. A misfire procedure is developed and explained to all workers.
2. Workers treat any explosive components found while quarrying after blasting as live and immediately isolate the area and implement the misfire procedure.
3. Ensure pre-ignition tie-in inspections are conducted so all tie-ins are checked by at least the shotfirer and one other person.
4. Ensure post-blast inspections are properly conducted to identify areas of potential misfires.
