SAFETY ALERT

INCIDENT	A1/P1 Near miss
SUBJECT	Rope sheave guard fell from top of drill rig's mast
INCIDENT DATE	19-05-2021
BUSINESS UNIT	Brian Perry Civil Northern Region – Project Lightspeed
RADAR NUMBER	INCID-0045717

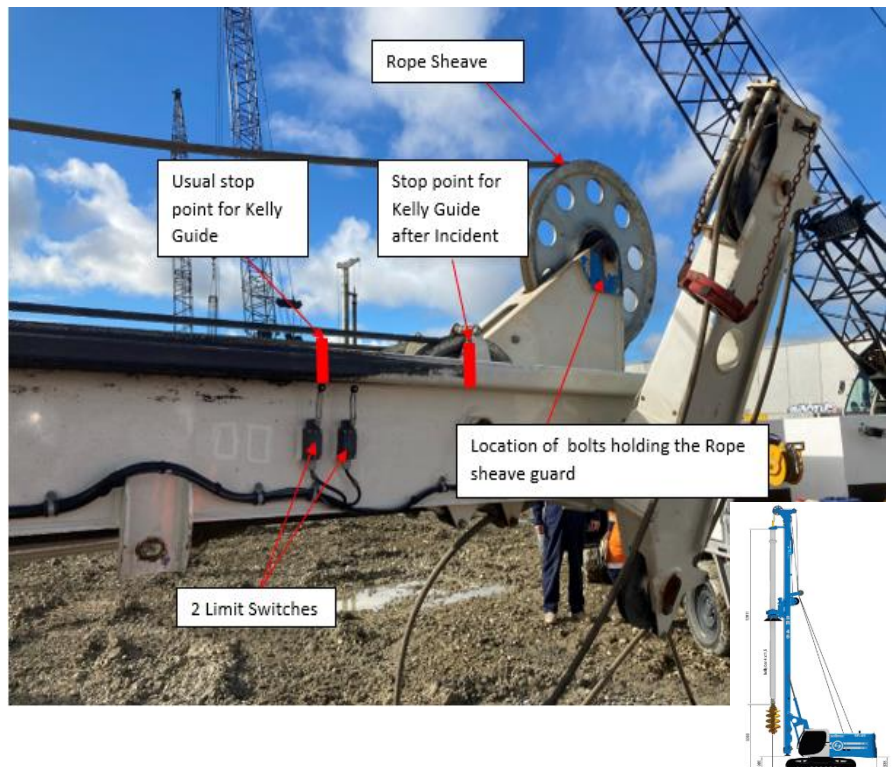
A Soilmec SR45 drill rig was carrying out normal piling operations. As the Kelly bar was retracted from the pile the Kelly bar guide passed through the electronic limit switch that cuts out the system. Before the hydraulics could cut out, the Kelly rope crimp and swivel connected with the rope sheave guard, shearing the six bolts retaining the guard. This resulted in the guard coming off the mast and falling to the ground.

- The 3 metre auger used during the time of the incident was replaced with a 2 metre auger to gain an additional metre clearance from the top of the mast.
- Both the Kelly and rotary limit switches were moved 100mm lower down the mast and a 2nd Kelly limit switch was put in place as a failsafe with the consent of the manufacturer. Other rigs were reviewed for set up.
