## INCIDENT ALERT

**Fatal 1 - Lorry driver near miss - Head stuck under tipper body**

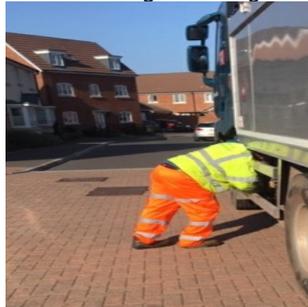
The lorry body design was such that an aluminium skirt around the bottom of the body sat approximately 6" from the side safety impact rail when the body was lowered.

As per the photo, when the driver leaned over the side rail to retrieve the scraper the body slowly came down and trapped him between the two surfaces and resulted in being unable to get his head out.

**Driver's head trapped**

The haulage company re-trained ALL drivers in relation to their company handbook - in particular, tipping procedures.

The haulage company discussed the incident with the vehicle manufacturer to modify the locations / designs of skirts, toolboxes, controls, etc.
