# Building failures during severe weather events

Issued by Resources Safety & Health Queensland

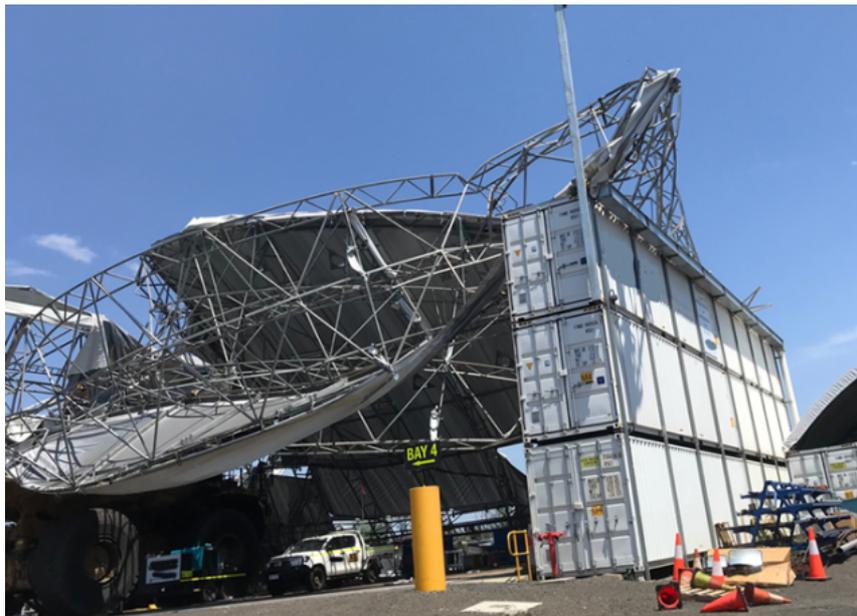
- The failure of several dome fabric structures (igloos):
  - One collapsing most of the structure as shown in Figure 1. Personnel were located within the structure at the time of the event.
  - Other dome fabric structures sustained partial structural damage to the roof. One failed structure is shown in Figure 2.
- A steel framed and clad shed collapsed.
- Snapped power poles, damage to building cladding, signs and up-rooted trees.

- Investigations of weather data suggests that in at least one event the site may have experienced a 'microburst' within a severe thunderstorm. Microbursts are very intense downdrafts that occur within severe thunderstorms and supercell thunderstorms.
- The thunderstorms were localised, intense and had a narrow path through the mine sites.
- Wind loads on the structures are believed to be within the range specified by the AS/NZS 1170.2-2011, but deficiency in the design meant that the structures were just not robust enough to withstand the storm.
- Wind loads on exposed structural elements of fabric structures can be significantly higher than the design loads assumed when the fabric clad structure is intact.
- The forensic investigation of one failure identified structural elements that may not have met design code strength requirements for design wind loads.

- Audit all structures to assess the structural condition and take remedial actions to rectify issues identified.
- Review the suitability of site facilities deemed to be places of safety during sever weather events.
- Review historical site and regional meteorological data and storm events. Validate the design criteria, including wind loadings to be used in the design of site structures.
- Review design and serviceability assumptions of domed fabric structures. Validate the design of existing structures to ensure they are capable of withstanding the assumed loads.
