Safety Bulletin 194

Excavator emergency access & egress systems

Appendix

OBSERVATIONS FROM TESTS ON SPECIFIC BRANDS AND MODELS

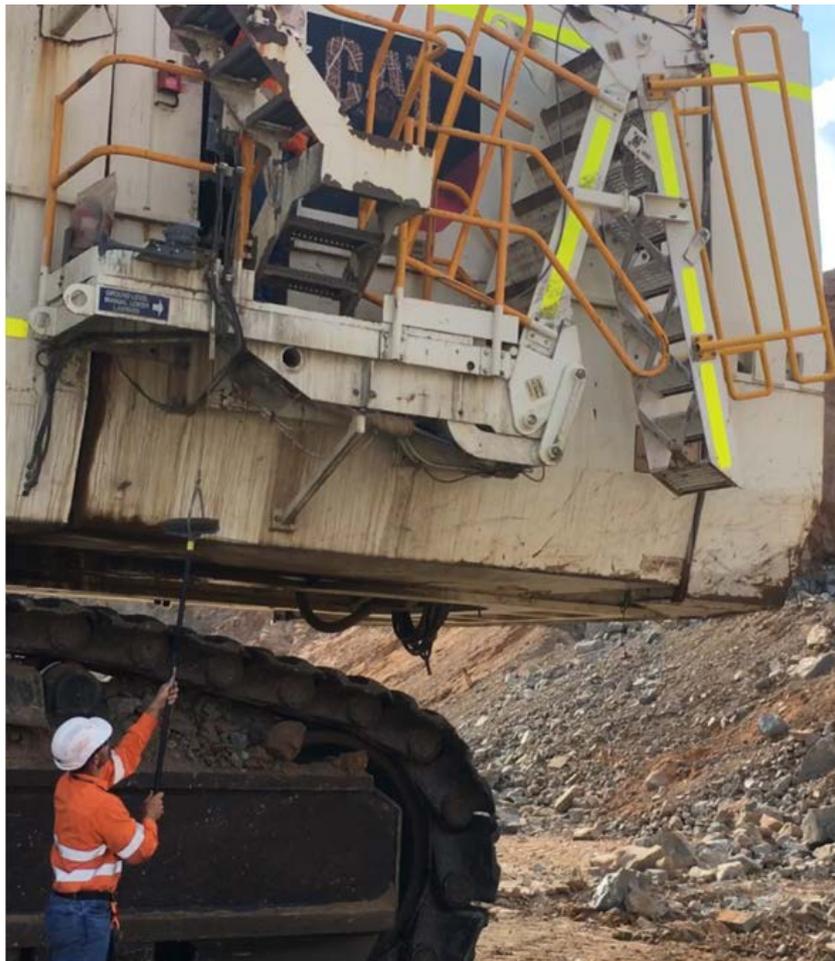
- The cable end was too high to access from ground level. (See Figure 1) We were informed that on both the left and right of the excavator, a rod with a hook was stored within the track frame. This could be used to reach the cable.
- On the side nearest to the cable, the bracket holding the rod had broken off, resulting in the loss of the rod. (See Figure 2). On the opposite side, the brackets were still in position, but there was no rod.
- In case of an emergency where the operator needs to be assisted from ground level, rescuers will struggle to access the machine in a timely fashion.

Figure 1 - Pull wire too high to reach

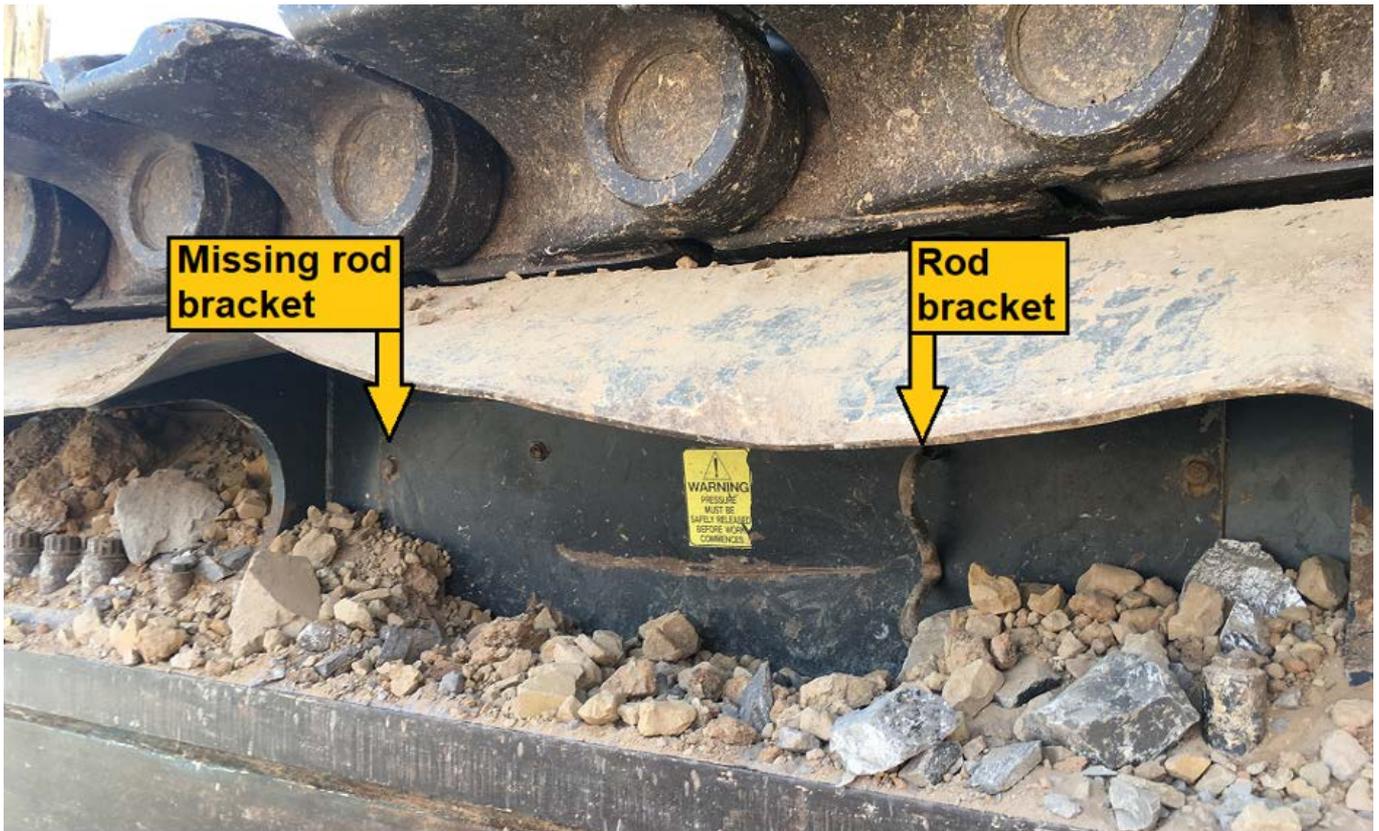
Figure 2 - Missing rod and bracket for pull cable

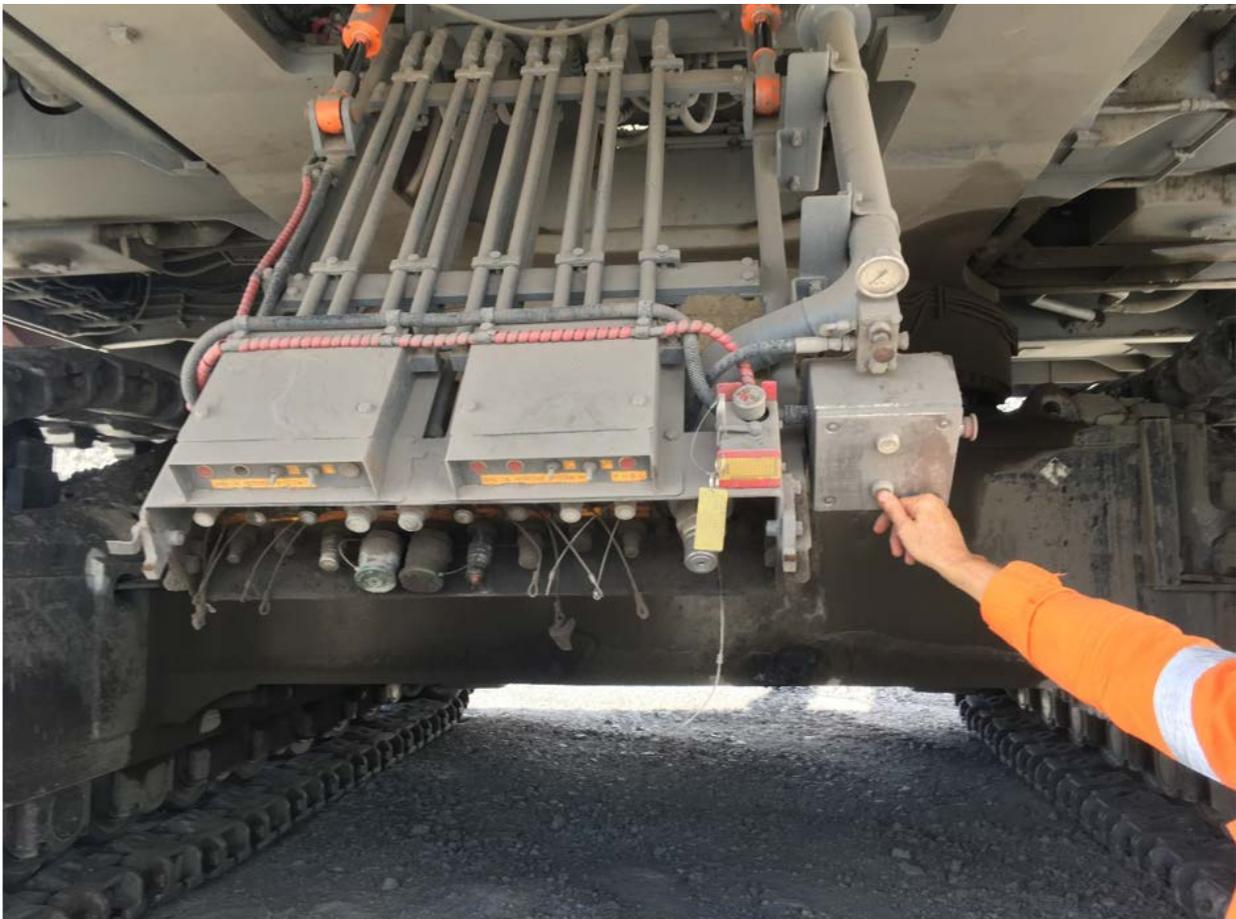
- We later learned that the service tail is lowered with this second cable. Once the service tail is lowered, switches within the tail can be used to lower the access ladder. None of this was communicated by signage or otherwise. (See Figure 3). Operators were unaware of this arrangement.

Figure 3 - Switch for lowering access ladder from ground is in the service tail

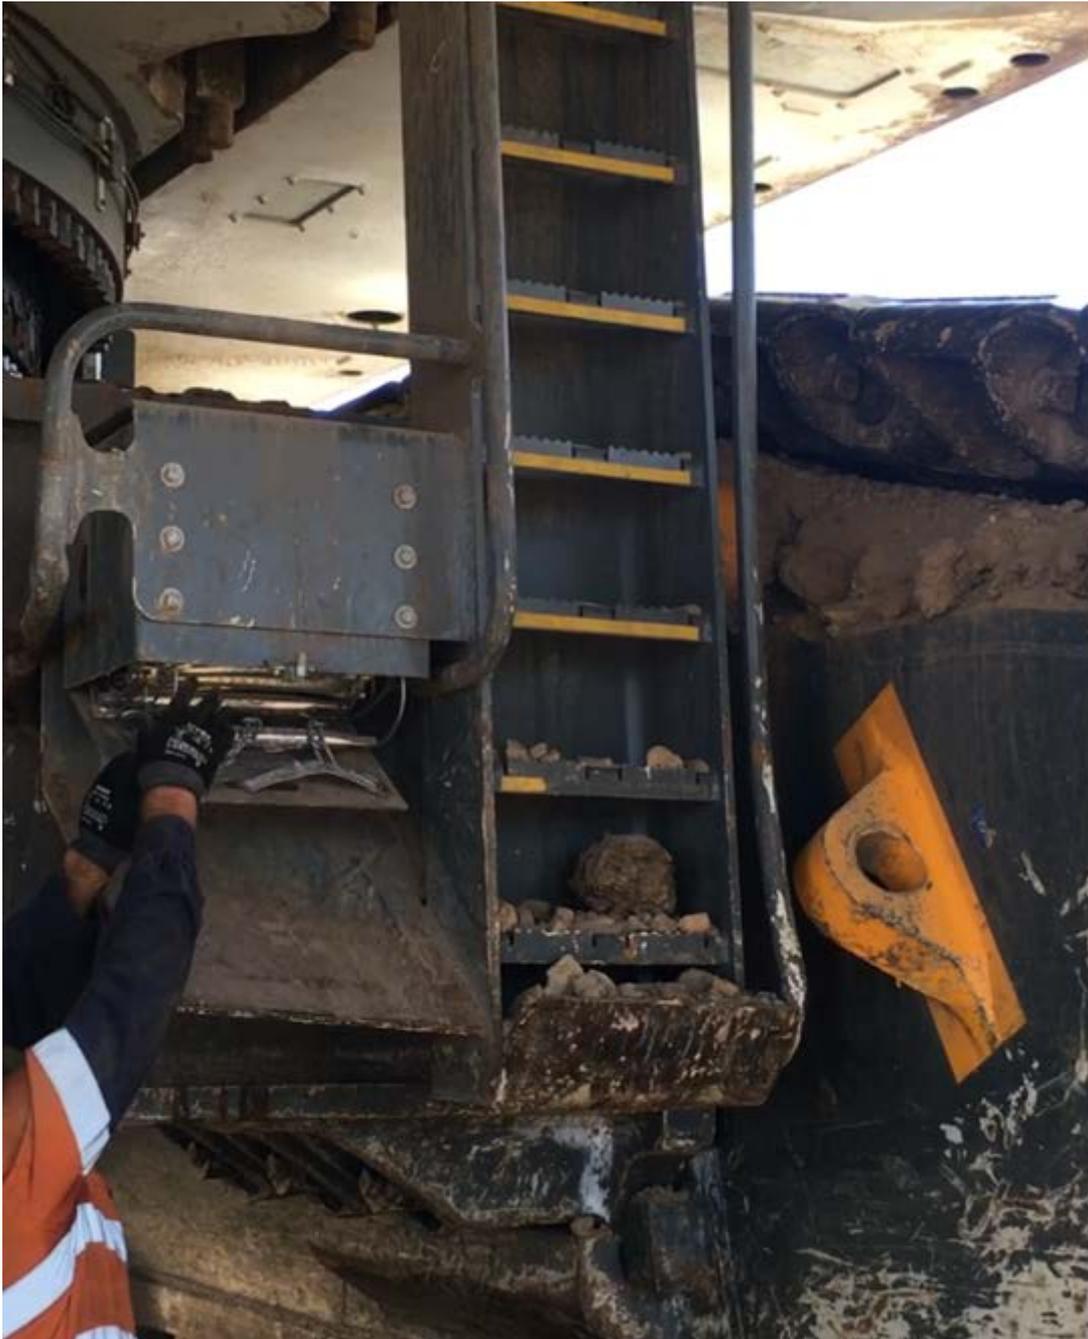
Figure 4 - Roll-up ladder from front of track frame to ground level

This issue may be resolved by installing a suitable roll-up ladder on the house and near the bottom end of the upper half of the ladder. It will rotate with the house and be available regardless of how the house is turned. (Figure 4 shows a similar ladder mounted on the track frame.)

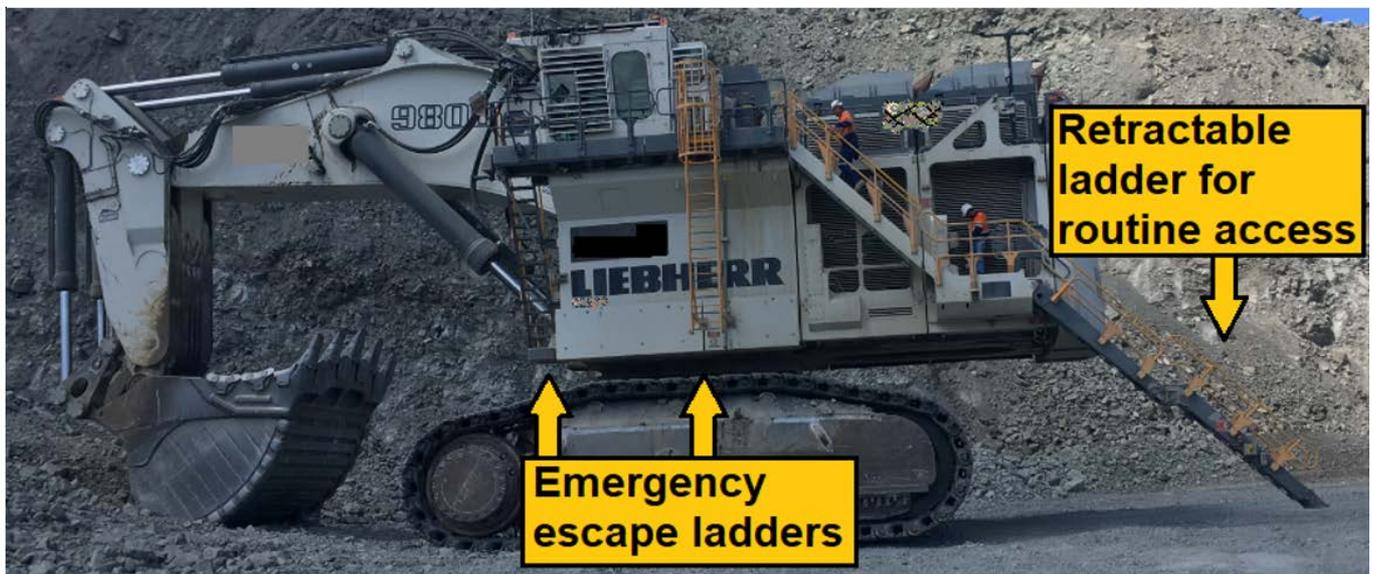
This excavator has one retractable main access ladder for both routine and emergency use. There are also 2 emergency egress ladders to the side and front of the operator's cabin respectively. (See Figure 5)

Figure 5 - Ladders for emergency and routine use

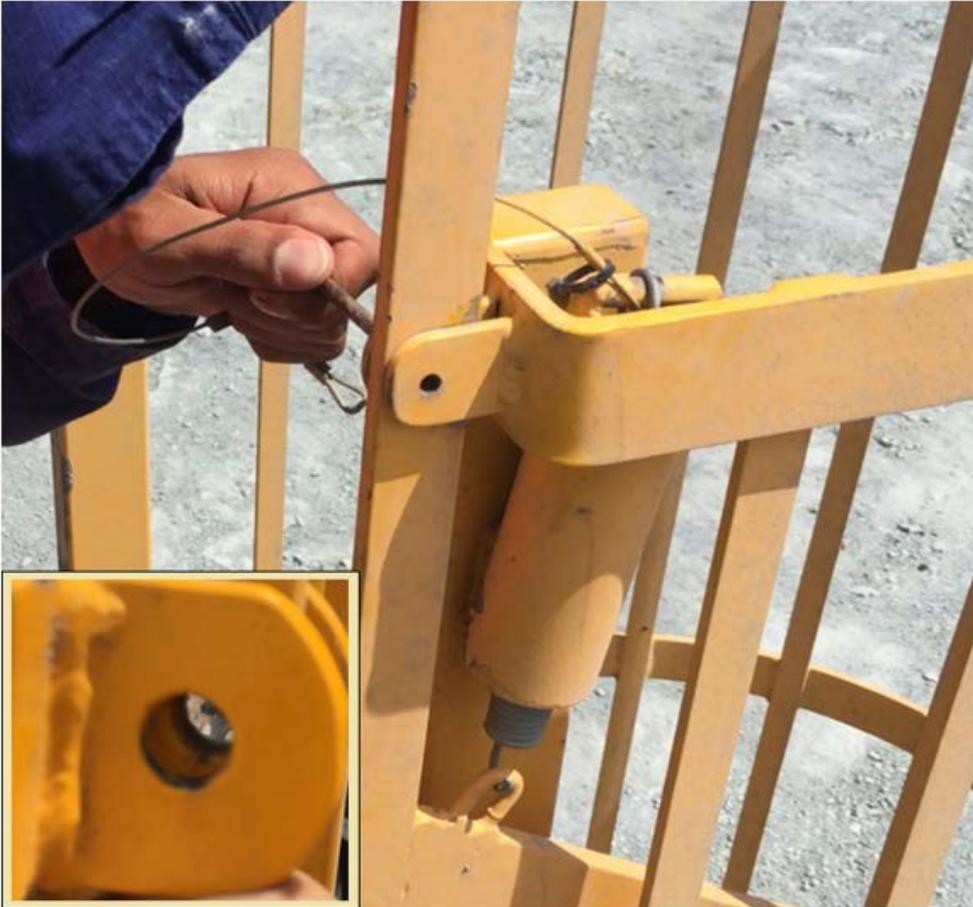
4. The operator, stuck on board, attempted to egress from the emergency ladder to the left of the operator's cabin. The release pin was stuck due to the pin-holes being misaligned and it took him approximately 3 minutes to get it out and for the ladder to fall to the ground. (See Figure 6)

Note that, for an excavator on fire, 3 minutes is a very long time

Figure 6 - Top of emergency escape ladder near operator's cabin. Misaligned holes caused the release pin to be stuck. The inserted photo is from a similar machine at another mine site, also showing misalignment. Note the undercut bracket welding

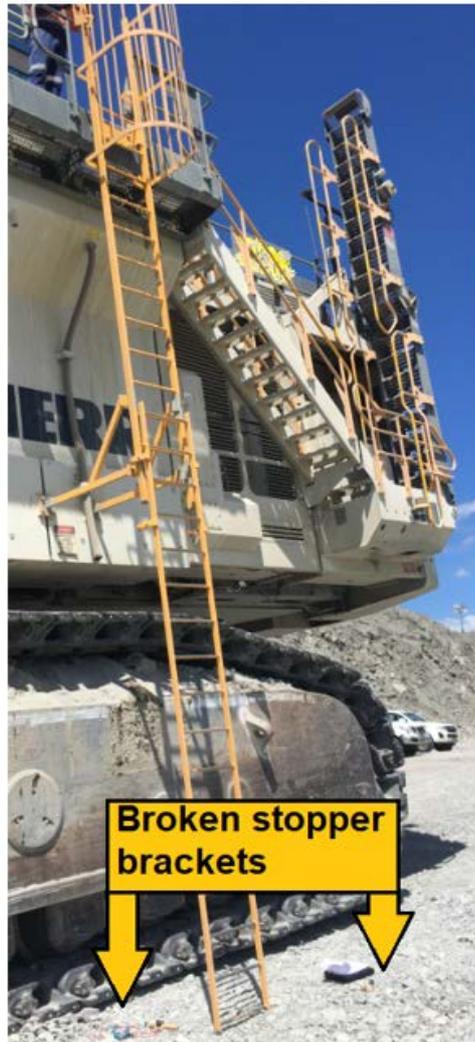
5. Near the end of its downward trajectory, the ladder in (4) was supposed to have been stopped by 2 brackets. The welds for both brackets broke and the ladder fell further down than it should have. In this position, the operator could not safely access this ladder. (See Figure 7)
6. Because of the rotation of the house relative to the tracks, safe egress or access from the ladder to the front of the cabin was not possible. (See Figure 8).

Figure 7 - Welds on both stopper brackets failed when the ladder was released

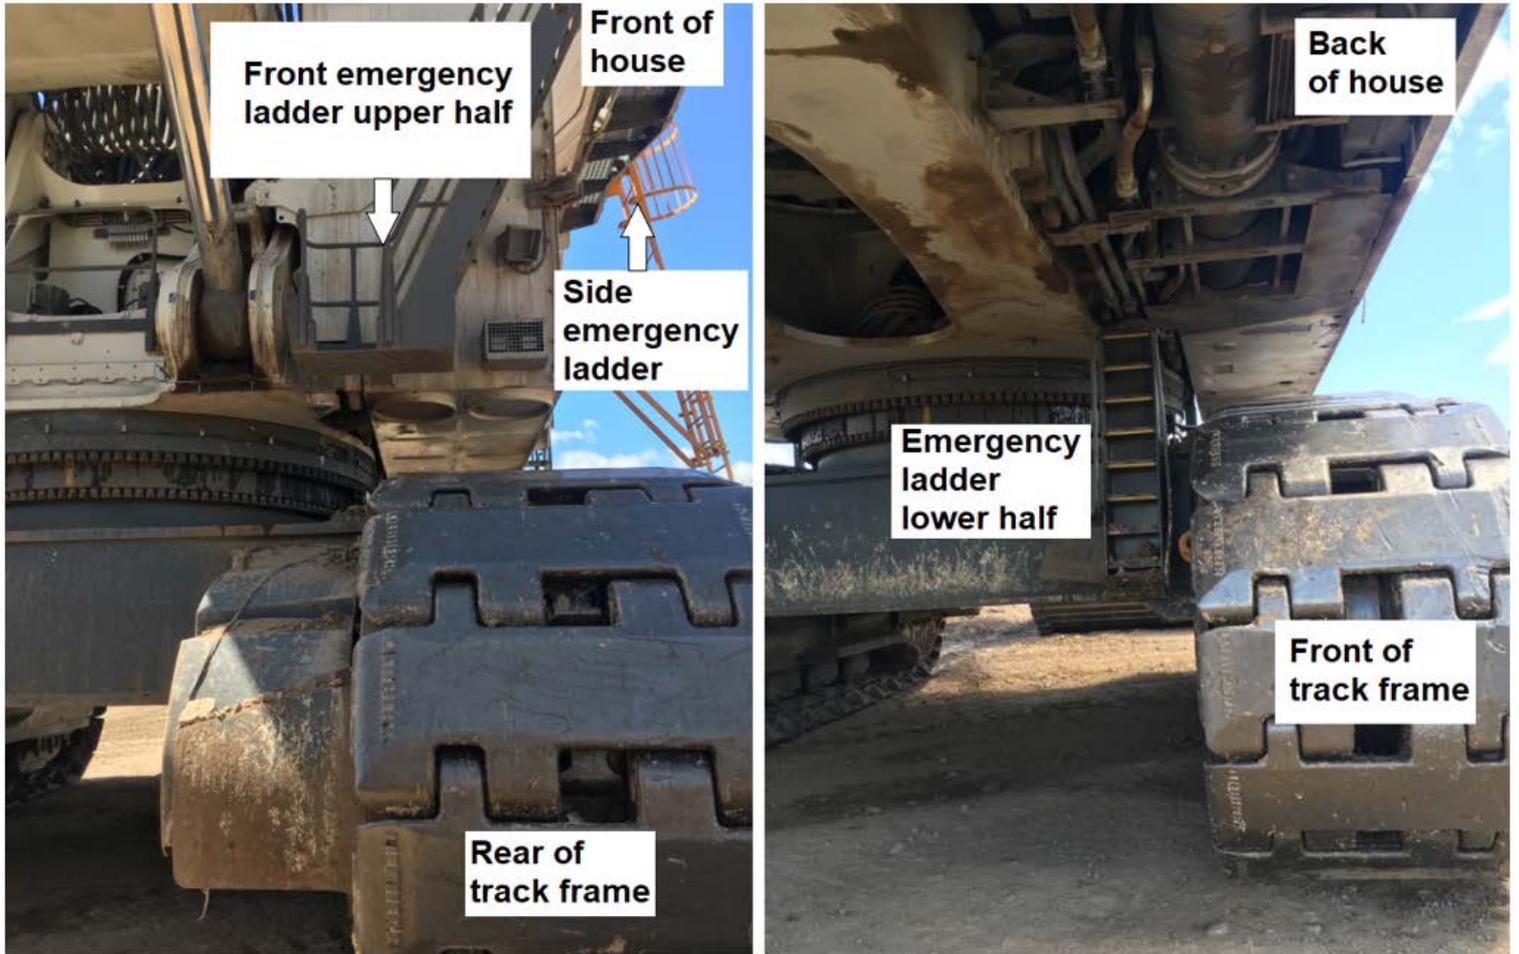
- Because of the 180 degrees rotation of the house relative to the tracks, safe egress or access from the emergency ladder to the front of the cabin was not possible. (See Figure 8)

Figure 8 - Misalignment of ladder halves. House is rotated 180 degrees relative to track frame
