INVESTIGATION INFORMATION RELEASE

Worker struck by light vehicle at quarry

Event: Fatal incident at a hard rock quarry

Location: West Wyalong Quarry, Wyalong NSW

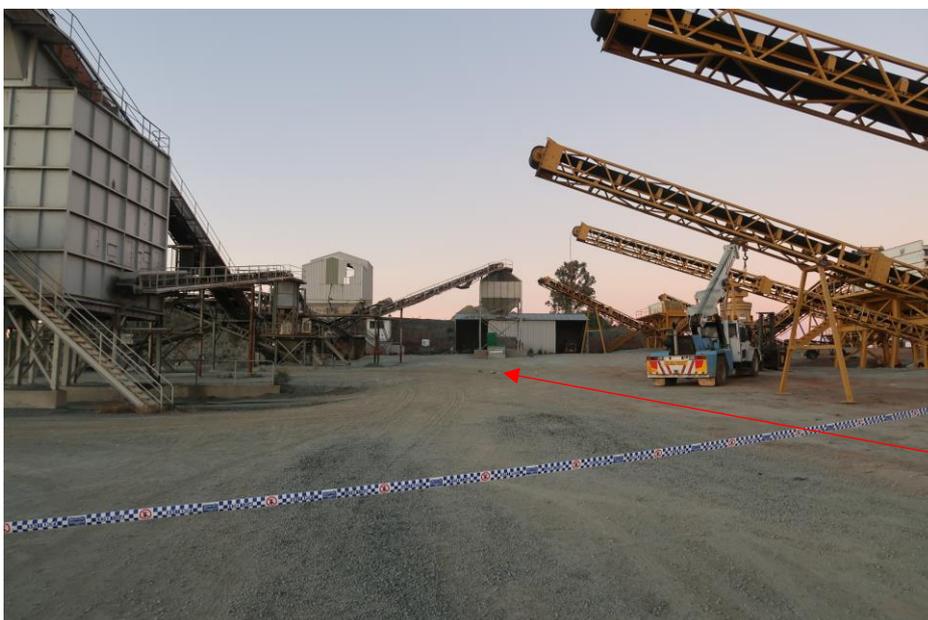
Figure 1: View looking south toward crushing plant showing location of the worker when struck.

Location of worker when struck by light vehicle

While the contract worker was still kneeling down collecting the washers, the driver started the light vehicle and made a left-hand U-turn in an easterly direction. As the light vehicle travelled around the yard, the lower front passenger side of the light vehicle struck the contract worker from behind and travelled over him.

- the adequacy of transport management plans including parking locations, separation between pedestrians and light vehicles, audible warning systems and communication protocols on site.

- observe the surrounding area and intended path of travel prior to starting vehicles
- ensure the intended path of travel is clear of pedestrians and other obstructions prior to moving.

- avoid placing themselves in trafficable areas unless safe to do so
- ensure effective positive communications with light vehicle operators
- ensure acknowledgement of their presence and intended work location by light vehicle operators.
