SAFETY ALERT

DATE: April 2021

Worker sustains critical injuries after driving loader over stope edge

CM9 reference	DOC21/220456
Mine safety reference	SA21-04
Date published	07 April 2021
Authorised by	Chief Inspector Office of the Chief Inspector

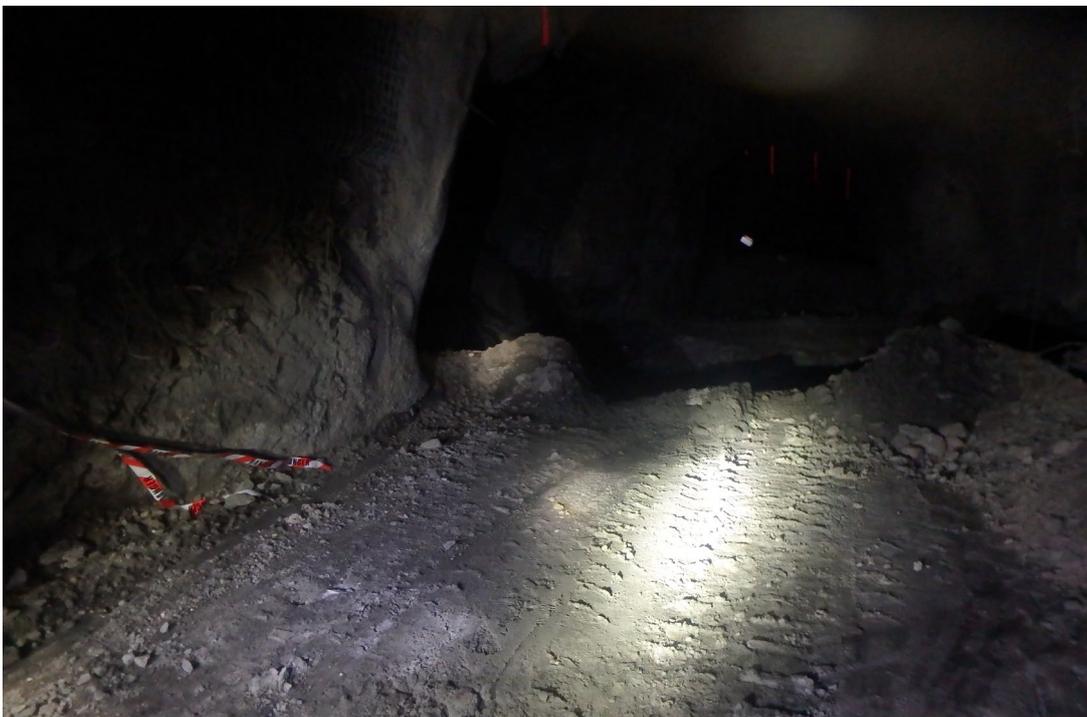
A worker has sustained critical injuries after inadvertently driving his Caterpillar R2900 LHD off the edge of a stope and falling 20 metres to the level below. The dirt bund has been completely knocked over by the LHD in the incident.

Figure1. Depicts the open stope tip edge following the incident.

For reasons unknown, the worker drove the LHD through a dirt bund at the stope edge and fell about 20 metres to the level below.

- fit for purpose stop blocks are installed and inspected when manual tipping from the edge of a stope
- bunds and associated markings and reflectors are built to the required standard and frequently inspected
- tele-remoting used as the primary control when tipping over the edge of a stope
- when retreat stoping towards the level access road, change management process are in place, to inform the workforce of the change of road layout, before firing out the access road stope.
- mines must consider this scenario when developing their emergency response systems.
