INVESTIGATION INFORMATION RELEASE

Person at risk from flyrock at quarry

Event: Dangerous blasting incident at a hard rock quarry

Location: Cootamundra Quarry, Cootamundra NSW

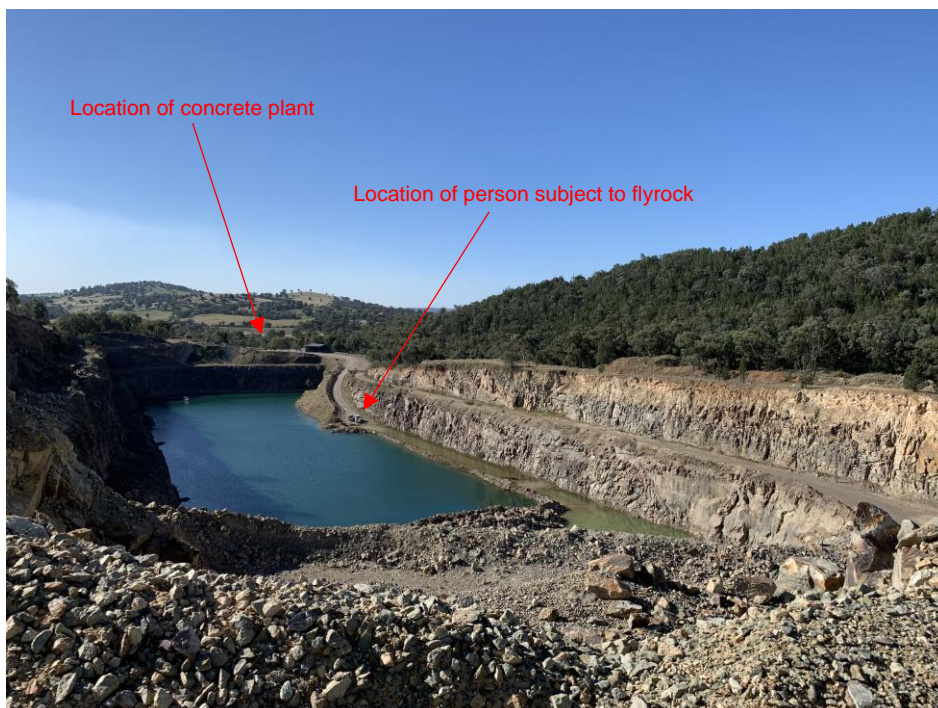
Figure 1: View looking north from area adjacent to blast showing location of person within blast exclusion zone

At about 2:15pm, while filling the agitator, the Tegra worker felt a rush of air and sheltered behind the truck for protection as the blast was initiated and flyrock landed around him. When the flyrock stopped falling the worker turned off the pump and drove the truck out of the quarry to the concrete plant and Milbrae office where he reported the incident.

The Tegra worker was approximately 347 metres from the blast when the shot was fired.
