# WEEKLY INCIDENT SUMMARY

Week ending Friday 22 November 2019

This incident summary provides information on reportable incidents and safety advice for the NSW mining industry. To report an incident to the NSW Resources Regulator: phone 1300 814 609 24 hours a day, 7 days a week.

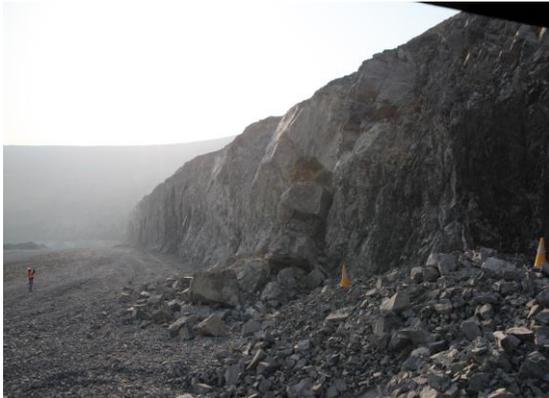
INCIDENT TYPE	SUMMARY	RECOMMENDATIONS TO INDUSTRY
Dangerous incident IncNot0036109	<p>A rock fall of about 250 tonnes occurred from the crest of a batter. There was a worker about 20 metres away when the first rocks fell. Just after the worker retreated, the major rock fall happened.</p>

<p>Operators and supervisors should be trained in geological hazard awareness.</p> <p>Once the cause of any slope failure is determined, mine operators must review their principal hazard management plans (PHMP) and implement effective controls including, but not limited to, catch berms, slope angles, water management and maximum heights.</p>

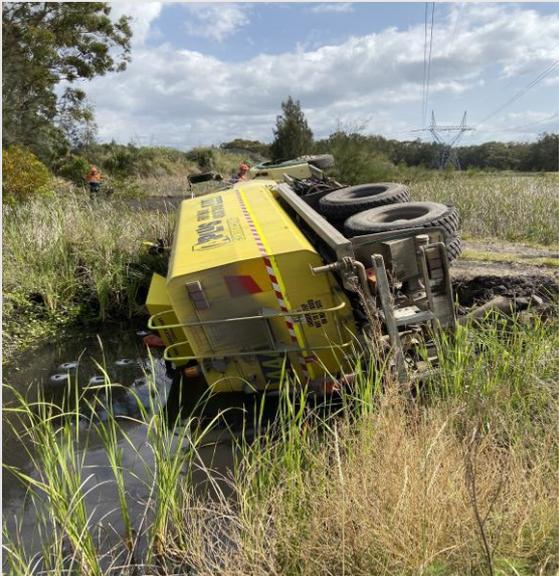
INCIDENT TYPE	SUMMARY	RECOMMENDATIONS TO INDUSTRY
<p>Dangerous incident IncNot0036075</p>	<p>A rigid water cart carrying out dust suppression around surface dams rolled onto its left side when a culvert collapsed. The back of the tank on the left side ended up in about 60 centimetres of water. The driver turned off the truck and escaped through the driver’s side window of the truck.</p>

<p>Principal hazard management plans for roads or other vehicle operating areas should consider factors including:</p> <ul style="list-style-type: none"> <li>• the impact of road design and characteristics, including grade, camber, surface, radius of curves and intersections for the vehicles using the roadway</li> <li>• the impact of mine design, including banks and steep drops adjacent to vehicle operating areas</li> <li>• having fit-for-purpose barriers in vehicle operating areas to prevent vehicles going over embankments or areas that are not suitable for their size.</li> </ul>
