## Significant Incident Report No. 278

**Subject:** Trailer tarpaulin cover mechanism fracture - fatal accident

**Date:** 22 October 2019

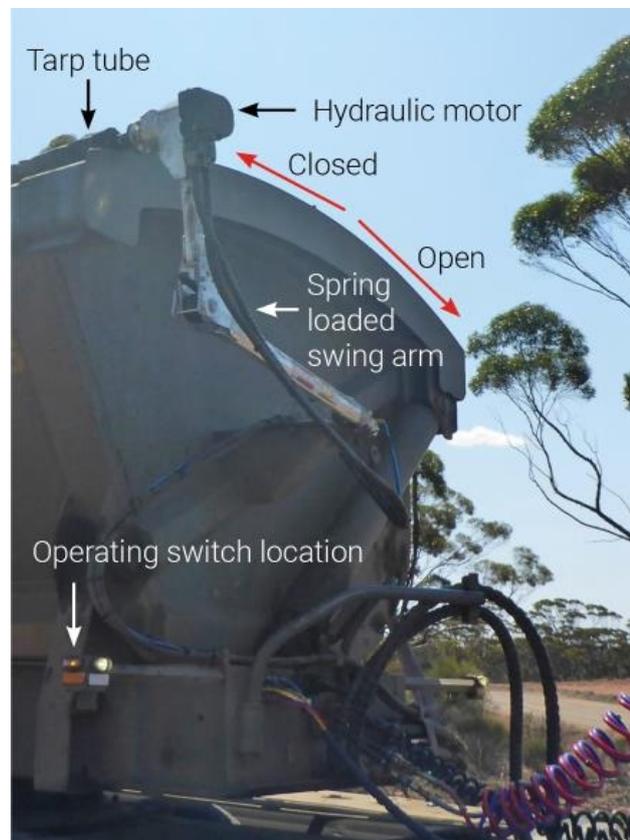
Road train trailer with swing arm attached to the tarp tube

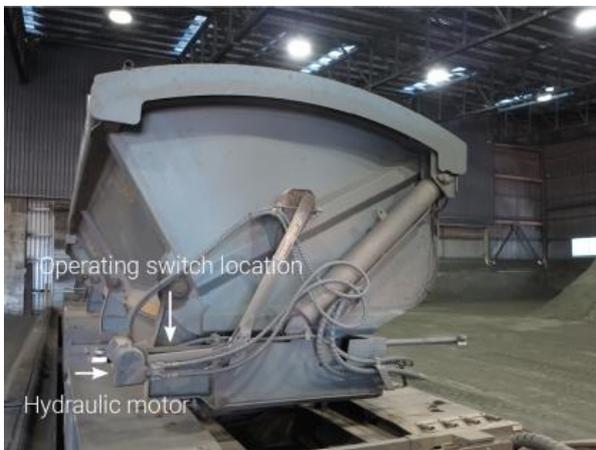
L. Detached motor and swing arm from the tarp tube. R. Fractured end of tarp tube where motor and swing arm attach on tarpaulin covering system

The operator was in the line of fire when the motor and swing arm became detached from the tarp tube.

- Conduct a risk assessment of trailer covering systems paying particular attention to the risk of an operator being exposed to hazards during opening and closing of the cover. Ensure all actions are implemented.
- Assess if the tarp roller operating switch is in a location that places the operator in the line of fire should a failure occur and implement controls to manage the risk.
- Ensure inspection and maintenance is carried out as required by the manufacturer or a competent person and all connection points are inspected.
- Ensure the trailer covers are being operated within design specifications.
- Promote hazard reporting and appropriate response to reduce the potential for inaction.

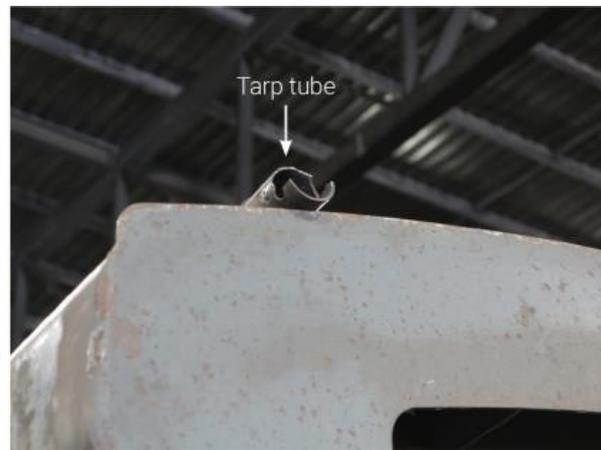
To close the cover, the tarpaulin cover is rolled from one side to the other over the top of the trailer while the tarpaulin tube (tarp tube) is rotated by a hydraulic motor located on the end of a spring loaded arm. As the cover approached the closed position on the top of the trailer, the tarp tube fractured. The combined tension and weight of the motor and spring arm caused the motor end of the arm to move through a downwards arc, ending up at the level of the cover operating switch at the front corner of the trailer. It appears this may have struck the truck driver who was found unconscious, and later died in hospital.

- The operating switch for the tarpaulin cover was situated in a location that placed the operator in the line of fire when the tarp tube failed during operation of the covering mechanism.
- The tarp tube failed.
