Incident periodical

Queensland Mines Inspectorate

October 2019

Coal mine incidents

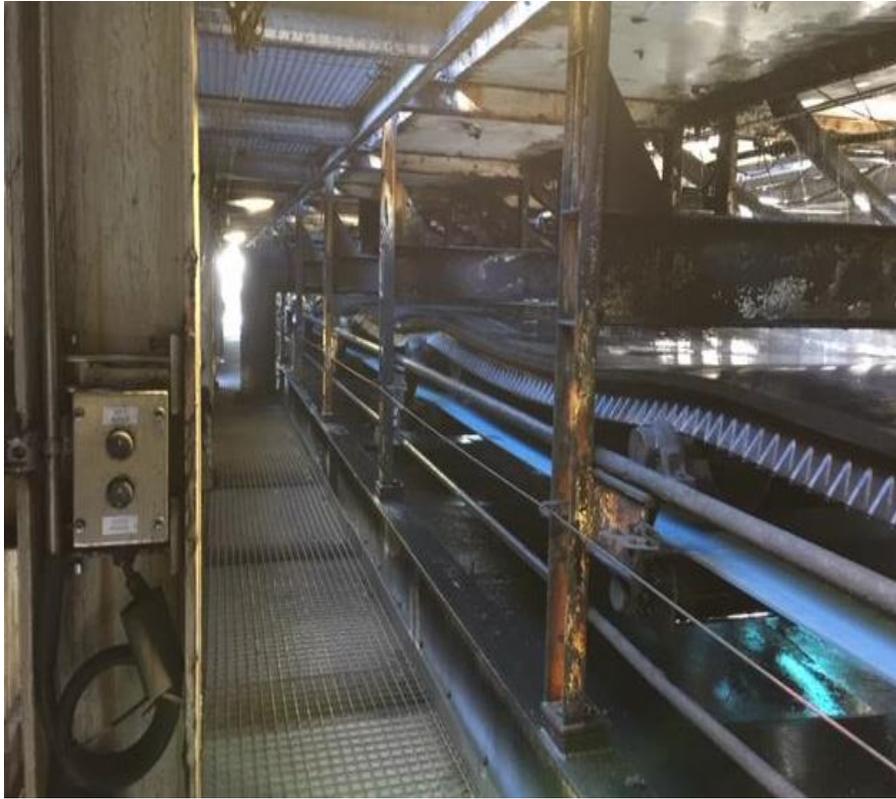
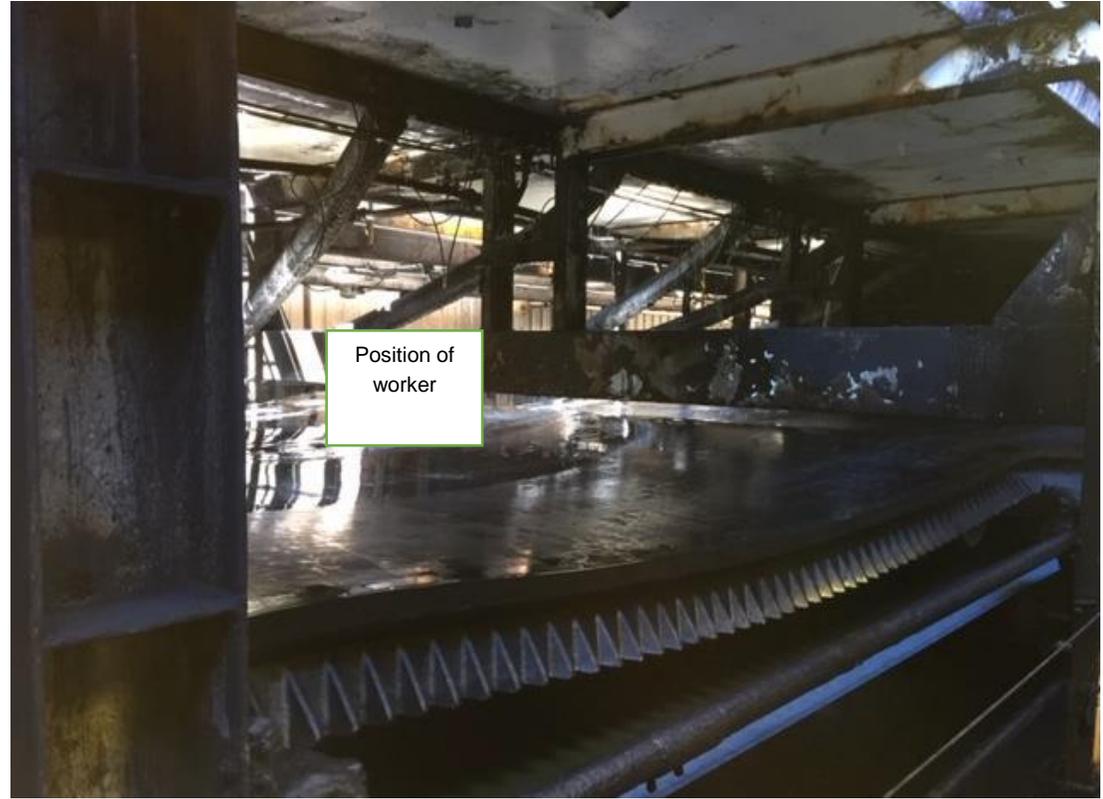
While undertaking maintenance tasks at the CHPP, a worker stepped onto a slow moving HBF Filter Belt. The worker walked to the centre of the belt and started cleaning clay out of filter belt vacuum holes.

The filter belt was not isolated and was operating.

Position of
worker

- Plant and equipment must be isolated before work commences.
- Supervisors and workers must ensure energy isolation and tagging procedures are adhered to.

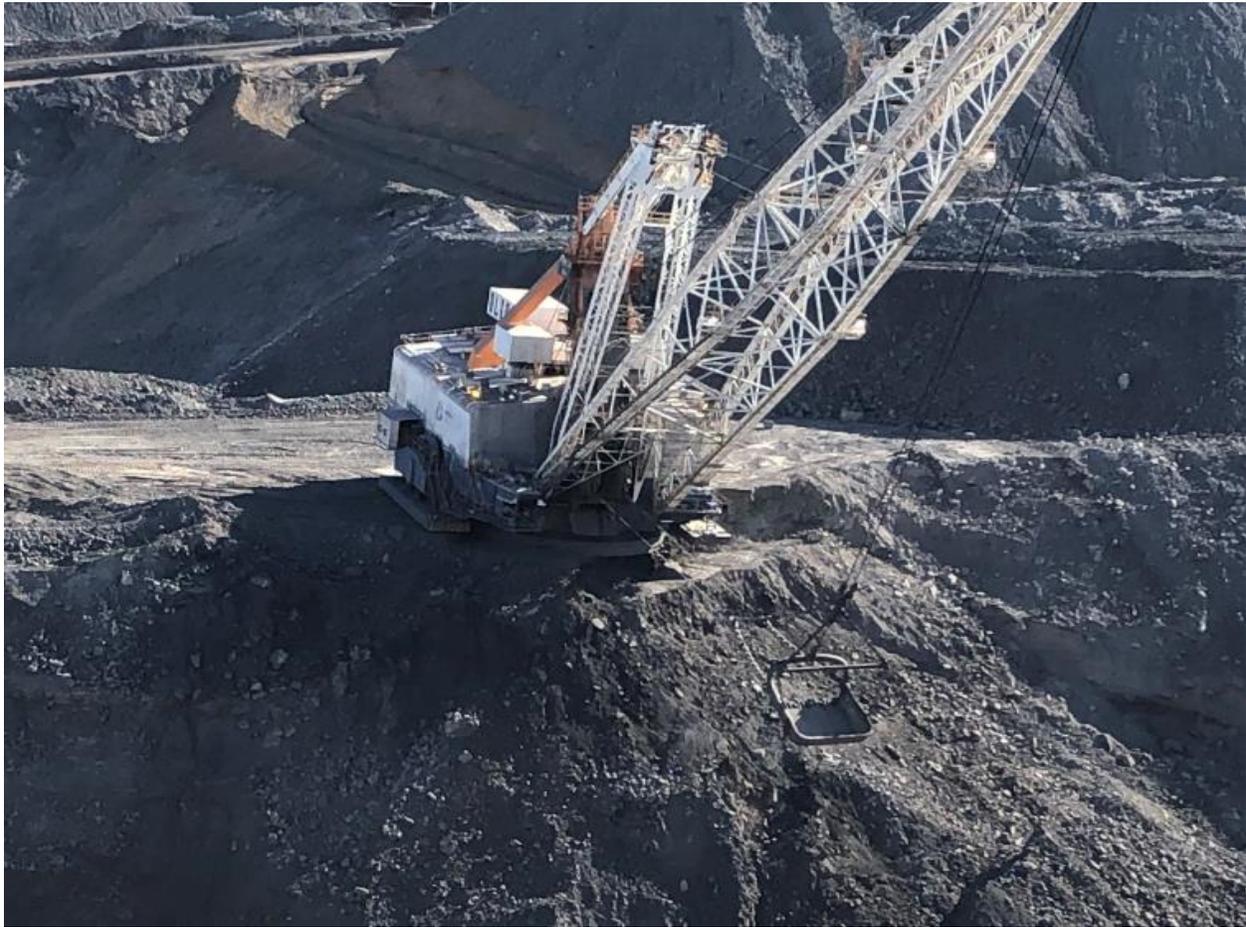
During dragline operations, the dragline bench has failed and the machine has listed towards the pit void. The speed of failure prevented the operators moving the dragline to stable ground; requiring them to evacuate to safety.

The bench was constructed on unsuitable base material.

Failure planes developed below the bench material and were not identified.

- Dragline operators should regularly check the integrity of their working benches.
- Work must not proceed until OCEs and geotechnical engineers have ensured and communicated to operators that pit floors and dragline benches are adequately prepared, constructed and maintained.

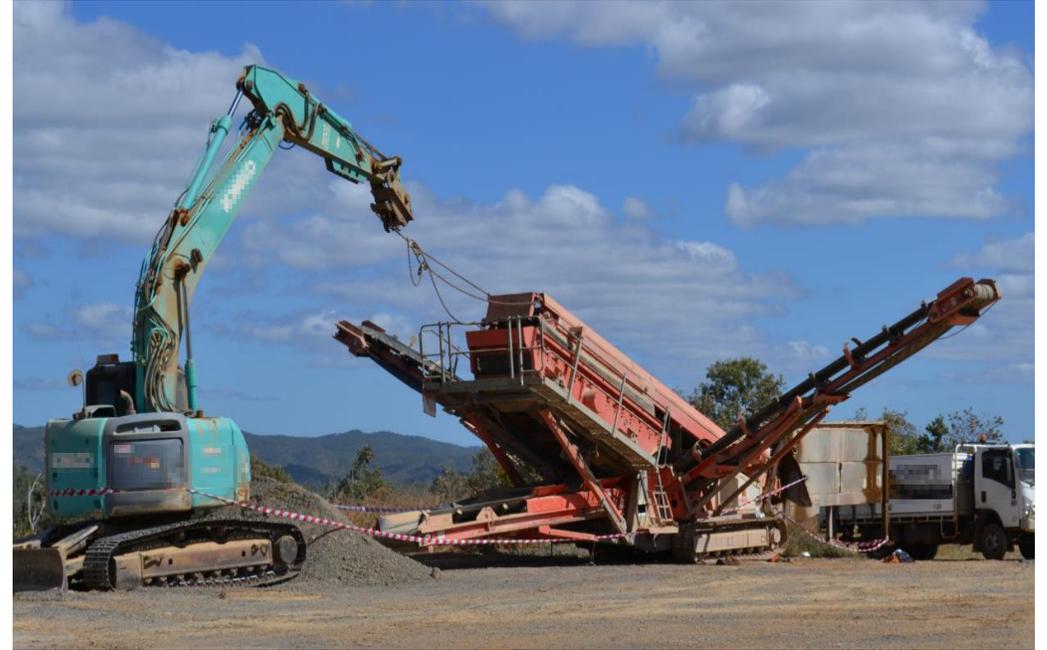
While undertaking repairs to a mobile screening plant, an apprentice fitter became trapped between the conveyor and a chassis rail cross brace. He had removed a hydraulic ram from the rear of the main conveyor allowing it to slide downwards under gravity. Fortunately, nearby workers who saw the incident were able to rescue the worker.

The apprentice was working alone. The supervisor was absent from site.

The experience and competency of the apprentice could not be verified before work started.

The plant was not isolated and de-energised prior to work commencing.

Information on how to safely maintain the plant was not available to the worker.

- Workers must ensure that plant is effectively isolated before work is undertaken. This includes verification and testing that ALL energy sources have been isolated.
- Supervisors must ensure that workers are appropriately supervised based on the nature of the task, experience and skills of the worker/s.
- SSEs must ensure workers are competent to perform the task, and that this information is readily available to supervisors. They must also ensure that information on safely maintaining and operating plant is available to workers.

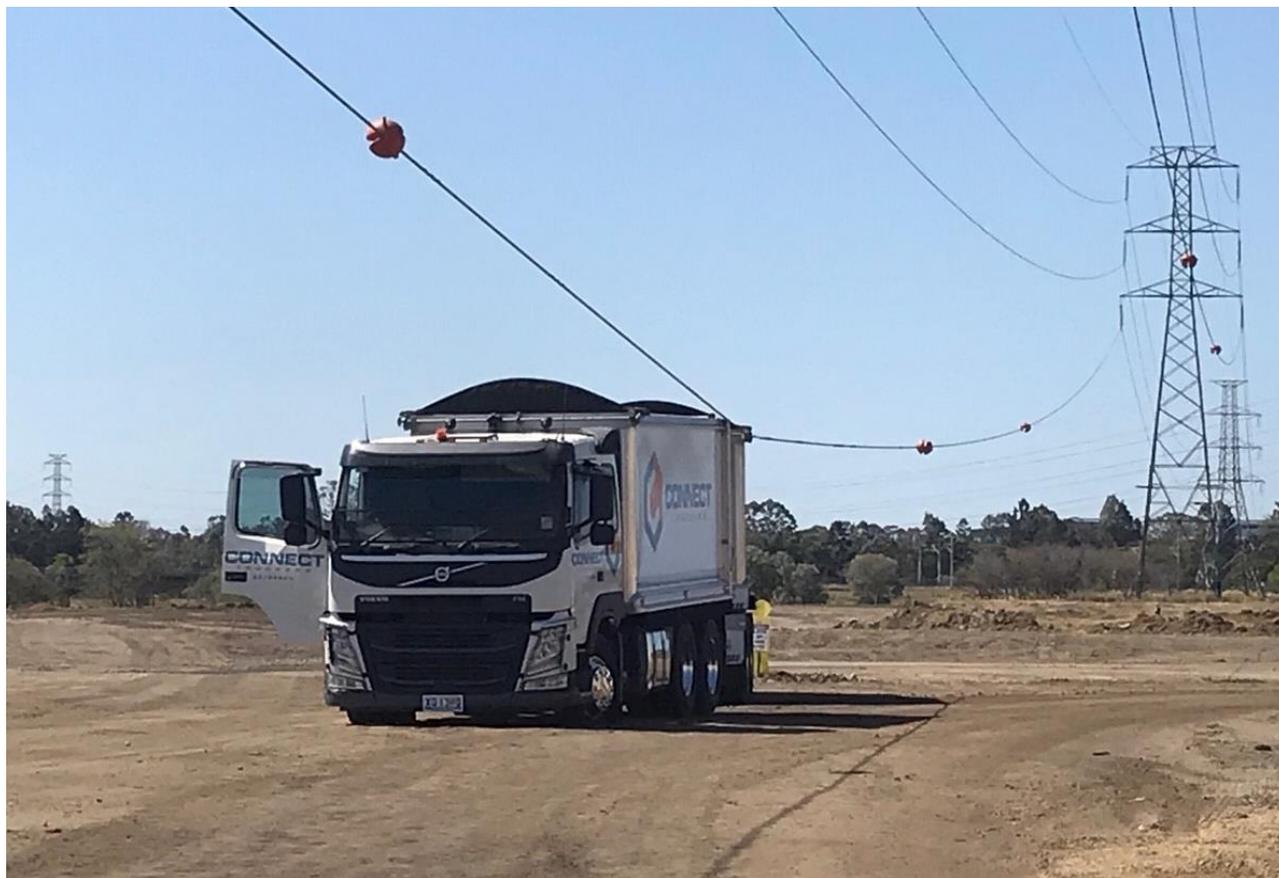
The elevated body of a dog trailer made contact with an overhead 110kV power line when leaving a screening plant stockpile.

Quarry was operating the stockpile in proximity to an overhead power line.

Control in place to prevent contact with the power line was administrative and did not remove or control the potentially fatal hazard.

- SSE must implement measures (engineering controls) to ensure mobile plant is not operated under nor adjacent to an overhead power line.
- Supervisors must ensure stockpiling, or other operational activities, do not occur beneath or adjacent to power lines.
- Workers should never leave a tipping point without first lowering the trailer body.
