WEEKLY INCIDENT SUMMARY

Week ending Friday 1 November 2019

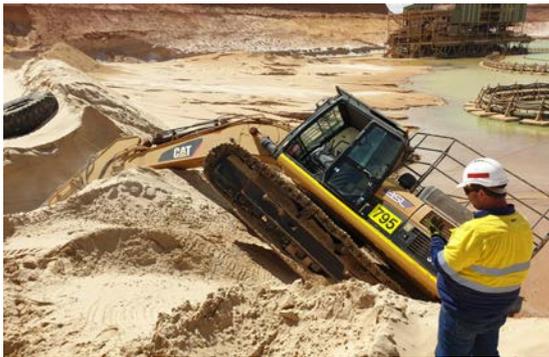
INCIDENT TYPE	SUMMARY	RECOMMENDATIONS TO INDUSTRY
Dangerous incident IncNot0035947	<p>An excavator was being utilised to dig a trench along a 2 to 3metre high bench adjacent to a tailings dam. When the excavator reached the end of the bench it slid sideways off the bench and came to rest at a 30-degree angle. The operator safely exited the cabin.</p>

<p>Equipment operators must maintain situational awareness and remain vigilant to manage the risk of machine rollovers. The circumstances of this incident under-pins the importance of wearing seatbelts as a mitigating control. When planning tasks and travel paths, supervisors must consider rollover hazards.</p>

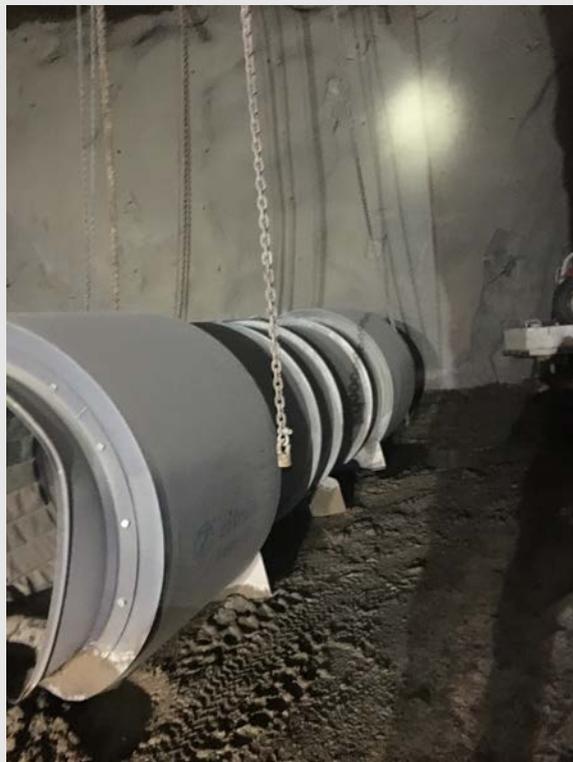
Dangerous incident
IncNot0035890

While using an endless chain block to lower a 4.5 tonne ventilation fan, a chain failed and the fan fell about four metres to the ground. A preliminary investigation suggested one of the endless chains failed at the gooseneck of the hook and had moved about 100 millimetres when it began to fail. This caused the fan to shift and a second chain to break. No-one was injured.

Mine operators should ensure that pre-use inspections are available for workers and are completed for all lifting/lowering equipment tasks.

The rating of all lifting components within a system should consider the worst-case scenario if loads are off balance or get caught on other objects.

Whenever there is a possibility that objects can fall, appropriate no-go zones should be established to protect workers. No-go zones should be clearly communicated and delineated to all workers in the vicinity.

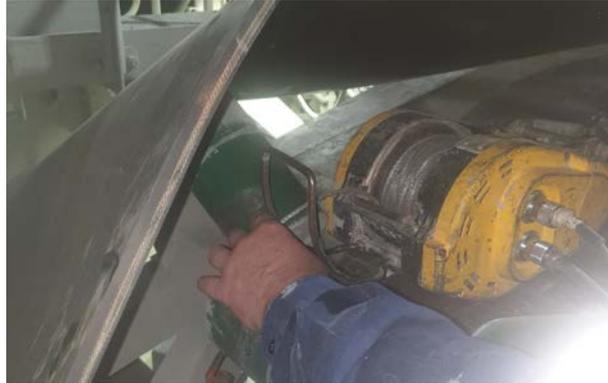
Serious injury
IncNot0035903

A belting contractor was guiding a wire rope back onto a winch drum after replacing conveyor belting when his left hand became caught between the cross frame and a roller set. This resulted in the degloving of his middle finger and damage to another finger.

Mine operators and contract companies should review their procedures to determine if their training includes the potential hazards associated with identifying potential pinch points. Appropriate guarding and rope guides must be used to minimise workers' exposure to pinch points.

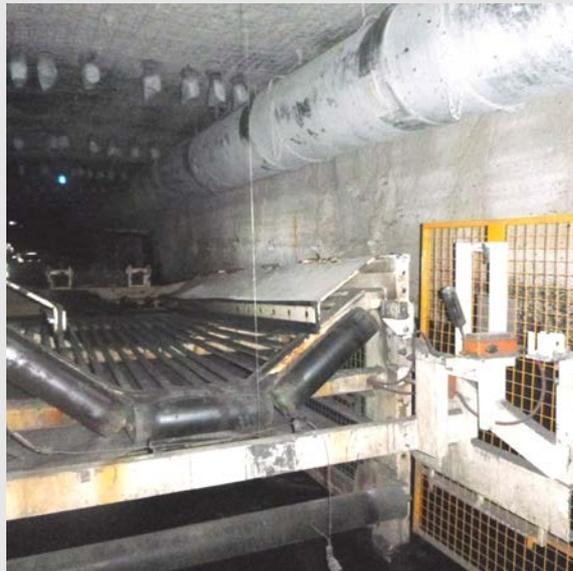
Serious injury
IncNot0035904

A fitter suffered rib injuries while working beside a boot end that was being positioned as part of a belt extension. The boot end was connected to a load haul dump (LHD) with a quick detach system (QDS). The boot end moved unexpectedly and hit the fitter.

We have published a safety bulletin (see below) with recommendations relating to boot end relocations. Safe standing zones must be created and communicated to protect workers when working in and around mobile machinery.

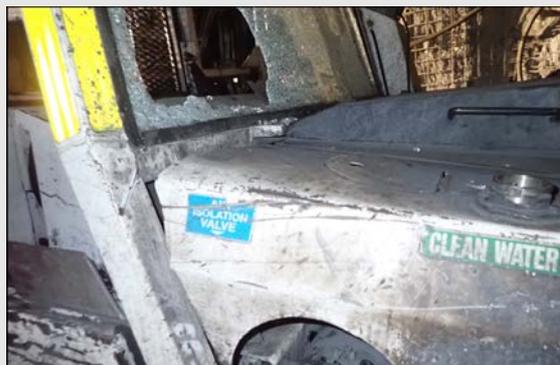
Dangerous incident
IncNot0035906

Two vehicles were travelling outbye when an LHD fitted with QDS forks shunted into a cut-through to allow the first vehicle to pass. When the first vehicle passed, the LHD drove out and collided with the second vehicle - shattering the windscreen. The driver of the vehicle suffered hand lacerations.

Effective communications protocols should be in place to ensure that positive communications between all operators is being achieved. Mines should monitor and assess compliance with site positive communication protocols. Refer to safety bulletin [SB18-06 Lack of positive communications](#).

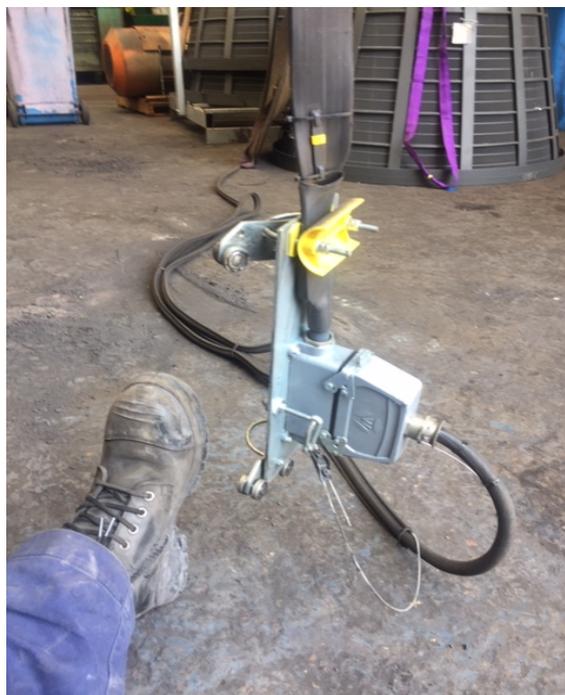
Dangerous incident
IncNot0035925

A 3 kilogram crane pendant trolley fell approximately 5 metres to the ground from an overhead crane. The trolley landed about 3 metres from the crane operator who was attaching a load to the crane hook.

Mine operators should review exclusion zones to ensure failures of pivot points and subsequent falling of equipment are considered. The location of overhead components should consider walkways and work areas below and should be located in such a place as to reduce exposure if there is a failure.

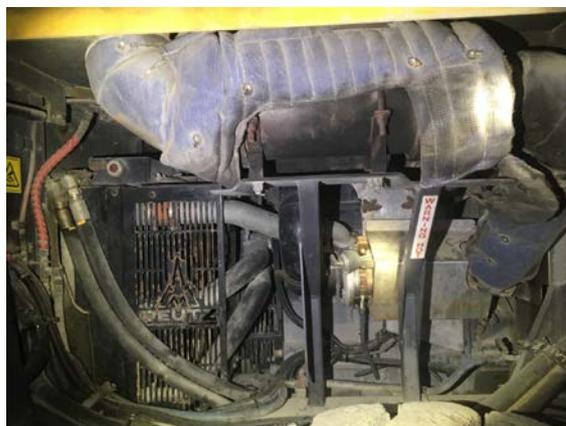
Dangerous incident
IncNot0035929

A drill rig was tramping on a main decline when the engine stalled. When trying to restart it, flames were seen coming from the exhaust of the machine. A hand-held fire extinguisher was used to extinguish the residual flames in the exhaust. No-one was injured.

Our position on fires on mobile plant is that all fires on mobile plant are avoidable and preventable.

Mine operators should be aware of our expectations with regard to fires on mobile plant as outlined in the recently published position

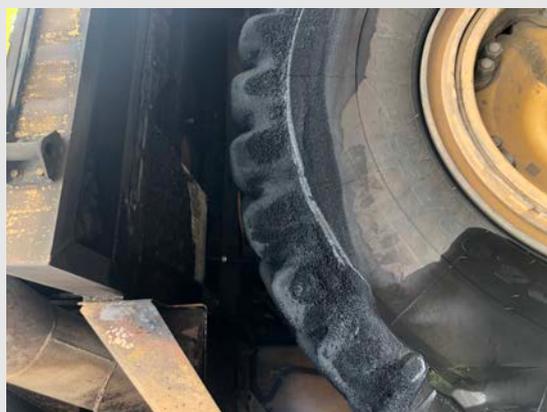
Dangerous incident
IncNot0035933

A fire occurred on a water cart truck. The fire appeared to be on a tyre so the area was evacuated in response to the mine's procedures. A preliminary investigation suggested the fire was caused by ignited hydraulic fluid dripping onto the top of the tyre.

Our position on fires on mobile plant is that all fires on mobile plant are avoidable and preventable.

Mine operators should be aware of our expectations with regard to fires on mobile plant as outlined in the recently published position paper [Preventing fires on mobile plant.](#)

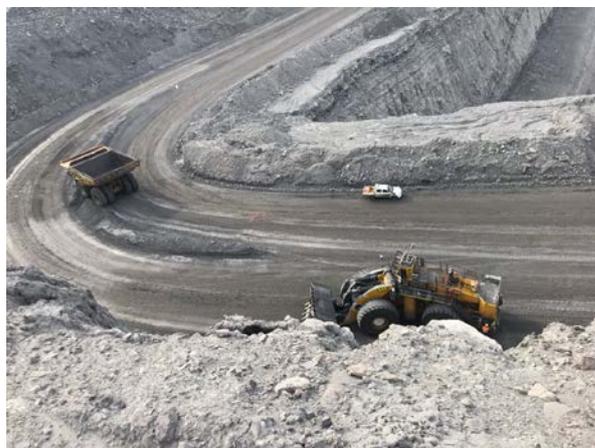
Dangerous incident
IncNot0035940

A haul truck passed onto the opposite side of a haul road to overtake a loader and was approaching a 90-degree corner on the ramp when a light vehicle approached in the opposite direction. By the time the haul truck operator and light vehicle operator realised the situation there was nowhere for either vehicle to go. The light vehicle operator veered to the edge of the windrow and the haul truck operator engaged the emergency brakes but was not able to stop in time. The haul truck passed the light vehicle at low speed with about 4 metres separation between the two vehicles.

Mine operators must continue to remind and enforce compliance with sites' roads rules. There have been fatalities and multiple near misses in relation to heavy and light vehicle interactions and enforcement of transport rules must be a priority of all operators.

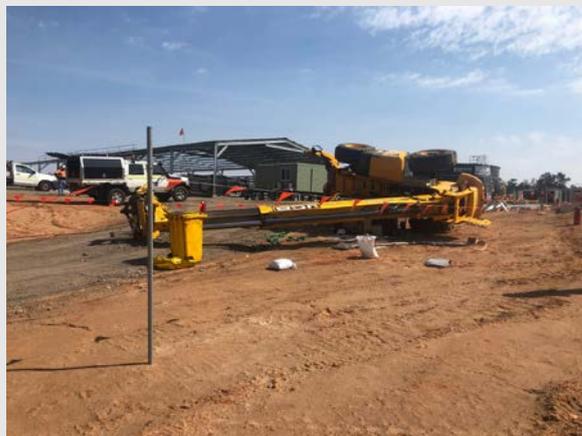
Dangerous incident
IncNot0035945

An operator stopped a telehandler on a slope to pick up a load. While manoeuvring the loaded telehandler, the front lifted and the telehandler fell on its side. The operator was wearing a lap sash seat belt.

The load he was transporting consisted of a 6 metre length of steel bracing with a support on top of it.

Equipment operators must maintain situational awareness and remain vigilant of the risk of machine rollovers.

Areas where vehicles are raising a load should be monitored for hazards such as cross grades, uneven ground, soft points and foreign materials.
