Safety Lessons Learned

Near Miss: Skid Steer Tyres Fell During Adjustment

WCX3A – St Peters Interchange site

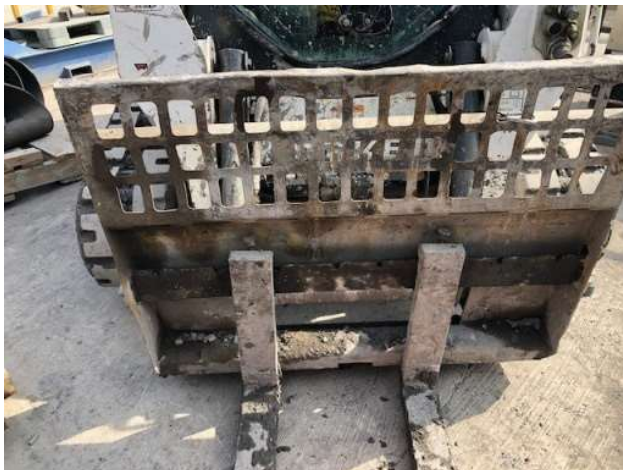
In preparation for lifting a load, the skid steer operator attempted to adjust the tyres. The operator requested assistance from a nearby worker and lifted the attachment from the ground to aid the manual movement of the tyres. As the worker pushed one of the tyres across the rail, it has fallen off, narrowly missing the worker's feet.

Fig 1. Skid steer tyres and rail system

Workers did not follow the Original Equipment Manufacturer's (OEM) method for adjusting tyres, which is to lower the attachment to the ground and adjust the tyres.

The design of the tyre rail system allows for the complete removal of the tyres, thus inadvertently allowing for the tyres to fall if not handled correctly.

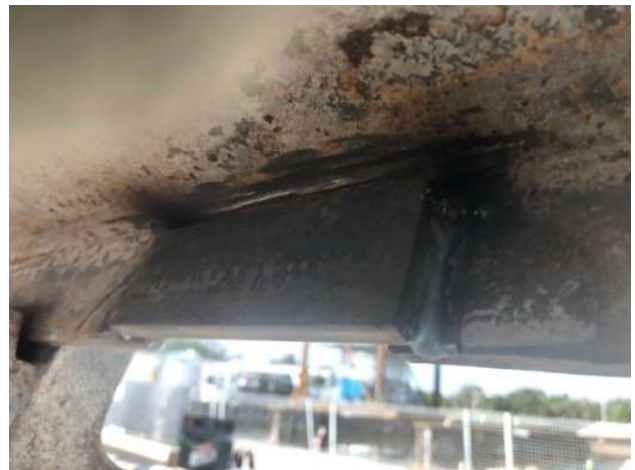
Fig 2. Plate welded to plant

- A plate that eliminates the risk of the tyres from inadvertently falling has been welded to all relevant plant; and
- Always refer to and follow the instructions and safety requirements in the OEM's manual when operating any plant, machinery or equipment.
