Incident Alert SA -17a

Date: 24 October 2019

At 11:40am on the 14th October 2019, an Inframax worker was fatally injured when a falling trailer ramp struck him whilst on the Te Kuiti depot wash apron.

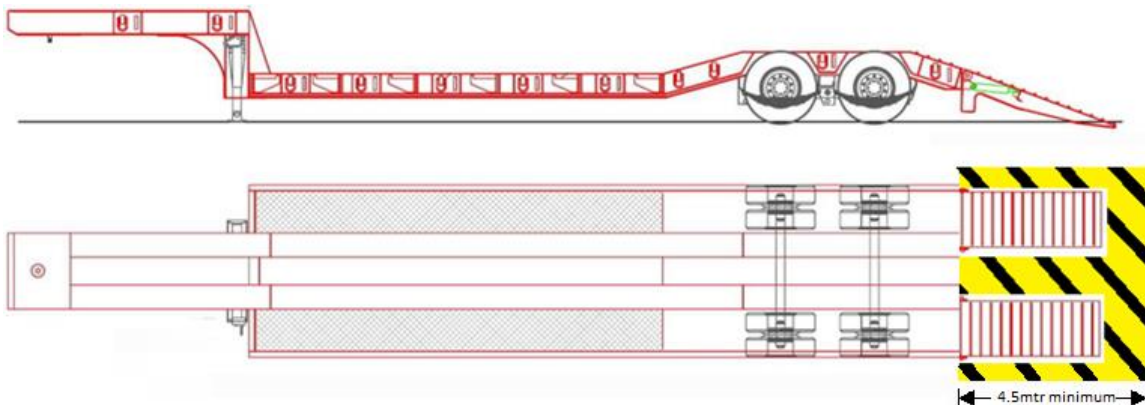
An Exclusion Zone MUST extend a MINIMUM of 4.5 Metres from the rear of the trailer – NO PERSON shall enter the Exclusion Zone when work described in 3 above is taking place.

1. Ensure that the trailer brakes are in the PARKED position.
2. Engage the PTO and enable the trailer hydraulics prior to releasing the trailer ramp chain restraints. Subject to the type of trailer you are operating always ensure that the trailer air suspension is lowered before attempting to operate the ramps.
3. Persons must always remain forward of the ramps whilst they are raised and lowered.
4. An exclusion zone **MUST** be maintained at the rear of the vehicle to ensure the fall zone of the trailer ramps is clear when:
 - a) removing and attaching the ramp restraining chains
 - b) trailer ramps are being raised or lowered
