WEEKLY INCIDENT SUMMARY

Week ending Friday 8 November 2019

CM9 reference	DOC19/983542
Mine safety reference	ISR19-44
Date published	15 November 2019
Approved by	Chief Inspector Office of the Chief Inspector

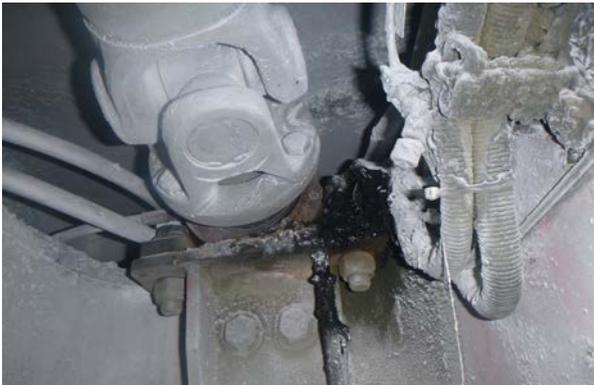
INCIDENT TYPE	SUMMARY	RECOMMENDATIONS TO INDUSTRY
Dangerous incident IncNot0035968	<p>An empty dump truck was being driven down a mine decline when the operator felt vibration in the drive train. He stopped the truck to investigate and saw a fire on the drive shaft. The fire was put out with a hand-held extinguisher. No injuries were reported.</p>

<p>Our position on fires on mobile plant is that all fires on mobile plant are avoidable and preventable.</p> <p>Mine operators should be aware of our expectations with regard to fires on mobile plant as outlined in the recently published position paper Presenting fires on mobile plant.</p>

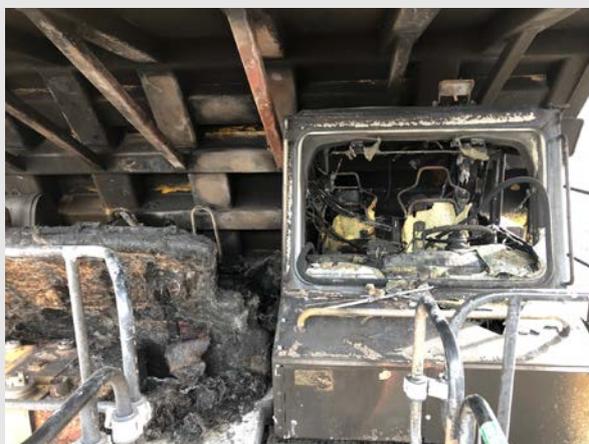
Dangerous incident
IncNot0035970

About 2 am while driving an empty haul truck down a ramp, the driver had to shut down the truck due to a critical engine alarm.

While the driver was in the process of parking up and shutting down, an orange flash was seen coming from the left rear of the truck. The driver heard a tyre deflating. The driver exited the cabin and attempted to lower the boarding ladder, however it would not operate.

The driver re-entered the cabin which was full of smoke.

The driver activated the fire suppression system and left the cabin. With some difficulty, due to poor visibility, the driver was able to descend the emergency ladder to the ground. The fire was extinguished by site water trucks.

The driver was taken to hospital for assessment as a precaution.

Our position on fires on mobile plant is that all fires on mobile plant are avoidable and preventable.

Mine operators should be aware of our expectations with regard to fires on mobile plant as outlined in the recently published position paper [Preventing fires on mobile plant.](#)

Mine operators should also review training packages for heavy plant to ensure they include the application of emergency escape procedures.

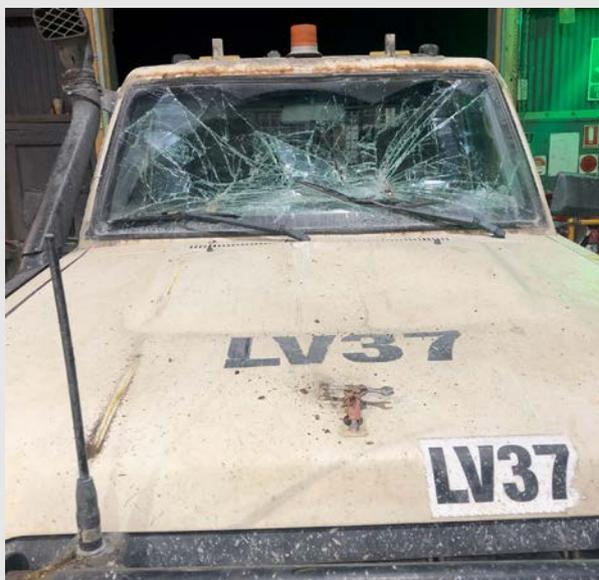
IncNot0035985

A drill operator was retrieving a production drill from the surface workshop after a service. To tram the machine from the workshop bay, the operator removed the barricade tape at the entrance and went back to the cabin of the machine. While the drill operator was preparing to begin tramping, a fitter parked a light vehicle in front of the drill without the drill operator's knowledge and walked away. The light vehicle was not visible from the cabin of the drill as the machine was in the tramping position with the boom and carousel raised. The drill operator moved the drill forward, colliding with the parked light vehicle.

The risk of collision when vision is restricted is well documented and reasonably foreseeable. Suitable risk controls such as cameras and vehicle escorts should be used when tramping large items of plant with restricted visibility around mine sites.

When dealing with the risk of a collision involving mobile plant, the hierarchy of controls should be followed. Systems such as collision detection and avoidance systems, visual aids and segregation should be implemented before relying on procedural controls.

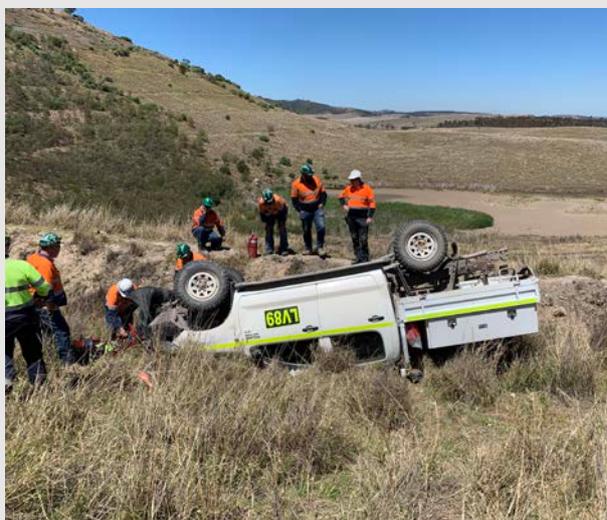
Dangerous incident
IncNot0035997

A light vehicle was driving up a rehabilitated slope towards a contour drain. The depth of the contour drain was not visible from the driver's seat with a drop-off on the other side of about one metre. When the vehicle crested the contour drain, it continued over the edge and overturned.

Four people were in the vehicle at the time. There were no injuries.

Vehicle operators must remain vigilant of the risk of rollovers and should be reminded of the importance of wearing seatbelts. When planning tasks and travel paths, supervisors must consider roll over hazards.

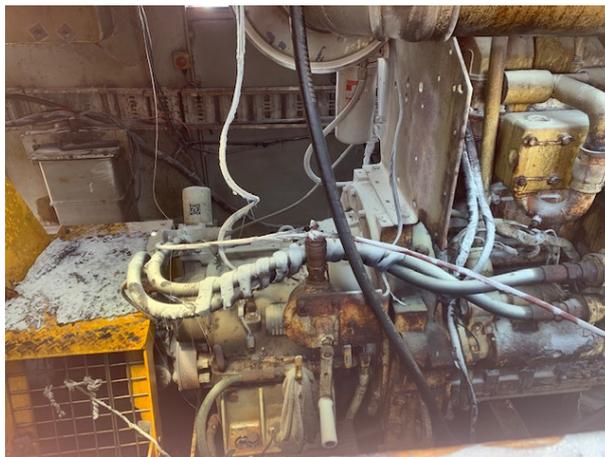
Dangerous incident A dredge on a river caught on fire in the engine
IncNot0036010 compartment.
The dredge operator followed the fire procedure, closed all the hatches and used a fire extinguisher to put out the fire.
The operator was not injured.

Our position on fires on mobile plant is that all fires on mobile plant are avoidable and preventable.

Mine operators should be aware of our expectations with regard to fires on mobile plant as outlined in the recently published position paper [Preventing fires on mobile plant](#).
