# SAFETY BULLETIN

**DATE: NOVEMBER 2019**

## Rapid face bolters incidents

<b>CM9 reference</b>	DOC19/959338
<b>Mine safety reference</b>	SB19-15
<b>Date published</b>	7 November 2019
<b>Authorised by</b>	Chief Inspector Office of the Chief Inspector

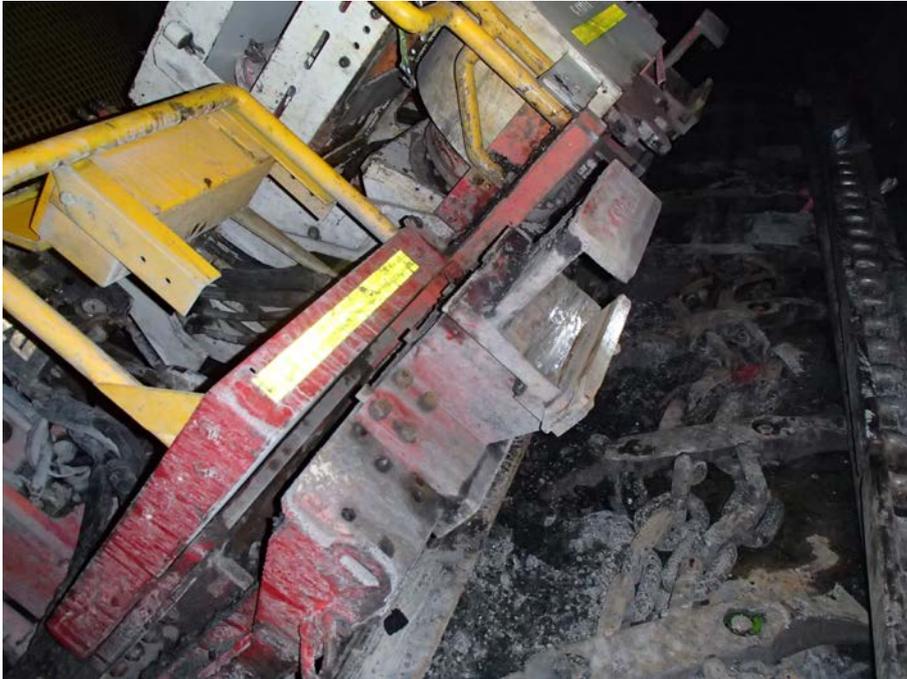
A rapid face bolter was positioned on an AFC near the tailgate drive. The operator extended the platforms and positioned the rigs, then identified the bolter was in the wrong location. The bolter was then trammed towards the maingate when it unexpectedly stopped. The worker assumed it was jammed and reversed towards the tailgate, freeing the bolter. The worker then started tramming the bolter towards the maingate. The bolter then disengaged from the AFC rack bar and tipped 45° towards the face (as shown in figure 1). The worker was ejected off the bolter, landing in front of the bolter between the two drill rigs. The worker suffered minor injuries requiring first aid treatment on site.

An investigation identified that when the rigs and platforms were extended, the centre of gravity shifted close to the skid shoe. As the rack bar position moved on the ramp pans, this shifted the bolter forward, tipping the bolter.

Figure 1 Rapid face bolter tipped 45° towards the face

1. Conduct an engineering review of the compatibility with the panline, rack bar and rapid face bolter. Ensure the trapping shoe engagement is sufficient to retain the bolter in all foreseeable operating configurations.
2. Verify that rack bar engagement with the trapping shoe is sufficient to retain the bolter as part of commissioning checks.
3. Repeat the above checks for any non-standard sections of the panline such as transitions and ramp pans.
4. Update operating procedures and training material to require that rigs are parked and platforms are retracted as specified in the original equipment manufacturer (OEM) requirements when rapid face bolters are trammed.
