# WEEKLY INCIDENT SUMMARY

Week ending Friday 15 November 2019

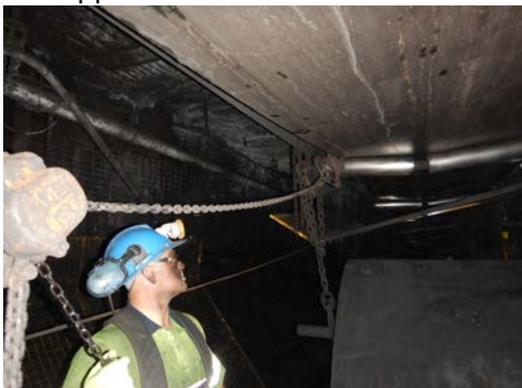
| INCIDENT TYPE | SUMMARY | RECOMMENDATIONS TO INDUSTRY |
|---|---|---|
| Serious injury<br>IncNot0036036 | <p>When changing a section of conveyor belt, a worker was using a chain block with a scissor clamp on the side of a belt when the clamp slipped off and hit him below the eye socket. The scissor clamp had very little tension on it and let go when tension was applied to the chain.</p> | <p>Pre-task job safety assessments should be undertaken before the start of any task.</p> |

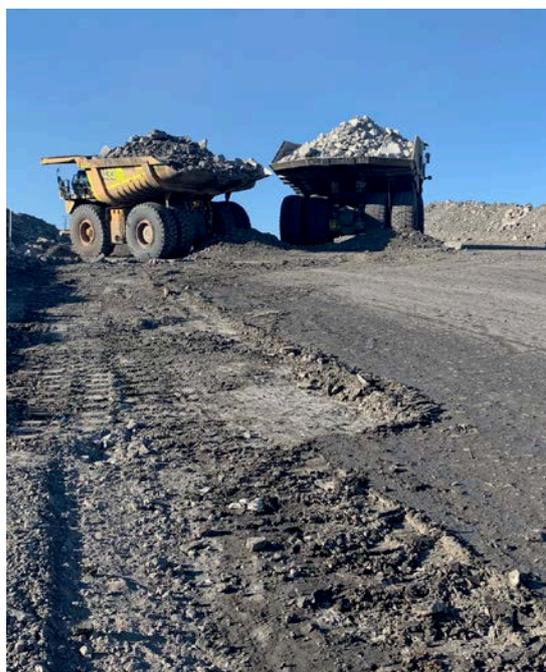
Dangerous incident  
IncNot0036032

While driving a haul truck up a ramp at an open cut coal mine, the driver tried to reduce the brightness level of the modular system display screen. The driver eased off the accelerator to the point where the truck began to roll backwards.

The driver did not notice the truck was rolling backwards. A second truck coming up the ramp moved across the ramp to avoid a collision but the trucks collided. The impact occurred at low speed (about 10kph).

The driver of the truck that rolled back had been operating the truck for the entire shift.

Mine operators are reminded that the machine operator cabs are work areas and that driver ergonomics are important. Mine operators should review machine operators' cabs to ensure items that could distract operators while in operation are minimised. Operators should also instruct drivers to stop in designated safe areas to make any adjustments to equipment.

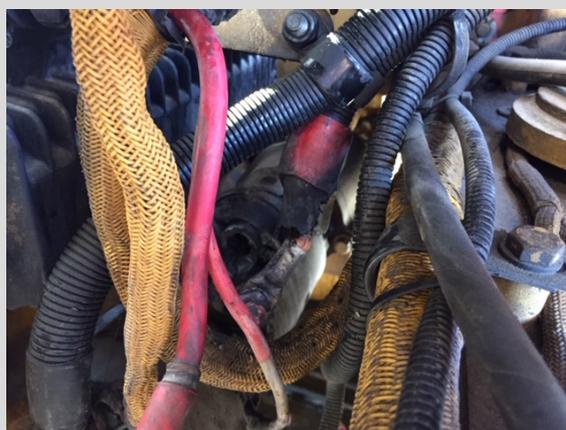
Dangerous incident  
IncNot0036040

An electrical fire occurred on an agitator truck when the starter motor solenoid failed to disengage. The continuously running starter motor and/or electrical contacts shorted out, causing heat and insulation on nearby cables to melt and ignite. The fire was extinguished when the operator activated the automatic fire suppression system.

Our position on fires on mobile plant is that all fires on mobile plant are avoidable and preventable.

Mine operators should be aware of our expectations with regard to fires on mobile plant as outlined in the recently published position paper [Preventing fires on mobile plant \(October 2019\)](#).

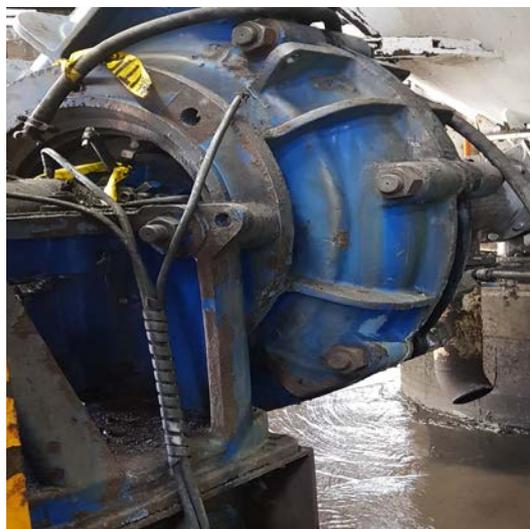
Dangerous incident  
IncNot0036063

Two mechanical tradesmen were commissioning a pump at a washery, had adjusted the gland packing and pumped grease into the gland and bearings. The temperature of the pump was about 50 degrees Celsius, so the workers set up an airline to cool the pump while the gland seals bedded in. As one worker was reaching to the top of the pump barrel to secure the airline, there was a loud 'pop' and one of the grease lines failed. The loose end of the hose hit the worker on the forearm, causing a bruise and swelling. The worker was taken to hospital and was cleared of fluid injection injuries.

An escape of pressurised fluid in the workplace represents a failure of a risk control to a major hazard (pressurised fluids) that may cause a serious or fatal injury. Mine operators are reminded that effective isolation and energy dissipation is a critical risk control when working on high pressure fluid systems.

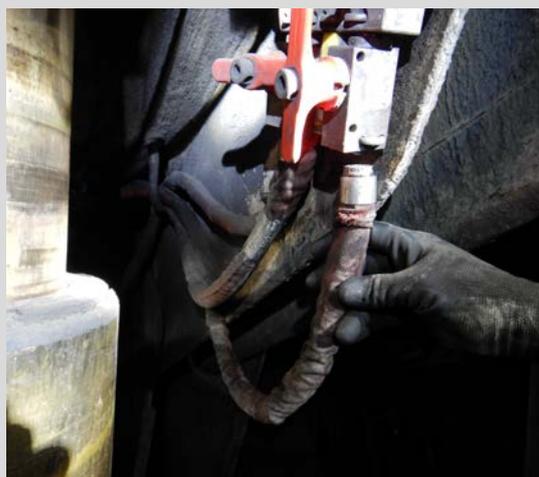
Dangerous incident  
IncNot0036064

A fourth-year apprentice, working under indirect supervision was function testing longwall shields as part of the longwall commissioning process. While he was function testing a shield, there was a release of fluid from a broken base lift hose. The broken hose had been identified earlier and an out-of-service tag had been fitted. It was later confirmed that the apprentice had not suffered a fluid injection.

An escape of pressurised fluid in the workplace represents a failure of a risk control to a major hazard (pressurised fluids) that may cause serious or fatal injury. Mine operators are reminded that effective isolation, correct use and understanding of out of service tags procedures and energy dissipation are critical risk controls when working on high pressure fluid systems.
