INCIDENT ALERT

LOCATION:	QUARRY	ALERT STATUS:	Normal
ACTIVITY:	MAINTENANCE & HOUSEKEEPING	DATE ISSUED:	25/11/2019 09:36:43
SUB ACTIVITY:	N/A	INCIDENT No:	01535

Fatal 6 - Conveyor LTI - Laceration to arm

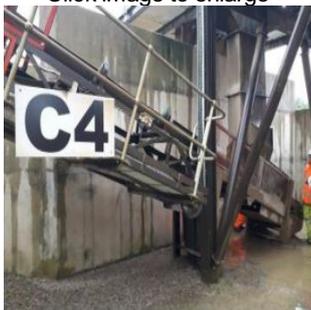
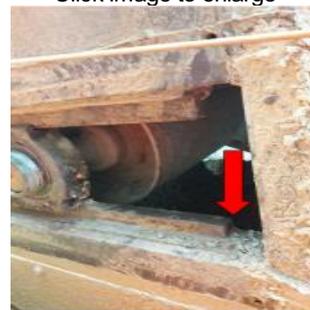
Due to the conveyor running off track, material spilt off the belt at the head and tail drum causing the belt to cut out. As this occurred at the end of the day, production ceased with the intention of addressing the issue the following day.

Due to the incident the previous day, the conveyor was not operated although the primary section of the plant was put into production. For the first hour all employees started cleaning up the spillage and thereafter cleaning was completed by various personnel in between other duties. During this time, no guards were removed and no isolations were in place. By midday the only spillage left was that tight to the conveyor and inside the guards.

After lunch the injured party (IP) had time to continue the spillage clearance. The IP isolated the conveyor and the conveyor anti-run back initiated before removing the guard around the tail drum allowing access to the tail drum. He then proceeded to clear the material with a bar and his hand from between the bottom of the tail drum and the conveyor. The conveyor belt suddenly moved forward (uphill) as the last remaining spillage was cleared nipping the IP's hand between the bottom of the tail drum and the return belt. The return belt had to be cut to release the IP's hand who received a cut to the elbow area of the right arm requiring surgery to clean and stitch.

- No risk assessment undertaken
- IP eagerness to start the task

- No Formal SWP in place
- Failure to wear the correct PPE – Although this would not have prevented the incident, the POL agreed the severity of the Injury would have been reduced

Risk Assessment: Had a discussion taken place before the event a different approach may have been taken

Stored Energy: The isolation of the conveyor had taken place and the direction movement of the belt may not have been foreseeable,

It was agreed to produce a training document to highlight all risks (including all types of stored energy)

PPE: Correct use for different situations (Produce CREW training to demonstrate why we need to use and the consequences of not using correctly)
