# SHE Flash Report

**Date:** 21/10/2019

**Project:** W2B

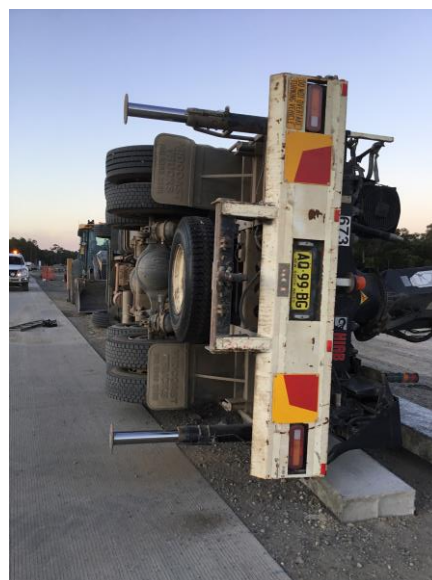
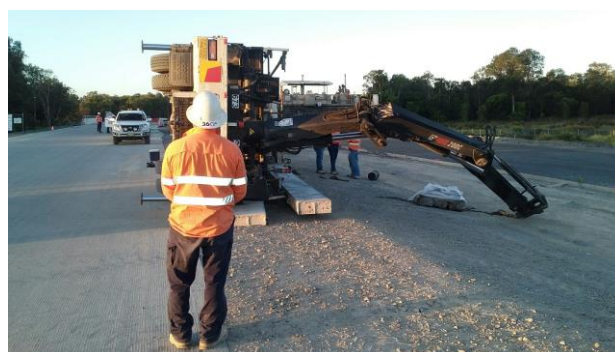
**Incident Description:** A CPB owned and operated Vehicle Loading Crane VT0673 (HIAB) was overturned while unloading a pallet of steel reinforcing bars. No injuries were sustained

The truck was positioned on concrete pavement without the outriggers extended (short legged). The outriggers were down with the base plates on the concrete pavement.

The load was being placed at approx. 4 meter radius. Adjacent to previously unloading form boards.

The reinforcing bars weighed 1767 Kg plus rigging equipment and timber pallet.

Post event re-enactment showing position of operator during the lift.

Stood down all Vehicle Loading crane operations pending further investigations
