WEEKLY INCIDENT SUMMARY

Week ending Friday 25 October 2019

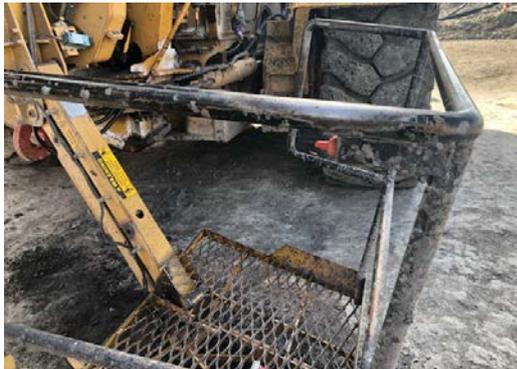
INCIDENT TYPE	SUMMARY	RECOMMENDATIONS TO INDUSTRY
Dangerous incident IncNot0035855	<p>A grader driver was using a hydraulic platform to lower himself to the ground when the hydraulics failed and the platform fell. The driver hit his ribs on the hand rail. He was taken to hospital.</p>

<p>In relation to hydraulic systems and equipment, mine operators should ensure:</p> <ul style="list-style-type: none"> • case drains and return lines are installed as per the design drawings • workers have adequate information, training and competencies for the task • commissioning activities and checks for maximum working pressure, relief settings, flows are completed.

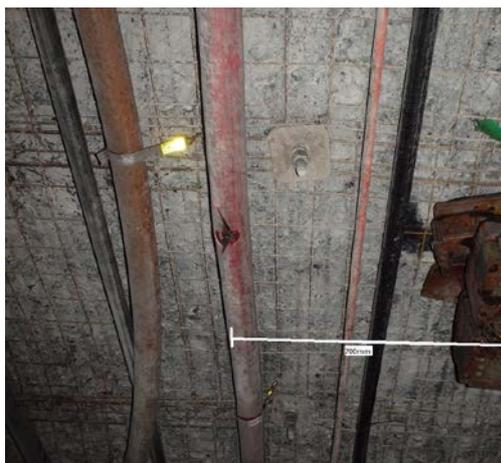
While installing 8 metre, twin-strand cable bolts, a drill steel contacted a powered 11kV high voltage cable, damaging the cable sheath and wire strands. The power remained on and was subsequently manually isolated. There were no injuries.

Workers need to maintain awareness when working around energised sources. Areas with high voltage cables are to be clearly delineated. The installation of isolation or hard barriers should be considered before starting work.
