# SHE Flash Report

**Date:** 24 October 2019

**Project:** West Zone - WGTP

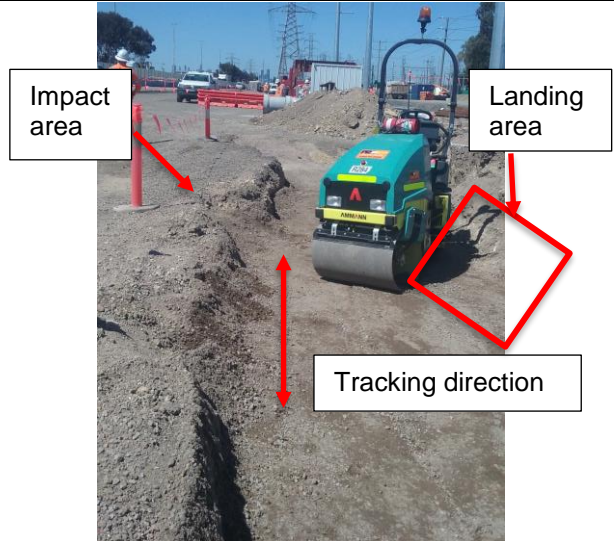
At low speed, an operator in a twin drum roller was compacting backfill in a trench (300mm depth) and, whilst tracking backwards has impacted the inclined edge. This caused the twin drum roller to overturn, slightly damaging the left-hand side of the unit.

The operator who was restrained by his seatbelt was able to render himself safe prior to the roller landing on its side, sustaining a scratch (from rubbing against the ROPS when exiting). ROPS was in place on the Roller. The twin drum roller was inducted to site at approximately 11:00am on the same morning.

It was identified that this type of machine is not fit for purpose as it is prone to tipping when not working on level ground.

All like activities across the project has ceased pending investigation and review of roller operations. This has included the following:

- All operators are suitably certified and deemed competent.
- The type of plant (roller) being utilised for the compaction is suitable for the task (type of drum width/size of roller).
- A risk assessment is done to best ensure fill is levelled evenly, safe distances from batters or verges and appropriate windrows in place, any undulating ground is assessed accordingly.
- Plant is fitted with ROPS and seatbelt.
