# WEEKLY INCIDENT SUMMARY

Week ending Friday 20 September 2019

This incident summary provides information on reportable incidents and safety advice for the NSW mining industry. To report an incident to the NSW Resources Regulator: phone 1300 814 609 24 hours a day, 7 days a week.

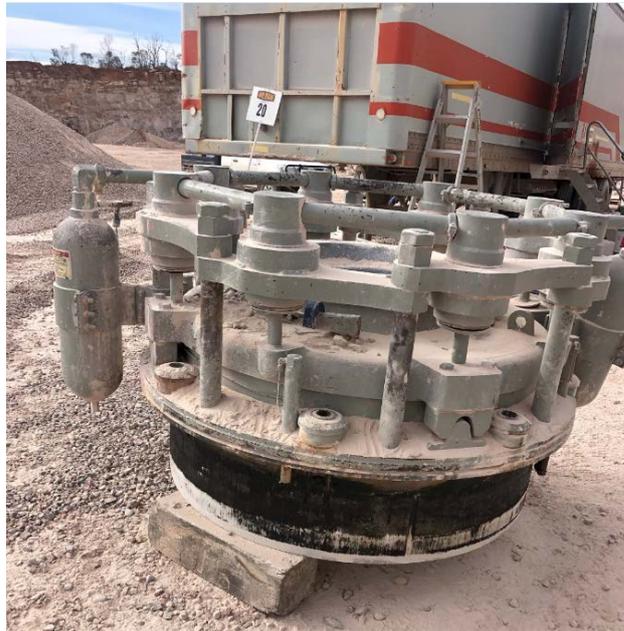
INCIDENT TYPE	SUMMARY	RECOMMENDATIONS TO INDUSTRY
Serious incident IncNot0035540	<p>Workers were lifting the lid of a cone crusher at a quarry using an excavator. The lid weighed about 1.5 tonnes. As the lid was lifted, it swung and hit a worker, who then made contact with a conveyor leg.</p> <p>The worker was given first aid and was taken to hospital, where it was confirmed the worker had broken ribs.</p>	<p>Work procedures and controls must consider the risk of workers being in proximity to equipment. No-go zones and safe standing zones for workers should be implemented and communicated to all workers involved in lifting tasks.</p>

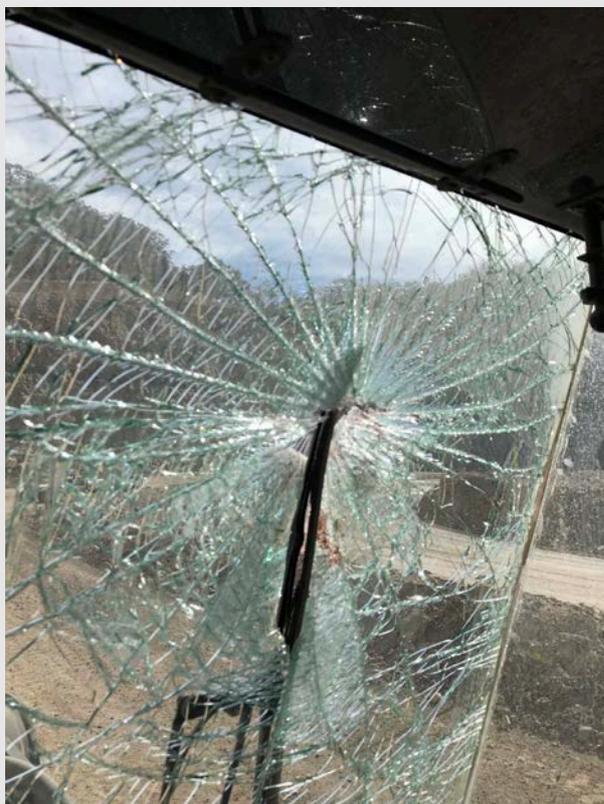
Serious incident  
IncNot0035550

While a loader at a surface coal mine was travelling down a pit ramp at 25km/h, a steel pin was rolling around on the floor of the cab.

The worker was distracted when he tried to pick up the pin. The loader hit a soft area in the haul road, causing the loader to jar the worker.

The worker's arm hit the bucket hoist lever, causing the bucket to dig into the ground and suddenly stopping the loader.

The worker's forehead hit the windscreen, causing cuts to his nose and ear and also damaging the windscreen.

The worker was taken to hospital and kept in overnight for observation and scans.

Machine operators must carry out pre-use inspections of machines. This should include the operator's cabin to confirm that any loose items are either restrained or removed before operating.

Mine workers are reminded of the importance of wearing seat belts while operating equipment, even at low speeds.

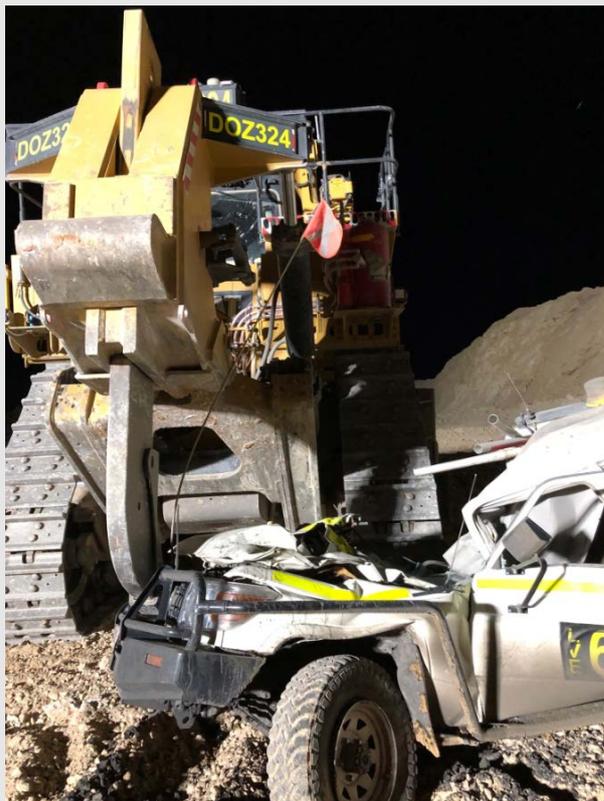
High potential  
incident  
IncNot0035570

A dozer reversed over a light vehicle at a surface coal mine. The light vehicle was parked on a bench about 30 minutes before the incident occurred. No-one was in the vehicle at the time of the incident.

An inspector attending the mine identified that pre-use checks were not being completed on light vehicles. He also noticed that light vehicles that were not parked in park-up areas, were not

using flashing lights and light vehicles were not parked in a fundamentally stable condition.

A 195 prohibition notice was issued to the mine requiring all workers (including supervisors) to be retrained.

Mine operators are reminded that light vehicles are to be parked in designated park up areas and are to have functioning flashing lights when in use on mine sites.

When light and heavy vehicles are likely to interact, all operators are to be trained and assessed on the sites safety procedure.

Ongoing monitoring of compliance with site park-up procedures should be included as part of the duties of supervisors.

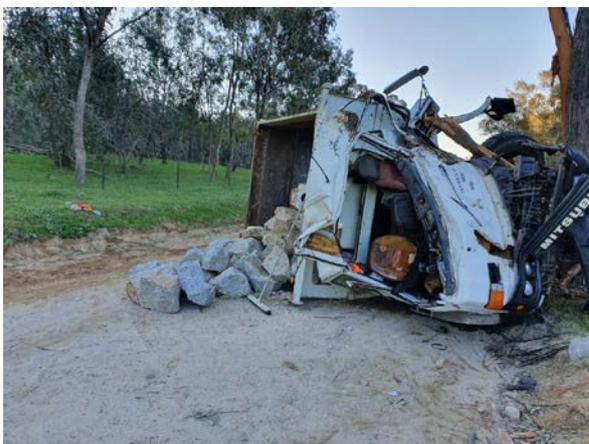
Serious injury  
IncNot0035593

A loaded road truck left a weigh bridge at a quarry. The truck had travelled about 300 metres when the driver reportedly suffered a medical episode causing him to lose control of the truck, which hit a tree. The driver suffered a broken leg. The truck was owned and operated by a quarry customer.

Mine operators should review and consider the findings from reports published by the NSW Resources Regulator in relation to non-work related deaths, for example the [Investigation report into the Bulga Open Cut dump truck collision](#), the [Investigation Information Release into a non-work related death at a mine site in May 2019](#) and also the [Investigation Information Release relating to a fatality that occurred at an open cut coal mine in 2018](#).

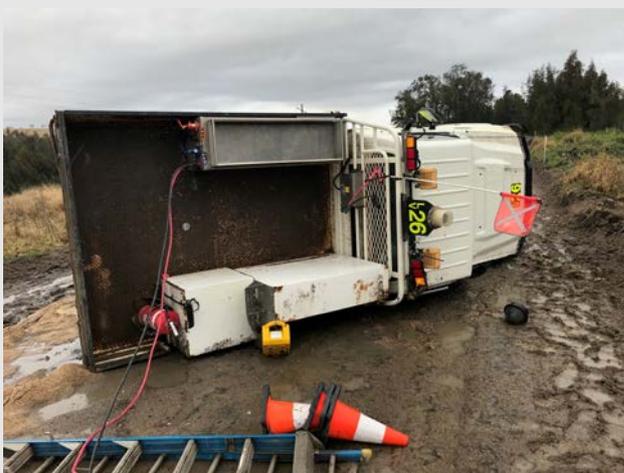
Dangerous incident  
IncNot0035597

At a surface coal mine, the operator of a light vehicle lost control of the vehicle in wet conditions. The light vehicle slid sideways into a bank and rolled onto its side. The driver was not injured.

Mine operators should assess road conditions and review training, or other instruction provided to workers to react to changes in conditions that may impact on their ability to operate equipment in a safe manner.

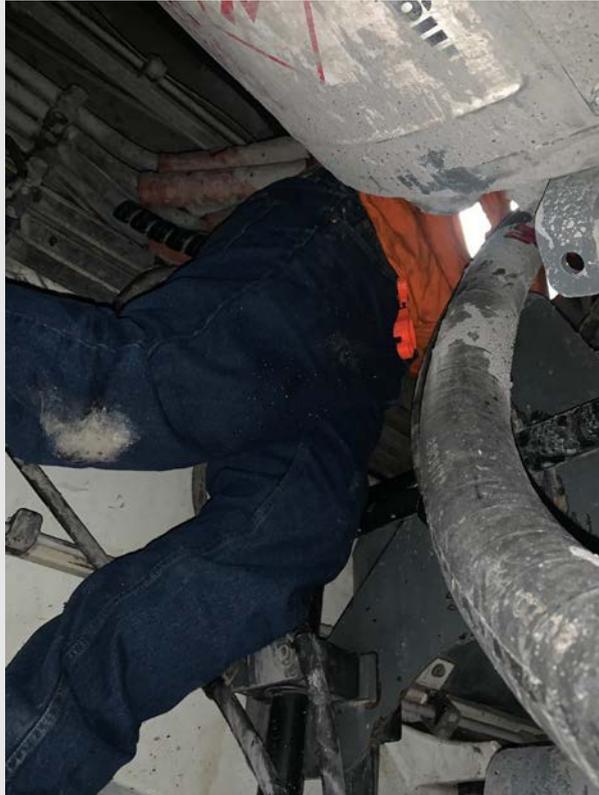
IncNot0035609

A mechanical fitter suffered an electric shock when he made contact with a cable joint and

the chassis of an electric haul truck at a surface coal mine. The haul truck was undergoing maintenance when the incident occurred. Electrical high voltage tests were being conducted at the same time as mechanical work.

Mine operators must have high voltage testing procedures in

place that exclude other workers from the areas being tested and reduce exposure to the risk of receiving an electric shock when testing is being undertaken.
