# WEEKLY INCIDENT SUMMARY

Week ending Friday 27 September 2019

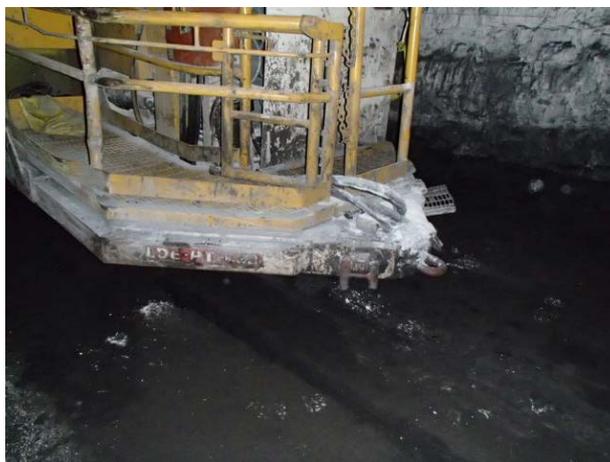
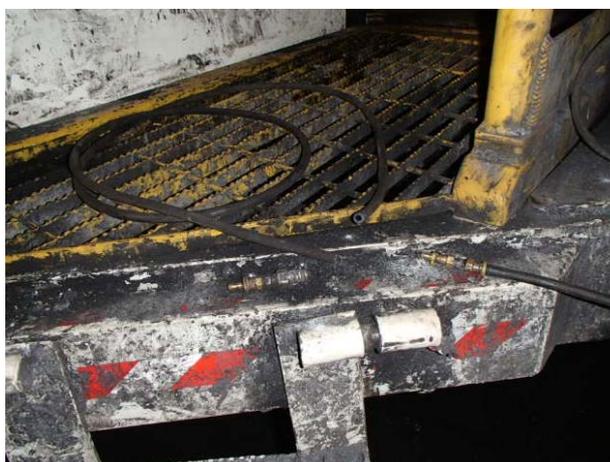
| INCIDENT TYPE | SUMMARY | RECOMMENDATIONS TO INDUSTRY |
|---|--|--|
| Dangerous incident<br>IncNot0035615 | <p>A load haul dump (LHD) machine coupled to a pipe trailer was being used to install pipes in an underground coal mine when an unplanned movement of the trailer occurred. The trailer detached from the LHD and began to roll down the drift.</p> <p>The trailer moved about 3 metres then broke the QDS hoses, causing failsafe brakes to engage, which stopped the trailer. A worker on the outbye end of the pipe trailer, jumped off once it started moving. Another worker, who was on the inbye end, remained on the trailer until it stopped. Neither worker was injured.</p> | <p>Pre-start checks of equipment are an essential part of maintaining fit-for-purpose plant.</p> <p>Unplanned movements of machinery should be accounted for when developing safe standing zones. The risks of unplanned movements should be communicated to all workers during no-go zone training.</p> |

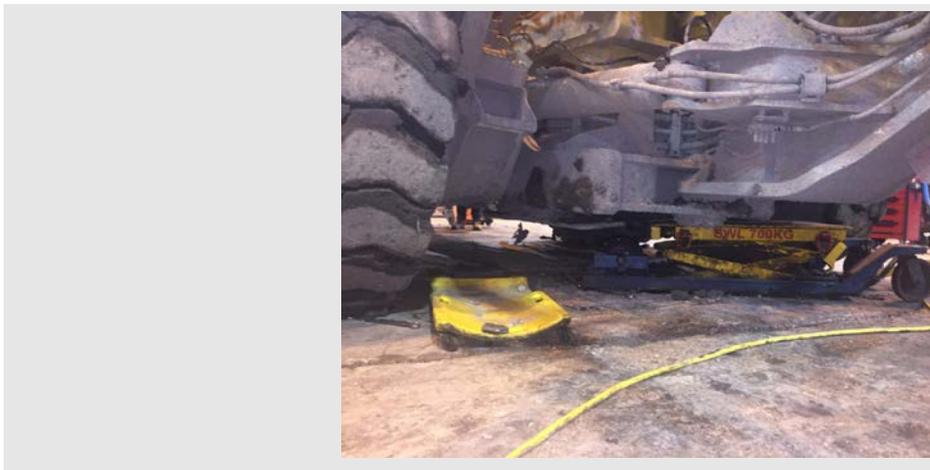
Dangerous incident  
IncNot0035623

A fitter working on a grader at a surface coal mine was removing the grader's belly guards using a rattle gun. The belly guard weighed at least 100 kilograms. The fitter had not put the trolley jack under the belly plate or removed the retaining bolts. The fitter had two bolts finger-tight, which failed. The belly plate swung down and pinned the fitter's hand between the rattle gun and the ground.

An X-ray confirmed there was no fracture, but the fitter suffered swelling and scratches.

The mine identified that there were no procedures for this task.

Mine operators must provide safe systems of work.

The work methods and controls used must consider the risk of falling material, the positioning of workers, and the use of mechanical aids.

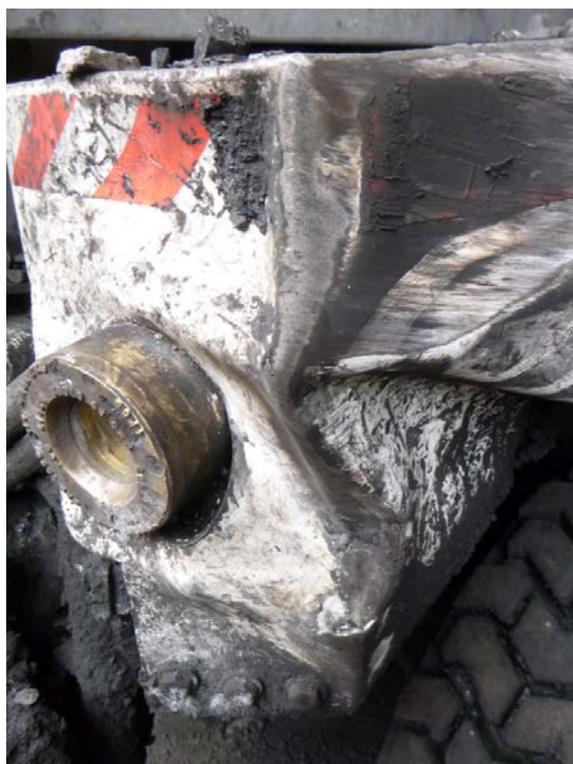
Dangerous incident  
IncNot0035634

A personnel transport vehicle was travelling out of an underground coal mine when it hit the rib. There were several workers in the vehicle and one worker, who was seated in the rear compartment, suffered a soft tissue injury.

There was damage on the front left-hand corner of the vehicle, however it was able to be driven out of the mine.

The driver may have been driving too fast and the road was reported as being slippery.

Mine operators must maintain travel roads in a safe condition and should establish and communicate speed limits when road conditions change.

Drivers should always adjust their speed to suit road conditions.

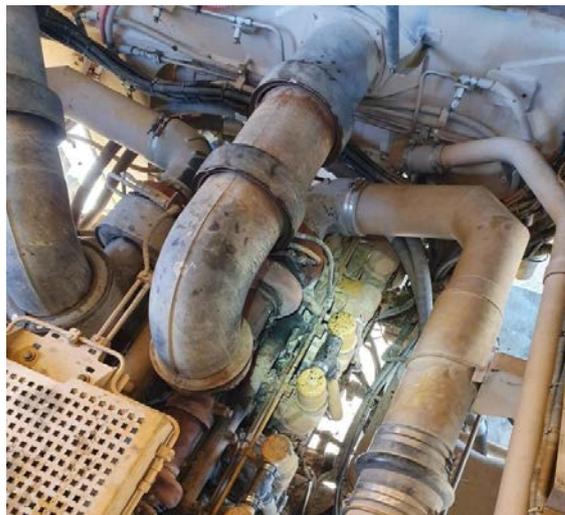
Dangerous incident  
IncNot0035643

A haul truck was travelling up a ramp at a surface metalliferous mine, when a turbo fire occurred.

The operator could not operate the fire suppression system because an 'R safety clip' was left under the activation button. A water truck travelling behind the haul truck extinguished the fire.

There were no injuries to workers, however there was damage to the vehicle.

When fires occur, mine operators must conduct thorough investigations by a competent person to determine the:

- fuel source and heat sources
- surface temperature value
- cause of the fire
- controls to prevent reoccurrence such as reducing engine component surface temperatures, segregating fuel sources from areas of high temperature and fire safety inspections
- worker training to identify fire risks such as fuels or oil leaks or worn hoses
- review of the fire risk assessment for the item of plant.

Mine operators should report the issue to the original equipment manufacturer.

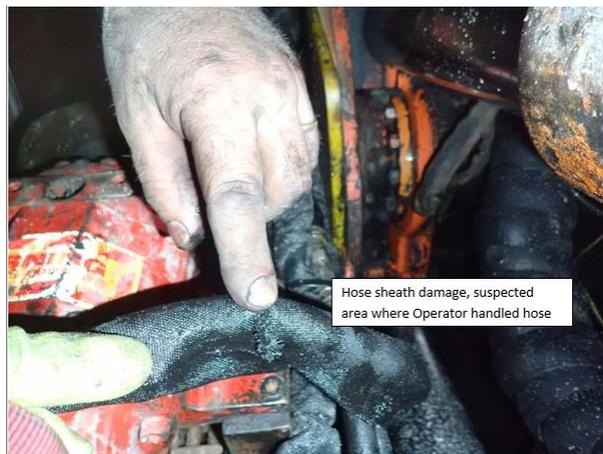
Dangerous incident  
IncNot0035656

An underground coal mine worker using a rib bolter was subjected to hydraulic fluid escape. The worker reported feeling a sharp prick to the right index finger. The mine followed its fluid injection protocol and after an initial assessment by paramedics the worker was taken to hospital. It was assessed that it was not a fluid injection.

Hydraulic hose management must include routine inspections of hose routing, protection and guarding.

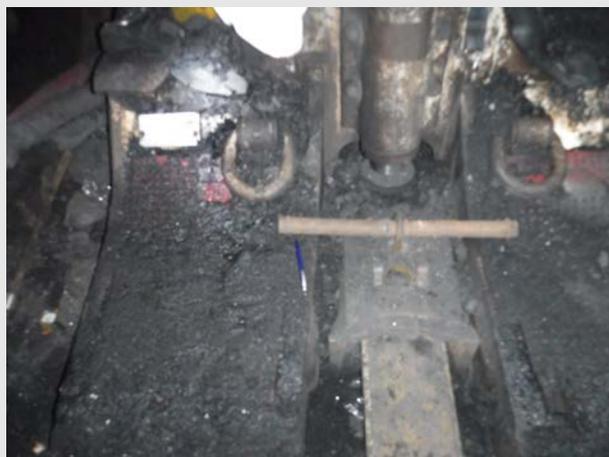
Serious injury  
IncNot0035659

A worker was installing a relay travel bar on a longwall support on a recovery face at an underground coal mine. A bobcat was being used to lift the relay bar while two workers inserted the travel bar. The relay bar was lowered, crushing the worker's finger under the travel bar. The worker's finger was de-gloved.

Mine operators must have safe work systems in place that identify any risks of injuries before commencing any tasks. The use of suitable equipment to control risks must be considered.

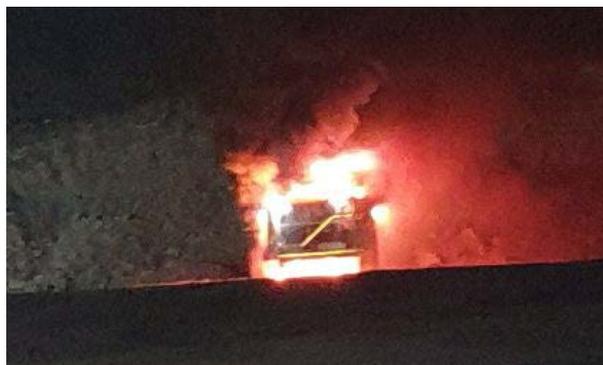
Dangerous incident  
IncNot0035685

A fire destroyed a haul truck at a surface coal mine. The operator applied the fire suppression system and left the truck.

The mine made a call to establish an exclusion zone around the machine to protect other machines and workers from the fire.

There were no injuries, however one of the tyres exploded.

The investigation is ongoing, however good maintenance practices are essential to preventing fires on mobile plant. Heat shields and lagging designed to prevent combustible materials from contacting hot surfaces must be regularly inspected and maintained. Maintenance practices should also include securing loose combustible items to prevent contact with hot surfaces.
