WEEKLY INCIDENT SUMMARY

Week ending Friday 11 October 2019

This incident summary provides information on reportable incidents and safety advice for the NSW mining industry. To report an incident to the NSW Resources Regulator: phone 1300 814 609 24 hours a day, 7 days a week.

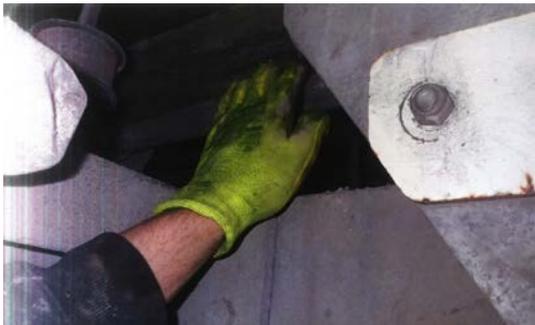
INCIDENT TYPE	SUMMARY	RECOMMENDATIONS TO INDUSTRY
Serious injury IncNot0035778	<p>A worker was installing a monorail in a maingate area on a longwall face. The worker was operating a malibou (a work platform suspended from the monorail system) with his hand on the monorail. When the malibou came to a stop it rolled back, crushing the worker's finger. The worker required surgery.</p>

<p>Mine operators and contract companies should review their procedures and training packages to ensure they include the potential hazards associated with placing body parts on solid objects around moving parts and material.</p>

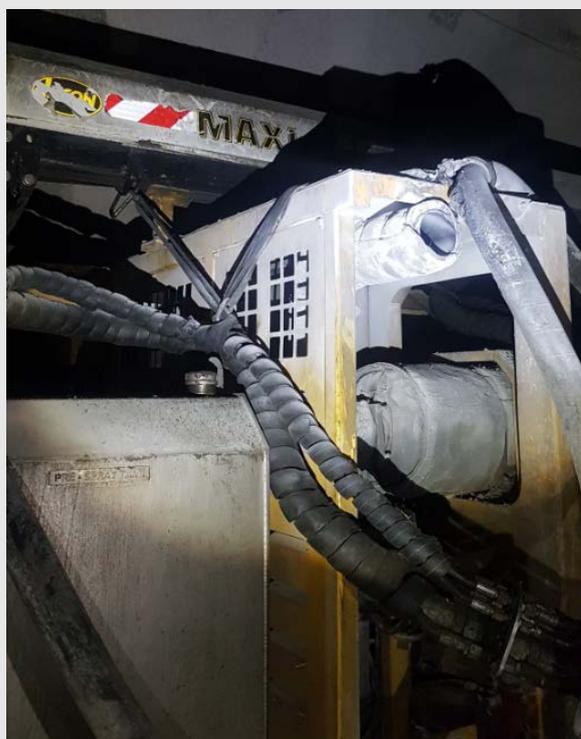
Dangerous incident
IncNot0035753

A shotcrete rig was being trammed to be fuelled when a rubber delivery hose dislodged. The hose fell in front of the exhaust discharge which burned the rubber and created an ignition source. Flames were seen by two operators in a light vehicle who notified the rig operator. A suppression system was activated, together with a hand-held extinguisher.

When a fire occurs, a competent person must conduct a thorough investigation to determine the:

- fuel source and heat sources
- surface temperature value
- cause of the fire
- controls to prevent reoccurrence such as reducing engine component surface temperatures and segregating fuel sources from areas of high temperature, and fire safety inspections
- training workers to identify fire risks such as fuel, oil leaks or worn hoses
- review of the fire risk assessment for the item of plant.

Mine operators should report the issue to the original equipment manufacturer (OEM).

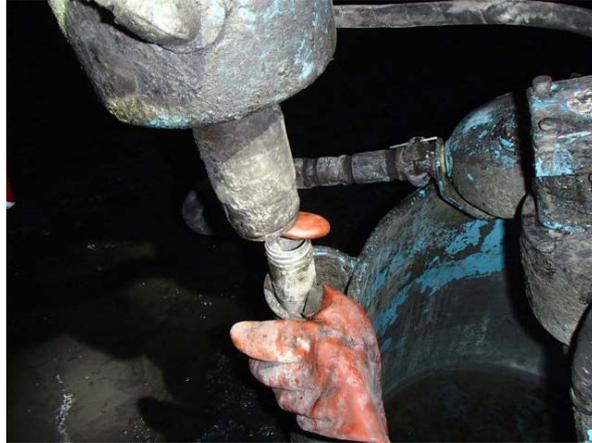
Serious injury
IncNot0035768

An underground mine worker was grouting 8 metre cable bolts when a worker saw grout leaking from between the housing and the reciprocating shaft. The worker discarded the grout and flushed the pump with water to reseal the shaft seal. While the pump was running, the worker tried to block the spray of water from leaking around the shaft. The threaded piston sleeve dislodged from the housing, lacerating the worker's left thumb.

Mines must have systems in place that require appropriate risk management tools to be available for use by workers for tasks. Additionally, supervision arrangements must include checks to ensure that risk management tools are in place.

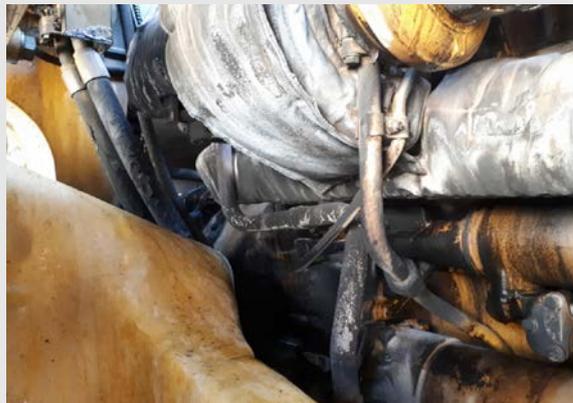
Dangerous incident
IncNot0035775

A water cart was at a fill point when the operator saw flames. The operator called emergency, activated the fire suppression system and exited safely from the water cart. There were no injuries.

We recently published a [position paper](#) relating to the prevention of fires on mobile plant, which should be considered by mine operators.

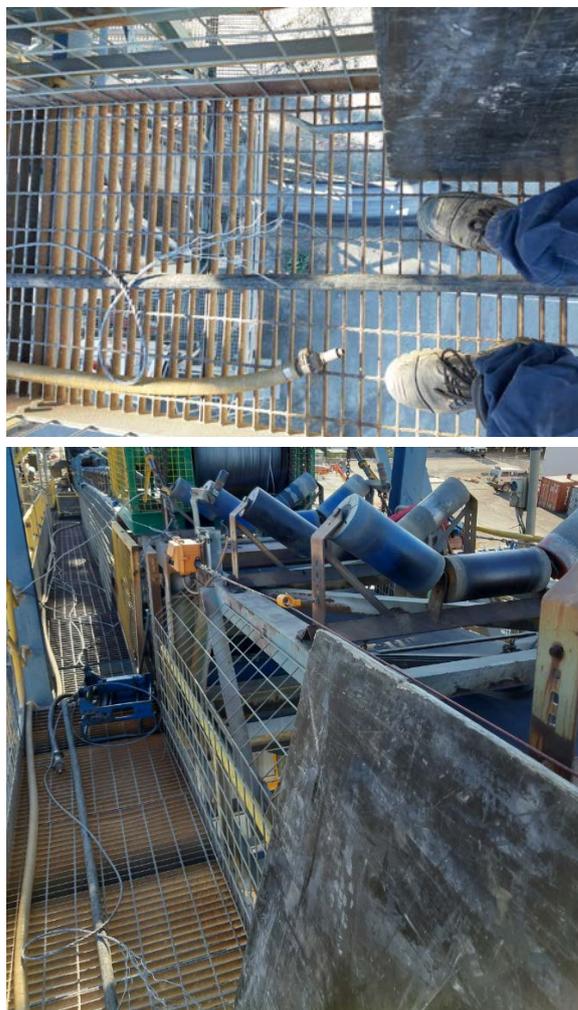
Dangerous incident
IncNot0035773

A worker was removing a conveyor belt from a surface conveyor. During the process, a splice plate and shackle became caught on the head drum. The winch wire rope (about 8 mm) broke and recoiled in the vicinity of the winch drum. The belt remained jammed and did not move. The belt was on the surface of the mine and was inclined about 30 degrees. No-one was reported to be injured.

Winch ropes should be regularly inspected during all tasks. Triggers for rope replacement should be determined according to the task, the rating of the ropes and the risk associated with rope failure. Mines must have adequate guarding and safe standing zones in place to protect workers in the event of rope failure.
