NZ Safety Alert

19 March 2021

Rockfall damages excavator

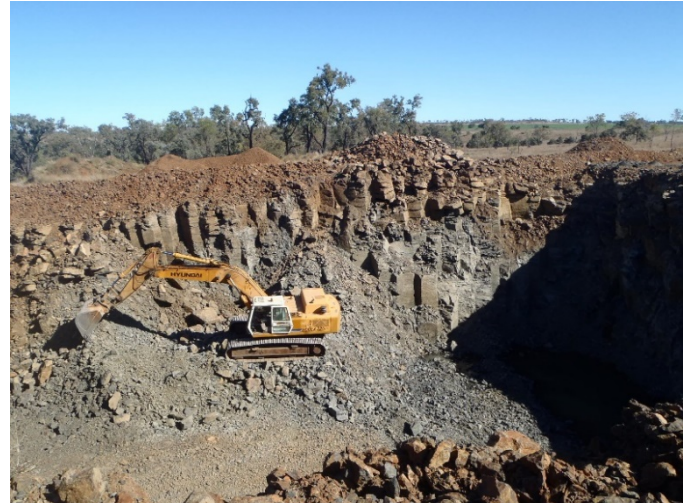
While an excavator was working at the toe of a bench, a rock fell out of the face hitting the excavator. The excavator was damaged, but no injuries were sustained by the operator.

1. Regular inspections of faces are conducted to identify unstable ground.
2. An adequate catch bund or trench is created between the face and the pad on which the excavator is operating.
3. Excavator operating platforms are constructed and compacted, and dimensions are at least 1 ½ times the width of the excavator tracks.
4. Excavator operators are trained and regularly assessed as competent to operate diggers safely at the face.
