SAFETY ALERT

Department: Lead Smelter, Structural Remediation

Incident Number: INC-0159268

Safety Alert Title: Corroded ladder rung

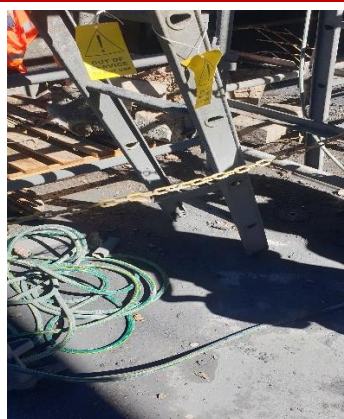
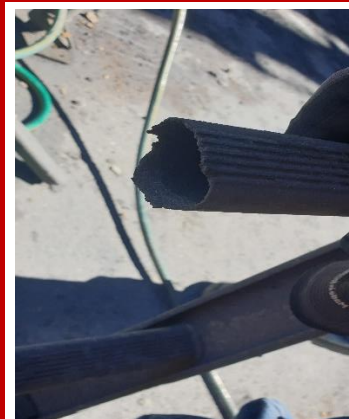
Worker was climbing down a ladder, when the second bottom rung gave way, whilst under foot.

Inspection was completed by the owner and user prior to use but failed to identify the corrosion of the ladder rung.

1. Communicate the event and importance of thorough scaffold inspection prior to use.
2. Audit scaffold companies procedure and their application of inspection of scaffold components.
3. Co-ordinate site wide inspection of scaffold condition, in particular ladders.
