Partial de-gloving injury to left hand ring finger.

Incident Location: 1225 Ore Drive 00

Incident Number: INC-0163358

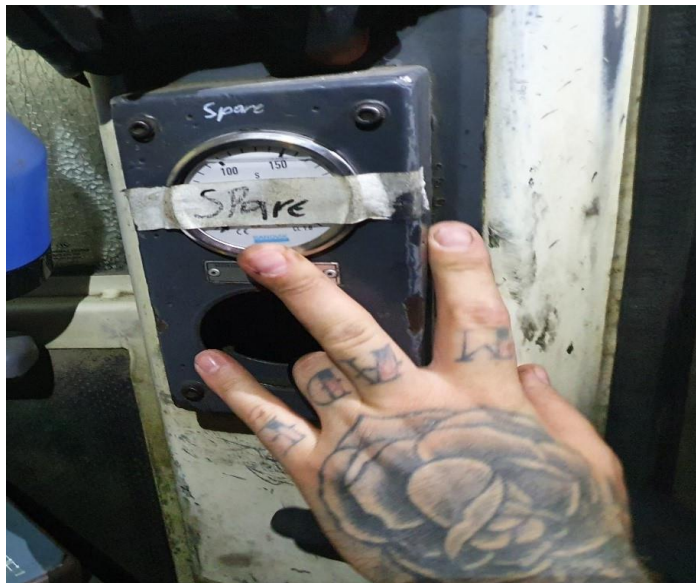
While exiting Jumbo 252, Jumbo Operator placed their hand on the cab pillar while exiting the drill and their wedding band caught against the edge of a gauge penetration that was not blanked off. This has resulted in the operator sustaining a laceration requiring 13 sutures to close the injury to their left hand ring finger.

1. Audit all mobile equipment for potential nip points and rectify with blanking plates or covers
2. Re-enforce the following with all crews when entering/exiting equipment, face the unit and maintain three points of contact at all times & avoid twisting and turning where possible.
3. Update induction materials - all rings/jewellery to be covered or removed
4. Develop and distribute information brief to crews -all rings/jewellery to be covered or removed.
