## NNTP SITE SPECIFIC SAFETY ALERT

# Insufficient Time Given for Excavator's Quick Hitch to Engage Causes Bucket to Drop.

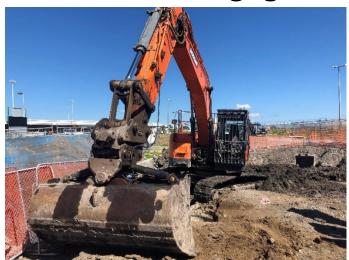
Excavator involved in the incident and the depression in the stockpile is where its' bucket dropped.

- A subcontractor was operating a 23 tonne Doosan excavator to pick up hard fill. His spotter was 20 metres away on a haul road stopping traffic.
- Nobody else was in the area.
- The excavator operator raised his bucket 1 ½ metres off the ground and its 1 tonne bucket fell off into a hard fill stock pile.

- The operator grabbed a bucket and went for a scoop of hard fill before its quick hitch had enough time to engage.
- The engagement process is automatic and takes about 4 seconds.
- The operator should have waited until the quick hitch's continuously sounding alarm stopped sounding to indicate that it was fully engaged.
- The Operator reported the incident.

- The operator stopped work, pulled his team together and held a safety meeting.
- The incident was discussed at a NNTP pre-start.
- Be patient, don't rush and give excavator quick hitch mechanisms time to engage.
- This incident was a reminder to everyone why we have safety rules such as:
  - Never stand under a raised load or excavator bucket.
  - Never enter an excavator's slew zone.
- If we unfailingly observe these rules nobody will ever be hurt.
