SAFETY ALERT

DATE: February 2021

Unattended haul truck rolls 65 metres

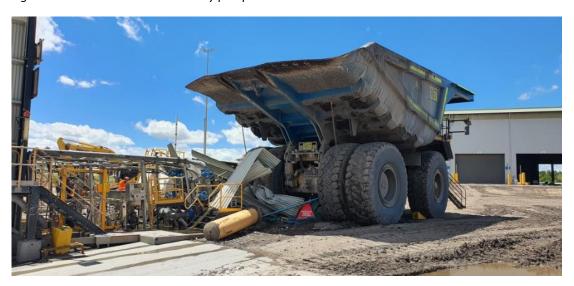
An operator parked a CAT793D haul truck on the workshop deadline for a defect repair. The truck was parked across a parking hump and the engine was switched off. Soon after the operator disembarked from the vehicle, it started rolling backward. The operator unsuccessfully attempted to stop the runaway vehicle. After rolling 65 metres, the truck collided with a pump and associated infrastructure at the heavy vehicle wash bay.

Figure 1 Truck collision with wash bay pump

- The park-up hump at the workshop deadline was not constructed to the site standard.
- The post-incident inspection of the truck cab found that the park brake had not been selected.
- The fail-safe park brake mechanism did not activate when the truck's ignition was switched off.

Further investigation on the vehicle found that a solenoid on one of the park brake valves failed and the air pressure did not bleed from the park brake circuit. This resulted in the park brake not being engaged automatically. The remainder of the fleet onsite was inspected and the same fault was also identified on another vehicle.

- All mobile plant park-up areas are designed, constructed and maintained to enable safe and stable parking.
- Work area inspections verify that mobile plant park-up areas are constructed and maintained to the standard.
- Brake testing regimes on mobile plant includes testing fail-safe mechanisms and interlocks.

Mine workers must ensure they apply the park brake prior to exiting mobile plant and must not rely on safety interlocks or other means of application of the park brake.
