NZ Safety Alert

10 March 2023

Collision of dump truck and loader

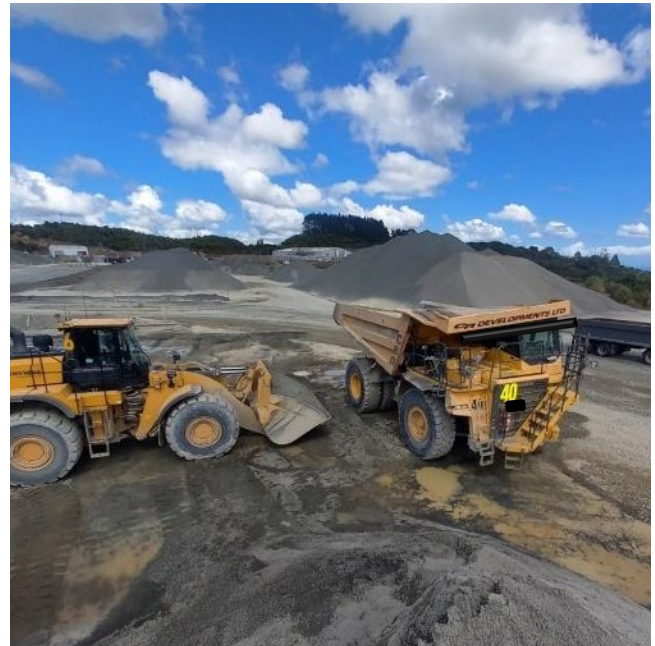
A dump truck operator was positioning himself to get loaded by a loader. The loader bucket was already lifted as the dump truck approached.

Being on the offside, the dump truck operator misjudged the distance and connected with the loader bucket.

The loader operator brought the bucket down to correct its centre of gravity and prevent it from being pushed over. In doing so, it damaged the side rail and mirrors of the dump truck.

1. Loader buckets are not lifted prior to trucks entering the loading zone, to ensure clear visibility is maintained.
2. Positive communication is maintained at all times in mobile plant operating areas.
3. Where possible, vehicles enter working areas from a direction that maintains clear visibility, i.e. operator side of vehicle closest to other operating equipment.
