NZ Safety Alert

1 December 2023

Dump truck tyre blow-out

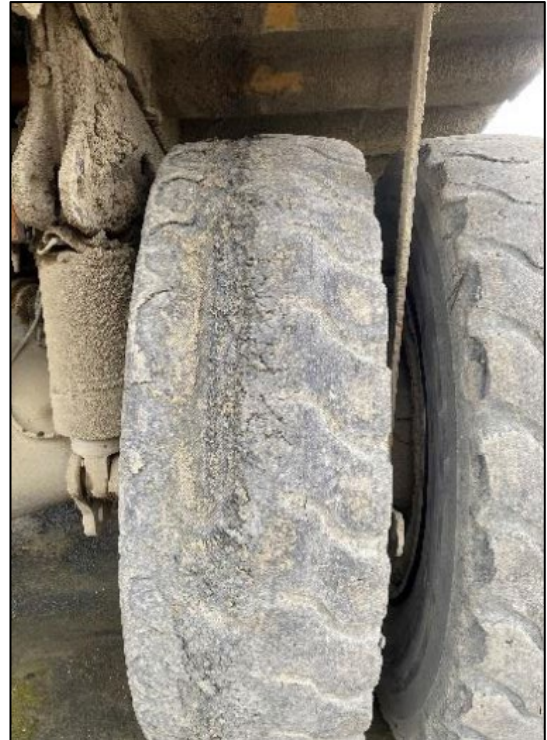
The occupants of the LV noticed a cut around the inner-right rear tyre on the truck. As the truck turned left at the switchback, it went over a rock, causing the damaged tyre to blow-out.

The force of the blow-out blew rocks towards the LV, which was turning right at the time, shattering the front passenger window. The passenger sustained a bruise to the left arm and a minor cut to the neck from the window glass.

1. Contractors follow maintenance and prestart protocols at your site or if relying on their HSMS, that you have verified their fitness for work checks and maintenance practices.
2. Adequate separation is maintained between heavy and light vehicles, particularly on haul roads.
3. Regular workplace inspections ensure haul roads are maintained to reduce tyre wear and damage.
