# NZ Safety Alert

24 February 2023

## Jack stand failure

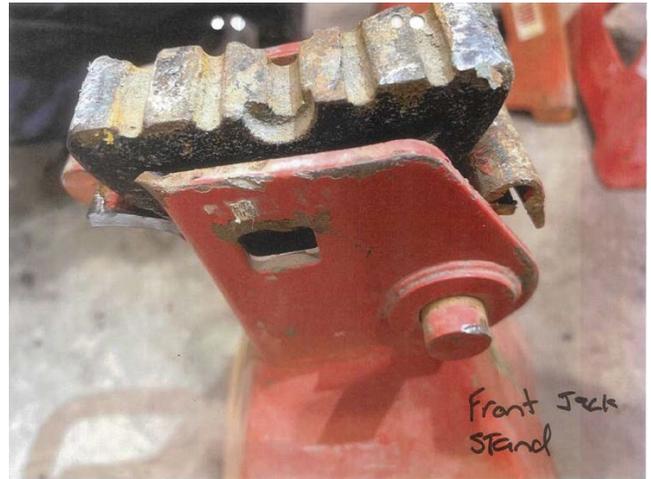
A fuel truck was being supported by 2 x 12T jack stands, while mechanics replaced the rear right and left leaf springs on the truck.

While carrying out the task, the jack stand on the right-hand side of the truck failed causing the truck to 'drop' to the right-hand side in an uncontrolled movement.

The weight of the truck (including actual fuel load) was unknown by the workgroup and was calculated based on best knowledge as approximately 21T, when it was > 26.4T.

The jack stands 'failed to safe' and no one was injured in the incident.

1. When planning for tasks that require the suspension of loads through either jacking or hoisting, the weight of the load being suspended is confirmed before commencing the task.
2. When a task changes, a risk assessment is to be carried out including the job steps, any additional hazards and any additional controls needed to be implemented.
3. No one is in the fall zone of plant being lifted or suspended.
