WEEKLY INCIDENT SUMMARY

Week ending Friday 30 August 2019

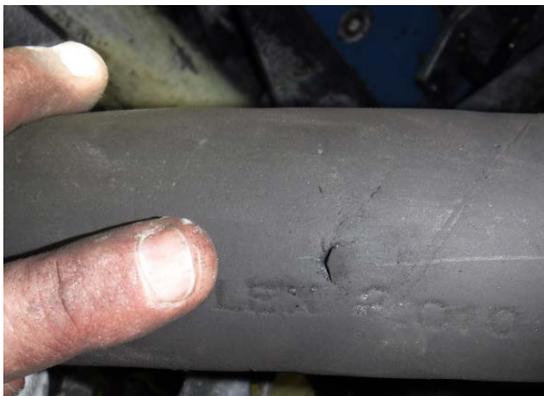
INCIDENT TYPE	SUMMARY	RECOMMENDATIONS TO INDUSTRY
Dangerous incident IncNot0035398

<p>A damaged continuous miner cable arced when a worker picked it up to move it.</p> <p>The continuous miner had previously tripped and the fault was reset. Upon repowering the miner and beginning the flit, an operator</p>	<p>It is crucial that electrical engineers know, understand and maintain electrical protection settings.</p> <p>Mines must have systems in place to complete inspections routinely as well as after any identified fault.</p> <p>Mine operators should also review their preventative maintenance schemes for electrical cables to identify defects that could lead to an arcing incident. The review should include:</p>

went to move the cable and there was an arcing event.

- inspections for cable and sheathing damage
- lifecycle management (age of replacement) for cables

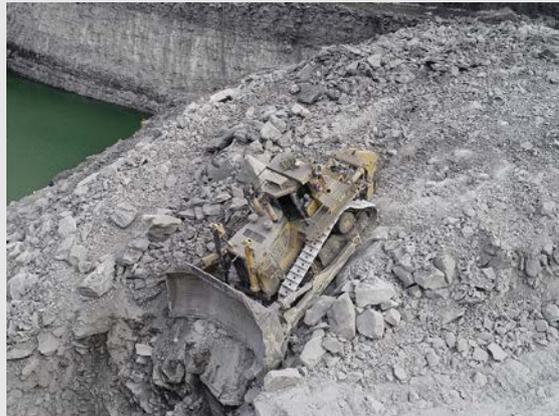
Dangerous incident
IncNot0035400

An operating dozer has pushed over onto a grade and has lost traction and become stuck.

The operator has underestimated the grade and, combined with the hard and slippery material, he has not been able to get enough traction to reverse.

The operator removed himself from the machine and a recovery plan was developed.

Mine operators need to identify risks associated with working near a steep drop-off when combined with hard and slippery floor conditions.

Dozer operators should not be exposed to these risks when pushing shot ground.

The risks must be assessed, and suitable controls must be implemented to eliminate or minimise the risks.

Pre-task risk assessments (such as JSAs) should be considered as a minimum.

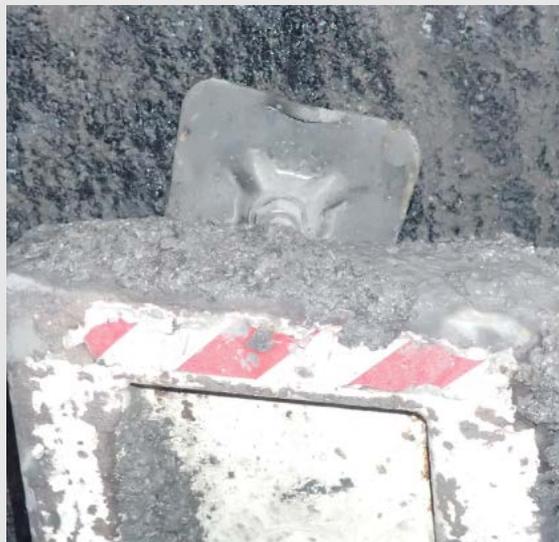
Serious incident
IncNot0035430

While reversing a continuous miner, the rib protection became jammed on a rib bolt causing the rib protection to deflect and strike the operator in the head.

Before the incident, the continuous miner was driven off-centre for approximately 50 metres, including 'over' correction. No corrective action had been taken.

Mine operators should review procedures that address how their development roadways are driven on centre.

Deputies and undermanagers should record when the continuous miner is not on centre and record any corrective action taken.
