WEEKLY INCIDENT SUMMARY

Week ending Friday 13 September 2019

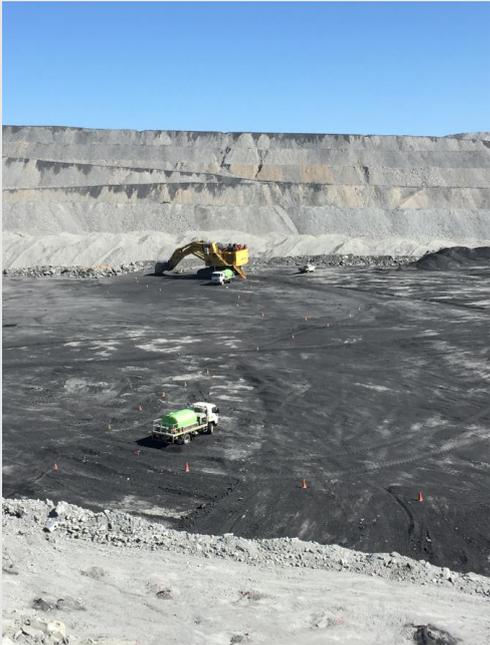
INCIDENT TYPE	SUMMARY	RECOMMENDATIONS TO INDUSTRY
<p>Dangerous incident IncNot0035498</p>	<p>A service truck, at an open cut coal mine, rolled away from where it was parked. The vehicle travelled approximately 50 metres before turning itself around. It continued to travel another 80 metres, coming to rest on a coal windrow on the bench below a loaded and demarcated blast zone.</p> <p>As the vehicle was rolling, a worker ran after the vehicle until the truck came to its finally resting place. The worker turned off the pumps and drove the vehicle out of the demarcated area.</p>

<p>Mine operators must ensure that all vehicles are parked in suitable areas or designated park up areas.</p> <p>Workers should receive communication regarding:</p> <ul style="list-style-type: none"> • compliance with correct parking procedures • being situationally aware of hazards. <p>Mine operators should consider:</p> <ul style="list-style-type: none"> • audible warning systems and/or visual alarms to warn of the lack of park brake application • interlocking that automatically applies the park brake when the operator leaves the operator's position (i.e. door interlock). • functional testing of park brake application warning systems • the recommendations in safety bulletin SB13-02 Unplanned movements of vehicles - too many near misses.

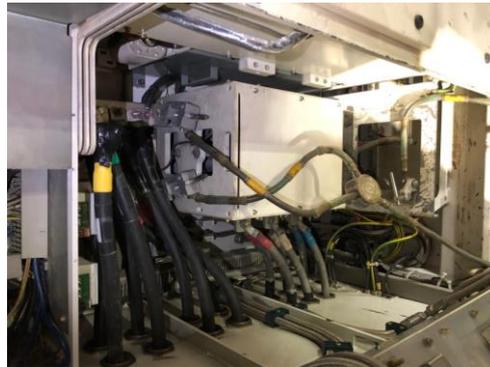
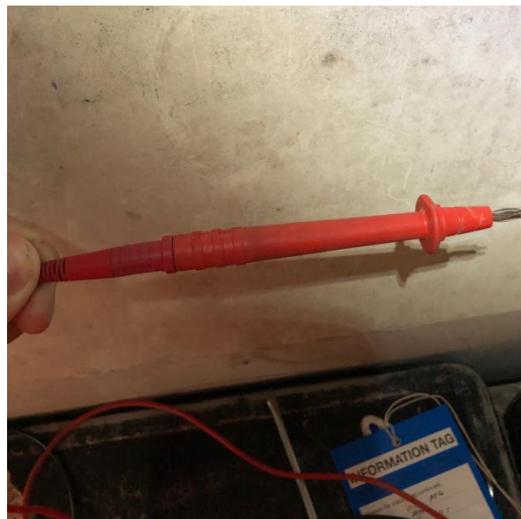
<p>Dangerous incident IncNot0035515</p>	<p>A contract worker suffered an electric shock at an open cut coal mine. The worker was conducting insulation test using a 5 KV tester on a Liebherr 282 haul truck wheel motor.</p> <p>The investigation identified a lack of procedures and training regarding the correct use the 5 KV insulation tester, and that the tester leads were not fit for purpose.</p>	<p>A section 195 notice was issued to the mine prohibiting the use of the 5KV tester until safe work procedures were developed and implement.</p> <p>High voltage test equipment must be operated by a trained and competent person and must be maintained in a fit for purpose condition.</p>

The worker was taken to hospital for further assessment.

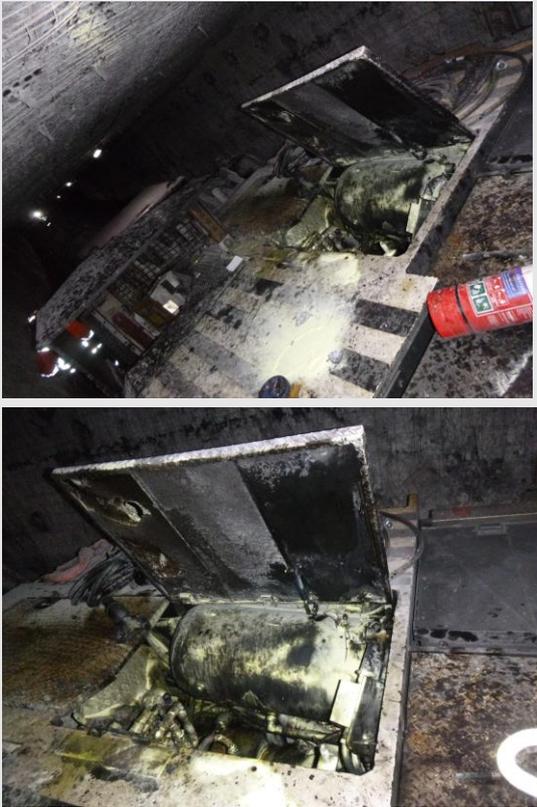
Dangerous incident
IncNot0035517

A load haul dump (LHD) was towing a feeder breaker on a sled into an underground coal mine when a uni-joint on the tailshaft failed.

The tailshaft appeared to have damaged hydraulic hoses within the engine bay, resulting in a fire. The fire suppression system on the LHD was activated, extinguishing the fire in the engine bay.

A secondary fire occurred on one of the engine bay covers, forced open by the failure. The secondary fire was

INCIDENT TYPE	SUMMARY	RECOMMENDATIONS TO INDUSTRY
	<p>extinguished by the machine operator with a handheld fire extinguisher.</p> <p>No one was injured as a result of the incident.</p>

Mobile equipment should be inspected and maintained to a high standard to reduce the risk of component failure, helping to keep the risk of fires to as low as reasonably practicable.

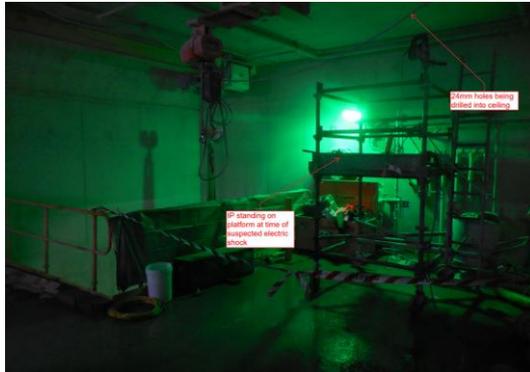
Dangerous Incident
IncNot0035523

A contract worker at a metalliferous mine was drilling a vertical hole into concrete using a hand held 240-volt wet drill. When the worker pressed the trigger of the device, an electric shock was felt.

The investigation identified that a water collection system, in conjunction with a wet-type industrial vacuum cleaner, is a mandatory requirement for working on ceilings.

Mine operators and contractor managers should ensure that before workers use 240-volt portable tools, they conducted an inspect of the equipment and it is used as per the manufacture’s recommendations.

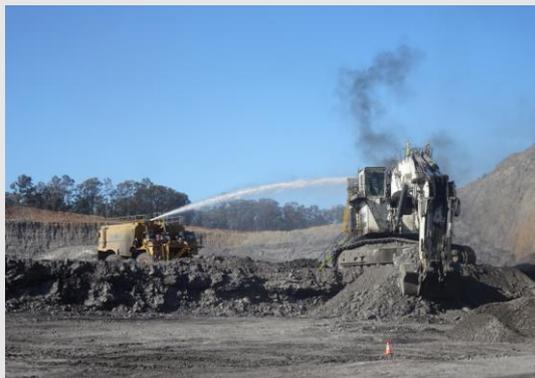
Dangerous incident
IncNot0035537

An excavator at an open cut coal mine was operating during production when a fire occurred.

Further cooling via water cart was required to fully extinguish the fire. The fire occurred in the engine bay of the excavator, with the specific cause still to be determined.

Mine operators must conduct a thorough investigation, by a competent person, to determine the root cause of any fire that occurs on mobile equipment. The investigation should include:

- fuel source and heat sources
- surface temperature value
- cause of the fire
- controls to prevent reoccurrence, such as reducing engine component surface temperatures and segregating fuel sources from areas of high temperature
- training workers to identify fire risks, such as fuels or oil leaks or worn hoses
- review of the fire risk assessment for the item of plant.

Mine operators should report the issue to the equipment manufacturer.

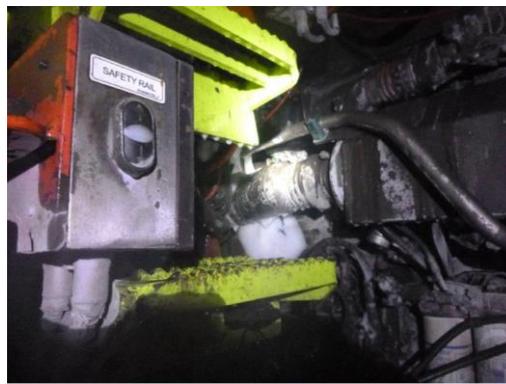
Dangerous incident
IncNot0035538

An underground loader, at an underground metalliferous mine, was in the process of bogging when the operator noticed oil spraying at the

rear of the machine and flames within the engine compartment.
 The worker manually activated the on-board fire suppression system, which immediately extinguished the fire.
 The worker was able to exit the machine without injury.

Mobile equipment should be inspected and maintained to a high

standard to reduce the risk of component failure, keeping the risk of fires to as low as reasonable possible.
