<b>INCIDENT</b>	<b>Near Miss P4</b>
<b>SUBJECT</b>	Truck Collides with Traffic Sign and Stops in Live Lane
<b>INCIDENT DATE</b>	03/07/2020
<b>BUSINESS UNIT</b>	Higgins – Auckland

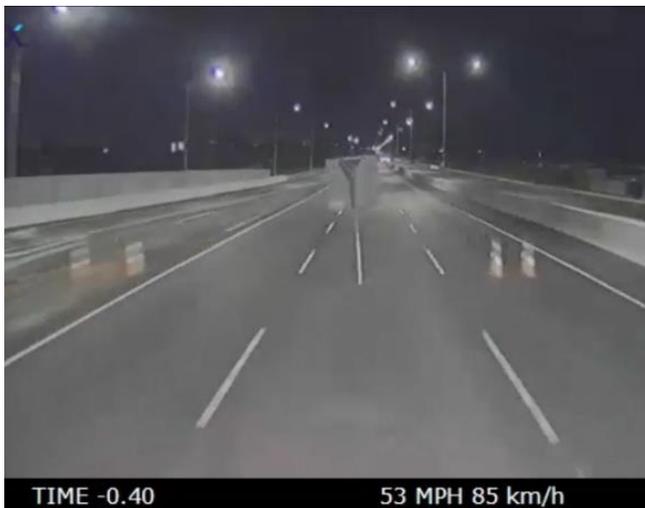
*Photos: Left – Dashcam footage screenshot showing traffic sign in middle lane moments before impact; Right – Damaged truck;*

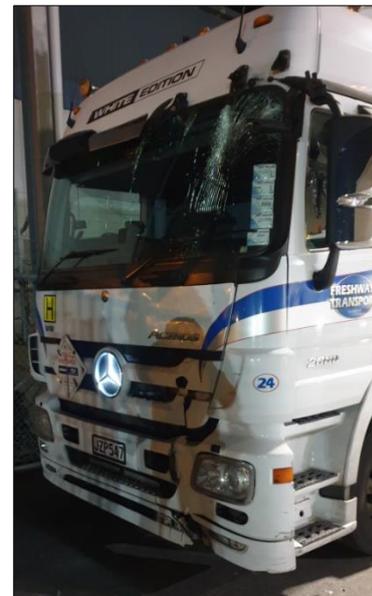
It was later confirmed upon viewing ATOC video footage that the truck and trailer in question had collided with a traffic sign and that the impact caused some significant damage to the vehicle.
