NZ Safety Alert

Truck tyre blow out

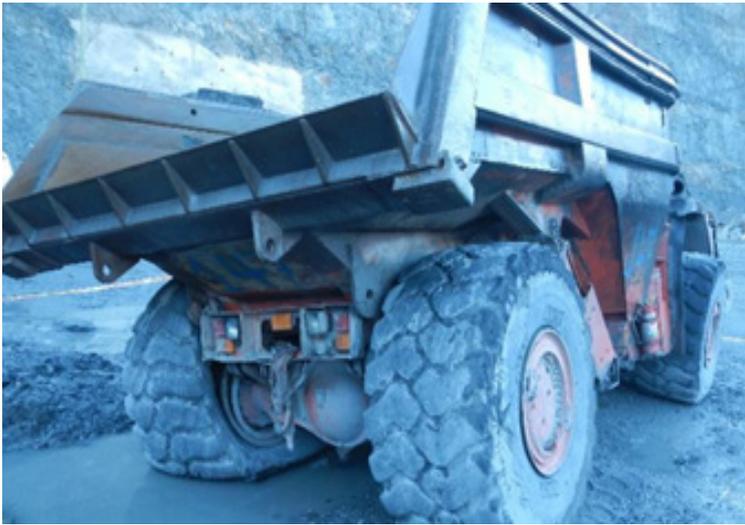
A worker was washing down a dump truck at the wash pad when the truck experienced a rupture of the rear left hand tyre involving the inside sidewall and bead.

At the time of the incident the body of the truck was in a raised position and the operator was at the rear of the truck, bending down to retrieve a hose, when he heard a loud noise and the truck dropped on the left side.

1. Regular inspections of tyres and rim assemblies are conducted to detect defects.
2. An exclusion zone is established when inflating tyres and workers stand outside of the exclusion zones when seating a tyre bead and inflating tyres above 35 kPa or 5 psi.
3. The air hose between the clip-on valve nozzle and the remote gauge and trigger is long enough for workers to stay outside of the exclusion zone.
4. A remote dump valve is fitted that is capable of rapidly deflating the tyre in an emergency.
5. Tyre fitters and workers inspecting tyres and rims are trained and assessed as competent to complete these tasks.
