Coal Inspectorate | Alert | No.386 V 1 | 19 February 2021

Unplanned vehicle movement - Failure of Battery Isolator and Braking System

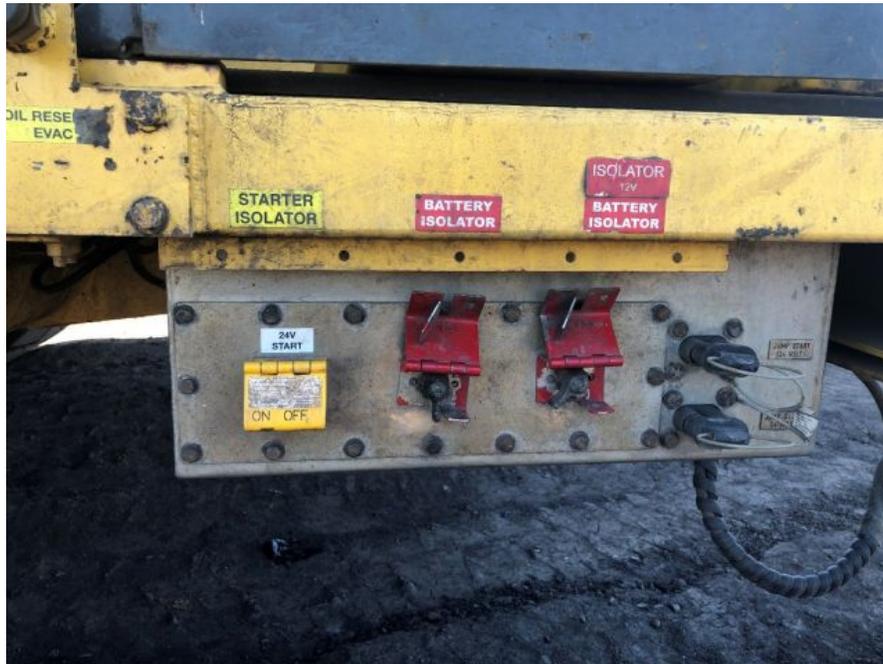
There was an existing issue on the main battery power isolator where it was difficult to initiate it into the ON position due to the mechanism being tight to turn. When the battery isolator has been reset it has not been fully turned, locked, and engaged into the ON position, allowing the isolator to trip to the OFF position, likely from vibration during operation of the truck.

- Mines should review their safety and health management system (SHMS) to ensure the continued effectiveness of braking systems on fixed and mobile plant used at the mine.
- Mines should review their SHMS to ensure training schemes for the operation of mobile plant communicate and control the hazard of park brake degradation to both assessors and operators if applicable.
- Mines should review their SHMS to ensure it provides for reporting all defects in the mine's plant, structures and procedures and the rectification of defects that create an unacceptable level of risk.
- Mines should review the battery power isolator operation on rear dump trucks and ensure that any similar defects are rectified.

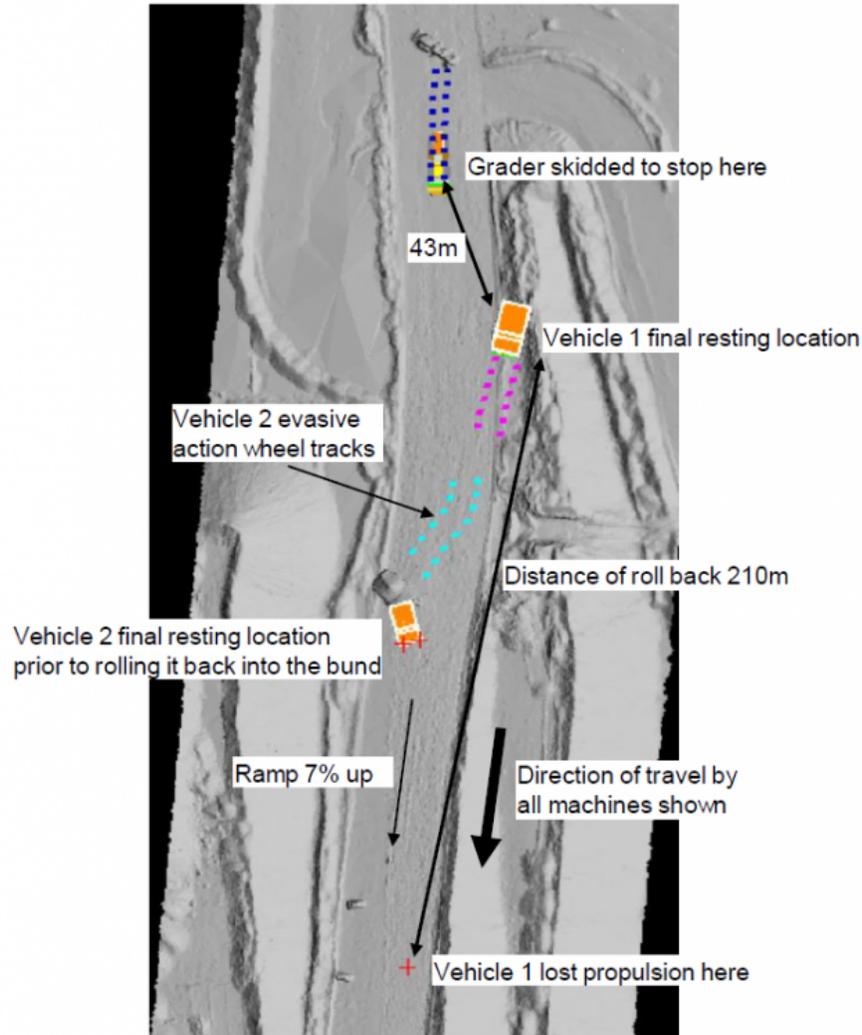
Incident Measurements

A Komatsu 930E-2 rear dump truck ascending a ramp incurred a fault and lost all power and propulsion, coming to a complete standstill on the ramp. The operator exited the cabin and descended to ground level to reset a battery isolator. When the operator stepped off the access ladder the rear dump truck began to roll backwards. It gained speed, travelling an estimated distance of 200 metres down the ramp and came to rest on a bund. A grader and another rear dump truck had to take evasive action.
