SAFETY BULLETIN

DATE: NOVEMBER 2019

Hoist rope unravels over head sheave

This safety bulletin provides safety advice for the NSW mining industry relating to small gemstone mine person-riding hoists (winding systems).

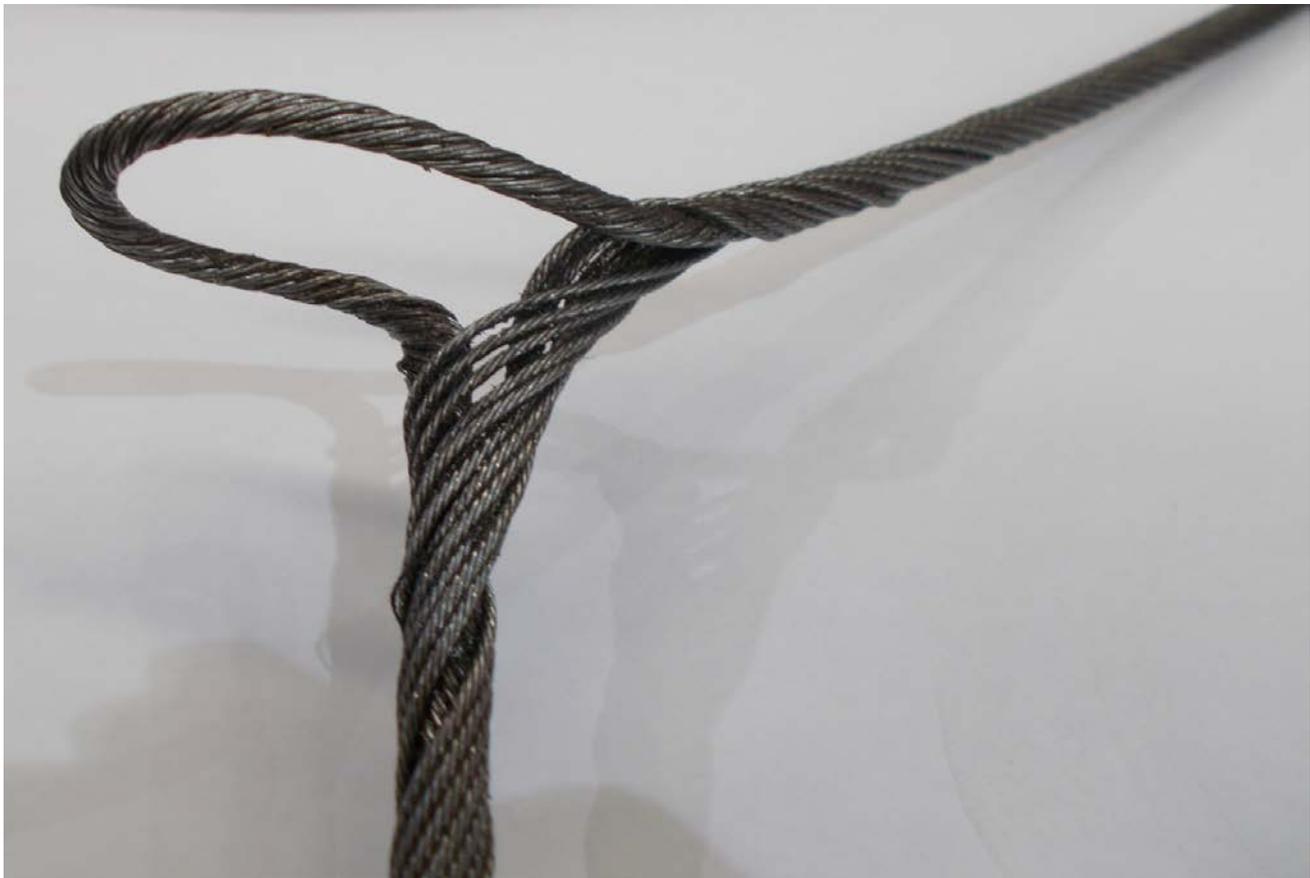
A person-riding gemstone hoist winch rope was found with the inner strand of the rope protruding from the rope lay in two places. This condition reduced the strength of the rope. This may have caused it to break and injure people, on or under the conveyance.

Figure 1 Hoist rope with inner strand protruding

In two places, the inner strand protruded from the outer rope layer as shown in figure 1. In other areas, some wires were found to be proud of the rope profile, as shown in figure 5 below.

When the rope was unloaded, the built-up torque in the rope resulted in two rope distortions occurring where the inner strand protruded from the rope.

The rope breaking force of the damaged rope was found to have lost 10% of its strength where the wire was proud of the rope and up to 50% loss of strength where the inner strand had protruded.

- carry out a visual inspection of hoist ropes to look for evidence of protruding wires or strands. If protruding strands are found, the rope must be replaced.
- measure both the head pulley groove diameter and rope diameter. Ensure that power to the hoist is isolated, all energy has been dissipated and safe access for working at heights is in place before taking measurements.
- consult the hoist designer to determine if the rope in service is compatible with the head sheave design.

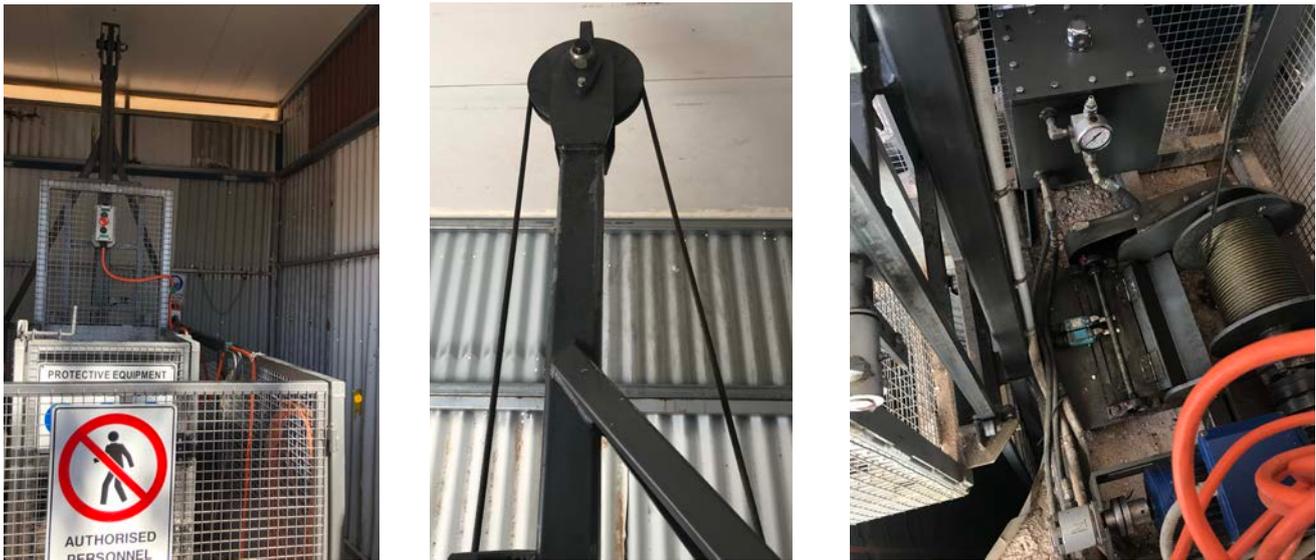
The 33-metre wire rope was installed on a man-riding hoist that was registered to carry one person at a small gemstone mine shaft.

The 8-millimetre diameter non-rotating wire rope lay in a 12-millimetre diameter head pulley groove.

Figures 2, 3 and 4: Arrangement of the hoist showing the conveyance, head sheave and winch drum.

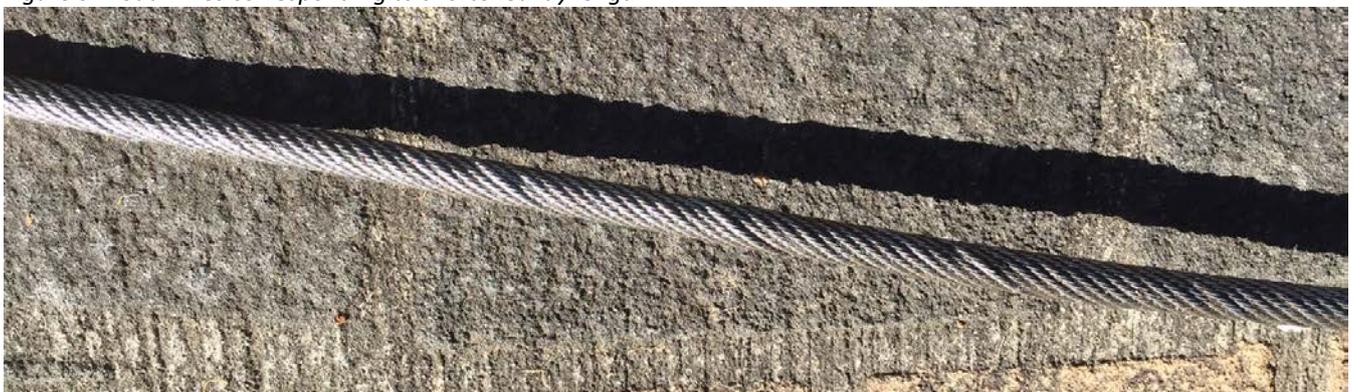
The rope lay length, which is the period of one strand from where it comes around the rope to the next in-line position was measured. The lay length was found to increase along the rope, affecting the non-rotating properties of the rope.

Figure 5 Proud wires corresponding to shortened lay length

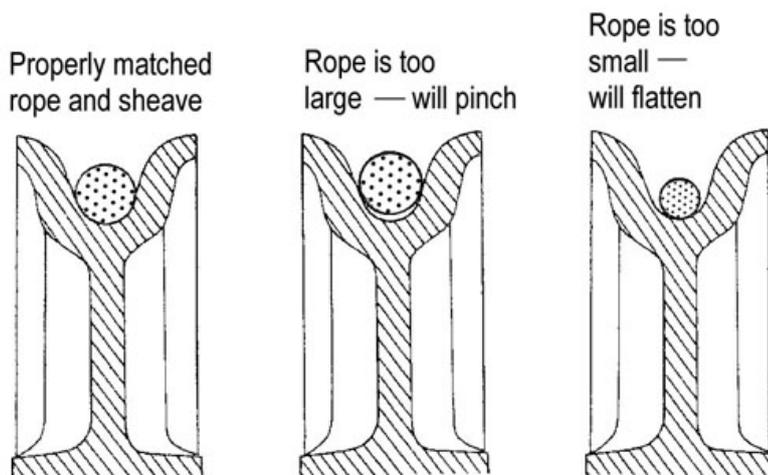
The rope condition is believed to be affected by compatibility factors associated with the head sheave groove dimensions.

Figure 7 Head sheave groove diagrams showing matched, tight and too large rope groove conditions.

- adhere to Australian Standard AS 3785.7 *Underground mining equipment – Sheaves* which gives guidance that the head sheave groove diameter should be 7.5% to 12% greater than the nominal rope diameter for which the sheave is designed.
- ensure that the sheave diameter should be equal to or larger than the diameter of the drive drum.
