Incident alert

LOCATION:	CONSTRUCTION/DELIVERF	ALERT STATUS:	Normal
	SITE	DATE ISSUED:	11/12/2019 09:30:37
ACTIVITY:	TRANSPORT / DELIVERY	INCIDENT No:	01539
SUB ACTIVITY:	PRODUCT DELIVERY

Hydraulic Tipper Door Injury

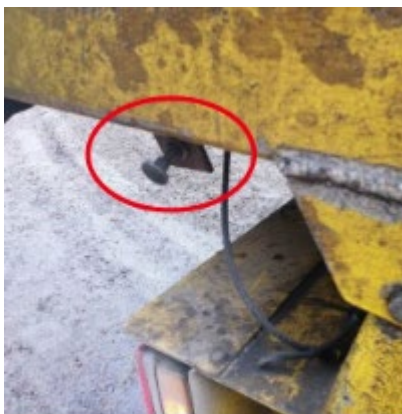
Air Ram Release Button

A tipper truck was reversing on site to tip and was being guided by the site banksman who was part of a contractors site staff. The banksman had stopped the truck, and whilst the driver was engaging the PTO for raising the body of the truck, the banksman took it upon himself to push the button to operate the air rams for the split half door.

The driver of the truck is the only person who should operate the system for releasing the back door - the banksman should not have touched the truck unless directed to by the driver.

Banksmen are NOT to touch any part of a vehicle or plant unless instructed to do so by the driver, or as part of their normal duties.

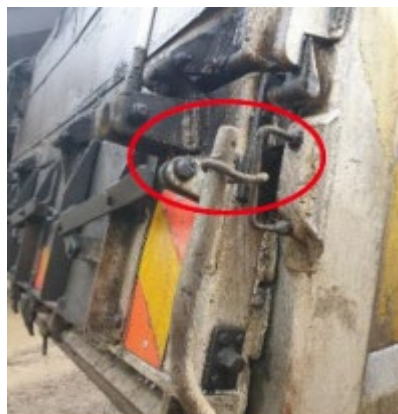
Door Handle Retaining Ring

Due to the retaining rings which hold the doors closed not being released before the air ram button was pressed, this put pressure on the door release handles. When the driver came to release the handles by lifting the rings, the split door opened under pressure and hit him on the side of his upper body near his ribs, causing significant bruising.

All drivers should be aware of their responsibilities when carrying out tipping operations.
