WEEKLY INCIDENT SUMMARY

Week ending 26 April 2019

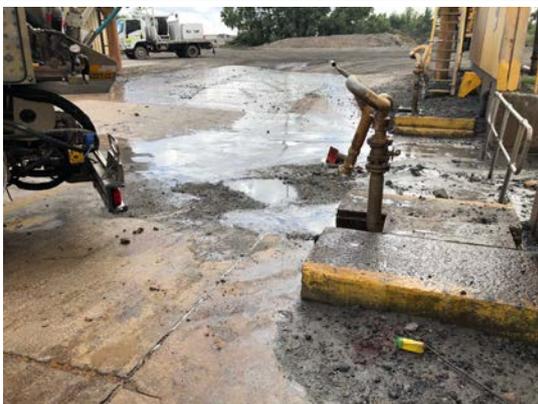
INCIDENT TYPE	SUMMARY	RECOMMENDATIONS TO INDUSTRY
Loss or theft of explosives IncNot0034414	<p>A vacuum truck was used at a mine to remove explosives from two holes that had slumped due to rain. The truck was inspected by the shotfirer and cleaned before leaving the site.</p> <p>Two days later, the same truck was used at another mine. While being cleaned, an explosives GL booster and detonator were found in the wash down bay sump. The booster was identified to have come from the previous mine.</p>	<p>Mine operators should review procedures for cleaning out vacuum trucks to ensure all lines and tanks are free of material that could contain explosive precursors from the blast hole.</p>

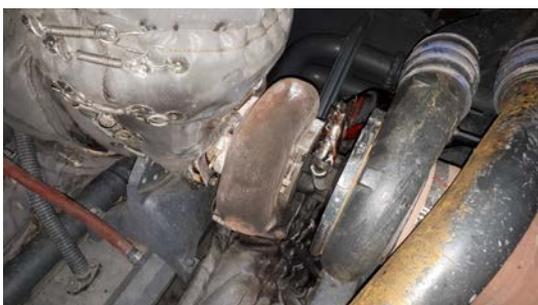
Dangerous incident
IncNot0034428

A Hitachi EH5000 haul truck stopped at an in-pit fuel farm. The operator left the cabin and noticed smoke through gaps in the top deck. The operator walked down the stairs and noticed flames at the left-hand engine bay. He returned to the cabin, called emergency and manually activated the fire suppression system. The fire was extinguished, and the water cart attended the incident.

Failures of turbocharger oil supply lines have been identified as the cause of many mobile plant engine fires. Mine operators must develop and adhere to strict inspection and maintenance standards and practices specific for their site conditions, to prevent loss of oil through oil feed lines and mitigate potential engine fires.

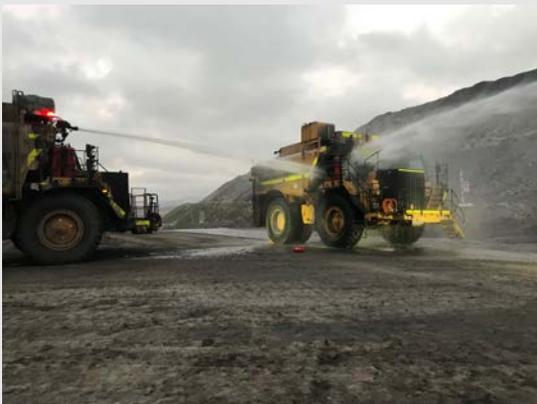
INCIDENT TYPE	SUMMARY	RECOMMENDATIONS TO INDUSTRY
<p>Dangerous incident IncNot0034429</p>	<p>A fire occurred on a water truck located at the top of a ramp. The operator stopped the truck and activated the fire suppression system. The fire suppression system was unsuccessful in extinguishing the fire. Hand held extinguishers and a water cart were used to extinguish the fire. No one was injured. An escape of fluid onto a hot surface was identified as the cause.</p>

<p>Loss of hydraulic oil or hydrocarbon fluids is a common cause of fire on mobile plant. Mine operators should identify, evaluate and segregate hot surface temperature ignition sources from potential fuel sources.</p>
<p>Dangerous incident IncNot0034437</p>	<p>Mineworkers reported a burning smell at an underground coal mine. On investigation, burning coal embers were identified, which were ignited by a dislodged roller that was running in fines at a roadway underpass. The heating was cooled and extinguished by a water hose. The dislodged roller was most likely caused by a vehicle contacting the underpass guards.</p>	<p>Mine operators must ensure a minimum clearance to vehicles at underpasses and that conveyor belts run clear of fixed structures and fines in all locations.</p>

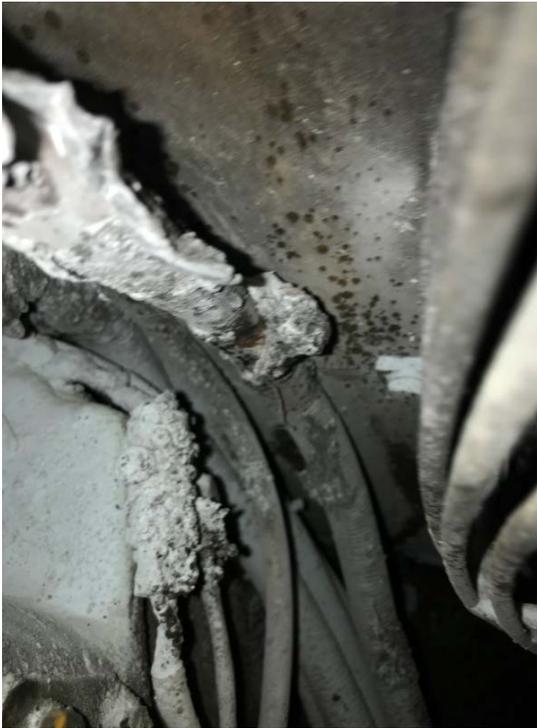
INCIDENT TYPE	SUMMARY	RECOMMENDATIONS TO INDUSTRY
	<p>managed to regain control on a flat part of the roadway.</p>	
<p>Dangerous incident IncNot0034443</p>	<p>An underground loader at a metalliferous mine caught on fire due to insulation on a battery lead being worn through. The fire suppression system was automatically activated. The operator then used a fire extinguisher to extinguish the fire.</p>

<p>Mine operators must ensure auto electrical components on diesel equipment are maintained in a fit for purpose state. Cabling and wiring harnesses should always be secured and routed to keep clear of moving parts and heat sources.</p> <p>Following a fire on mobile plant, once the suspected cause of the fire has been identified, all other equipment of the same type in service at the mine should be inspected as soon as possible to ensure the defect does not exist on these other machines.</p> <p>Refer to MDG15 for further information.</p>

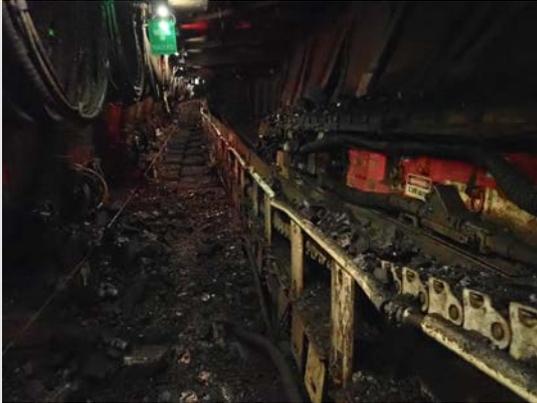
<p>Dangerous incident IncNot0034460</p>	<p>A coal burst occurred during remote mining on a longwall, causing the shearer and armored face conveyor to trip. Video footage was used to confirm the coal burst. The mine followed site procedures and no injuries occurred as a result of the incident. An investigation is continuing.</p>	<p>Mine operators must complete a geotechnical assessment to determine the correct support requirements taking into account the potential for rock burst as per cl44B(2)(d). Mine operators should firstly determine the risk of rock burst and then the required support to minimise likelihood. Following this assessment, the mine operator should assess appropriate controls including</p>

<p>de-stress drilling, hydro-fracking and no-go zones if the risk of rock burst exists. In most instances rock burst and coal burst should be treated as the same risk.</p>
